APPENDIX No. 29.

LIVERPOOL, CROSBY, AND SOUTHPORT RAILWAY.

I HAVE the honour to report to you, for the information of the Lords of the Committee of Privy Council for Trade, the result of an inquiry which, in compliance with the instructions conveyed to me in your letter of the 26th ultimo, I made into the circumstances attending a singular accident which occurred upon the Liverpool, Crosby, and Southport Railway on the evening of the 11th ultimo.

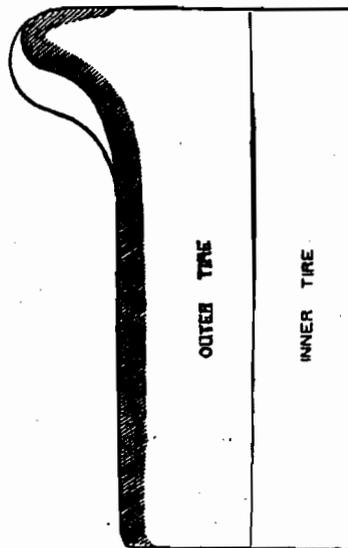
On examining the trailing wheels, however, I found that the right-hand trailing wheel was very much bent upon its axle, and that the flange showed several deep notches which corresponded exactly with the ridges of the ribs of the cast iron chairs. It was clear that this wheel had been bent by being dragged along outside the right-hand rail, and that the notches had been made by the ribs of the broken right-hand chairs.

On comparing the tires of the two trailing wheels I found that the flange of the right-hand wheel had worn so thin as to have been quite unsafe. I have traced a section full size of the tires of these two trailing wheels, and it will be seen that the flange of the right wheel had worn to scarcely six tenths of an inch, while that of the left-hand wheel still remained at nearly its original size. The engine had only been sent out from the Lancashire and Yorkshire Company's workshop on the 17th July, and the accident occurred upon the 11th August, when the engine had only been running about three weeks, and there was no circumstance whatever connected with the traffic to make the flanges wear so unevenly in so short a time. At first I thought that an unequal wearing might have been produced by the left-hand wheel being somewhat larger in diameter than the right, which would have the effect of continually pressing the right-hand flange against the rail; but on measuring the wheels I found that the right-hand one was fully one third of an inch more in circumference than the left, and that if there had, therefore, been any inequality of pressure it had been borne by the left-hand wheel. I could draw, therefore, no other conclusion from the insufficiency of the right-hand flange than that the Lancashire and Yorkshire Company's locomotive staff had done their work in a negligent manner. The effect of allowing this engine to work with so thin a flange must have been greatly to exaggerate the inequalities of the wavy sinuous course peculiar to all outside cylinder engines, and there were traces in several places of the thin flange having become too weak to resist the heavy blows against the rail.

Section half size of the tires of the trailing wheels.
 The inner flange is that of the right-hand trailing wheels.
 The outer line shows the flange of the left.

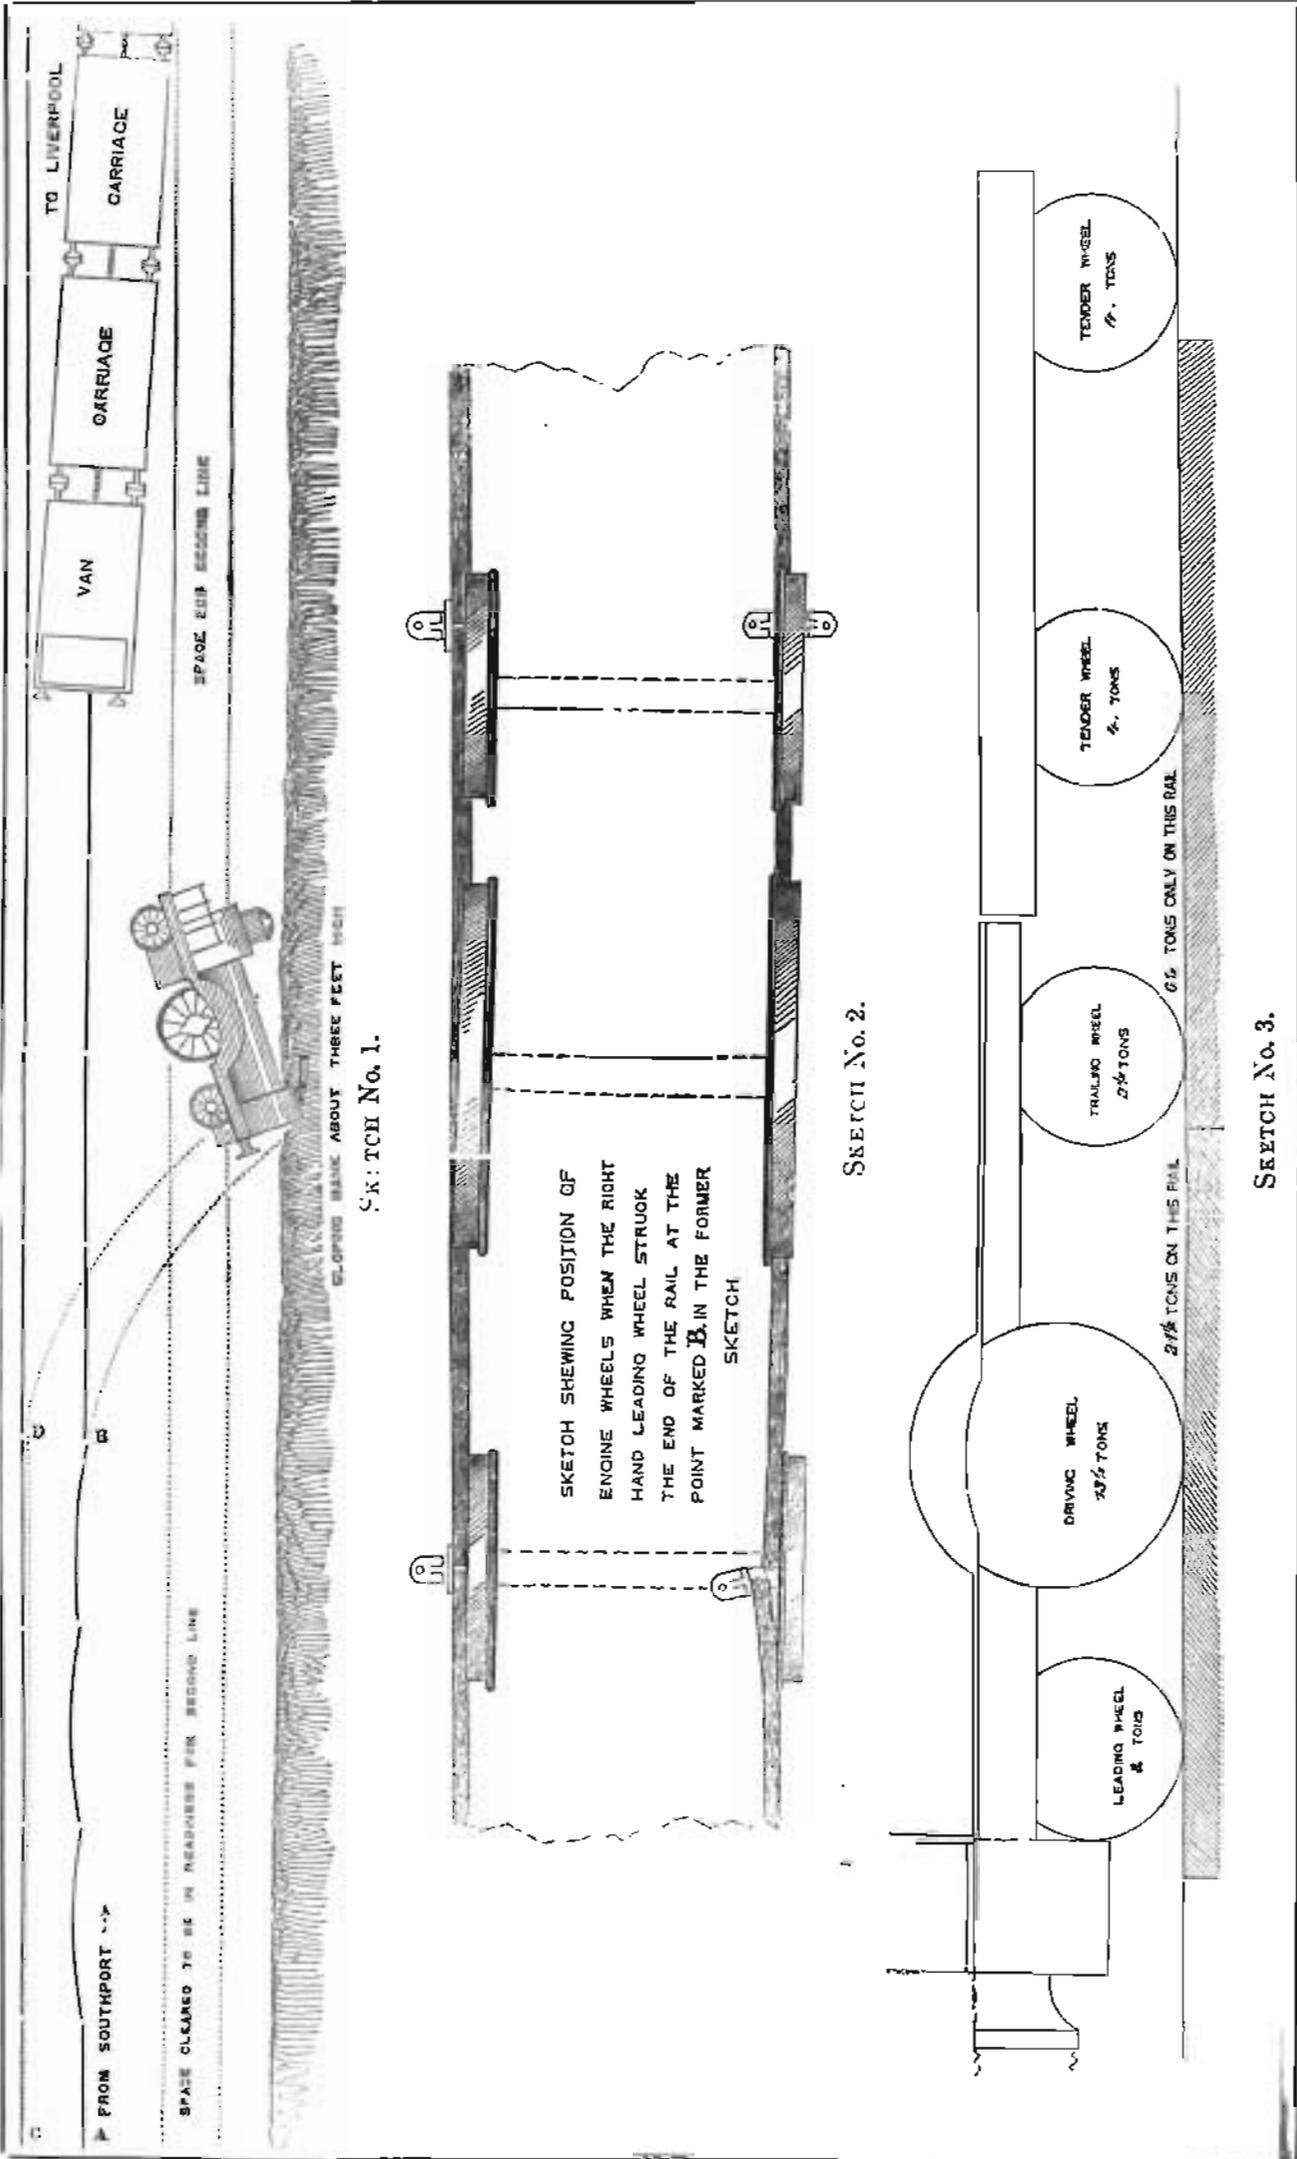
I have sketched the position in which the engine and carriages were found, and the appearance presented by the permanent way immediately after the accident.

It appears that the engine left the line at the point marked B, and at that point the end of the next rail shows a deep indentation, and the iron is split, as by a violent blow to the depth of several inches. The indentation corresponds exactly with the form of the flange of a wheel, and it was evident, therefore, that the engine had left the line in consequence of one of its wheels coming in contact with the end of the rail at B.

Next, tracing back the line towards Southport, it was found that the four right-hand rails, extending back to the point marked A, were bent and forced from their places, and that all the chairs which held them were broken across the bed, and from the marks on these chairs and rails it was evident that one of the wheels of the engine had got over the right-hand rail at the point marked A, and been dragged along outside it till the other wheels got off at B.

At the point marked C (corresponding to A on the right-hand rail) the track of a wheel lightly traced upon the sand was observed to run parallel to the left-hand rail, and inside it, and the chairs of the left-hand rail from C to D bear faint marks, sometimes amounting only to a slight discolouration showing where they had been touched by the tire of a passing wheel.

In conclusion, I beg to recommend that the Liverpool, Crosby, and Southport Company proceed at once to lay down a second line of rails throughout, and that in doing so they adopt a much heavier rail than that now in use. I would recommend also, so long as the Company retain any of the present light rail upon their line, they draw up their time bills so as to allow of a slower speed in their passenger trains. I would recommend them also to be more careful for the future in enforcing strict punctuality in the times of arrival and departure.

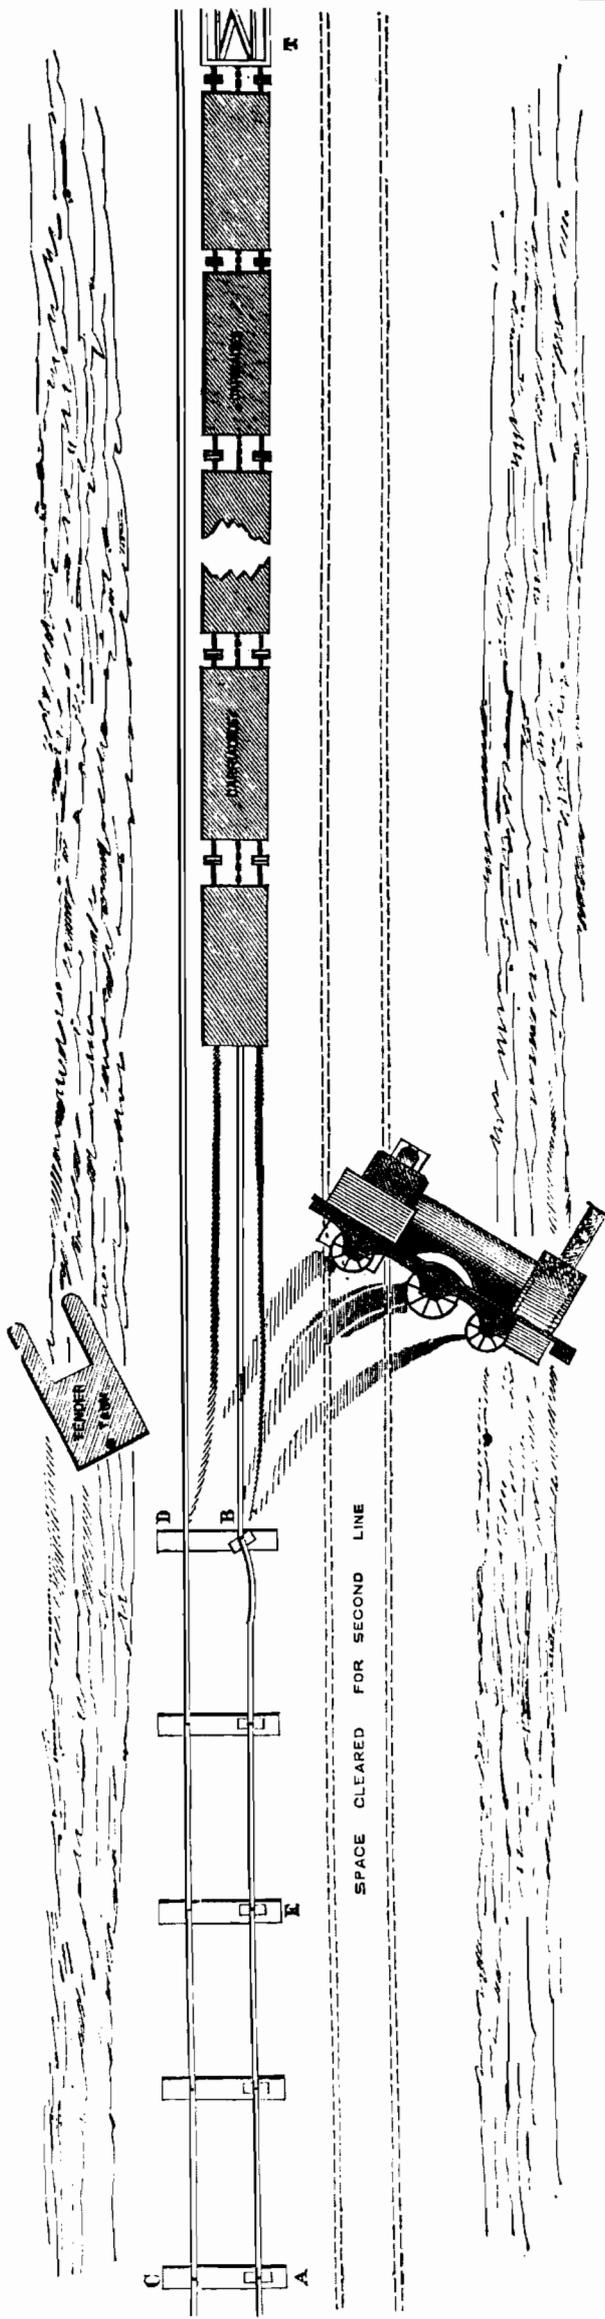
SKETCH No. 1.

Referring to sketch No. 1, it will be observed, the whole train left the rails at B, out no opening was made, as shown by Captain Laffan, nor was the chair broken; the tie nails gave way, and the chair turned upon its bed, still embracing both rails, and the key remaining in its place.

The broken chair, marked E, clearly explains in what way the indentations were made in the right trailing wheel flange.

Between A and B many chairs were broken, as shown by E, the outer part going with the rail, left the inner part fast to the sleepers; here the road was forced out of gauge, and the flange of the trailing wheel having worn thinner than the others, and consequently deeper, was brought in contact with the broken chairs, leaving "the deep notches" referred to.

On turning to the permanent way, several chairs were broken between A and B, three of the rails slightly bent, the fourth very much so, and in shape, as shown by sketch No. 1, leaving a break upon the inner surface of the next rail; upon this break the right leading wheel of the engine mounted, and ran off the rails suddenly; the right leading side of the engine had then mounted upon the bank, and its hinder end having been carried round upon the front end of the tender, was lodged cleared off the rails altogether, and the remainder of the tender was forced onwards by the carriages, for some distance beyond where the engine lay; everything showed that the right hind part and the right front of the tender had been in contact as described; under the foot-plate all was cleared away by the frame of the tender, and over it the hand railing, &c. had been taken off by the water tank, which was projected to the opposite side of the line, and the right side of the tender framing was broken downwards to the first axle, bearing on the same side.

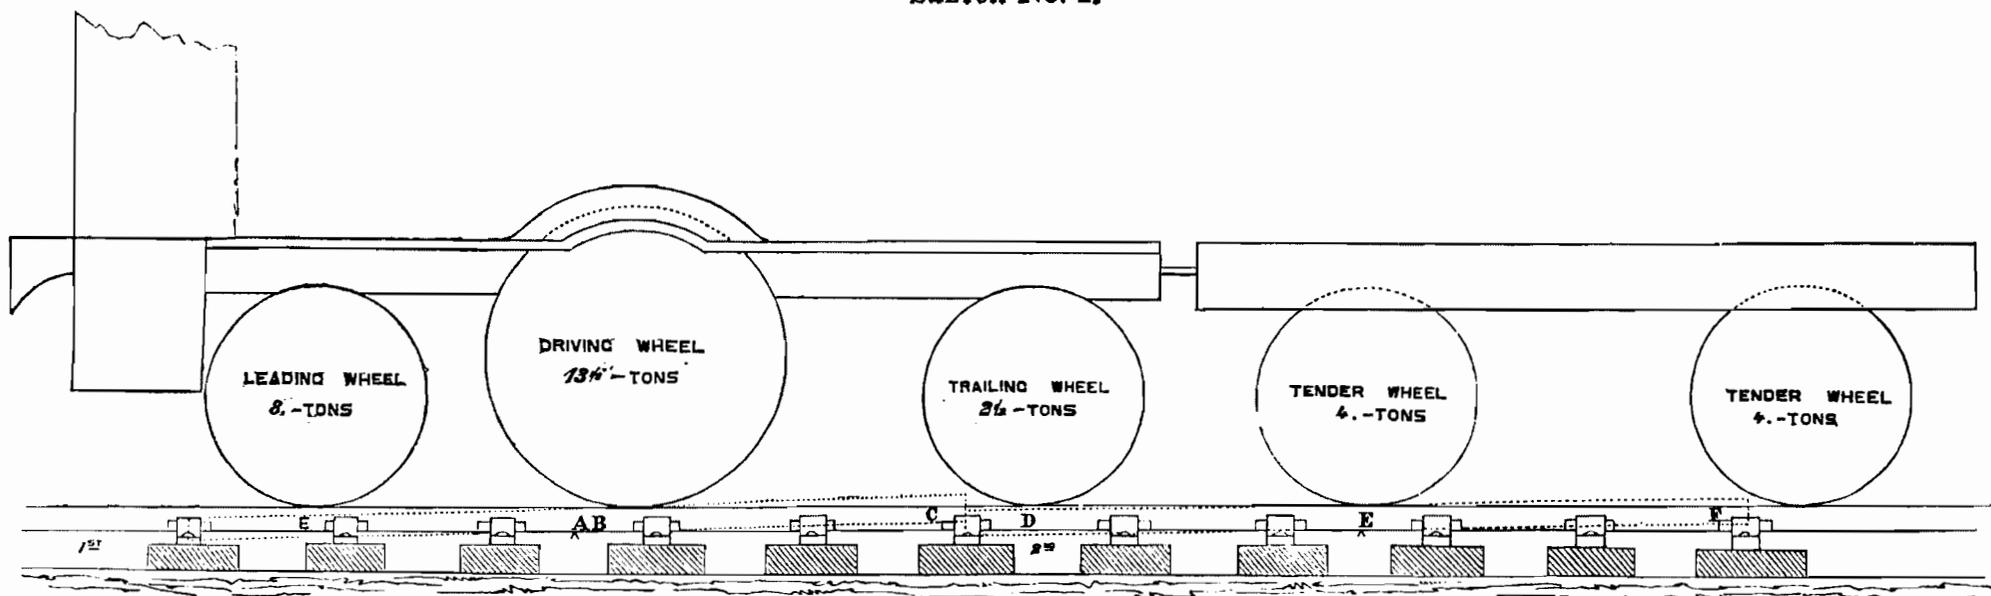
SKETCH No. 2.

Captain Laffan illustrates, by a sketch, the position of one of your engines, followed by its tender, and goes on to show that these "passing over a slight permanent way loosely fitted" has a tendency to depress the rails, so as to lead the trailing wheels from a "higher to a lower level," at every joint; and finally ascribes the cause of the accident to "one of these jumps at a joint," having caused the right-hand trailing wheel of the engine to cross over the right-hand rail.

The dotted lines show the position the rails would have assumed had they been closely fitted.

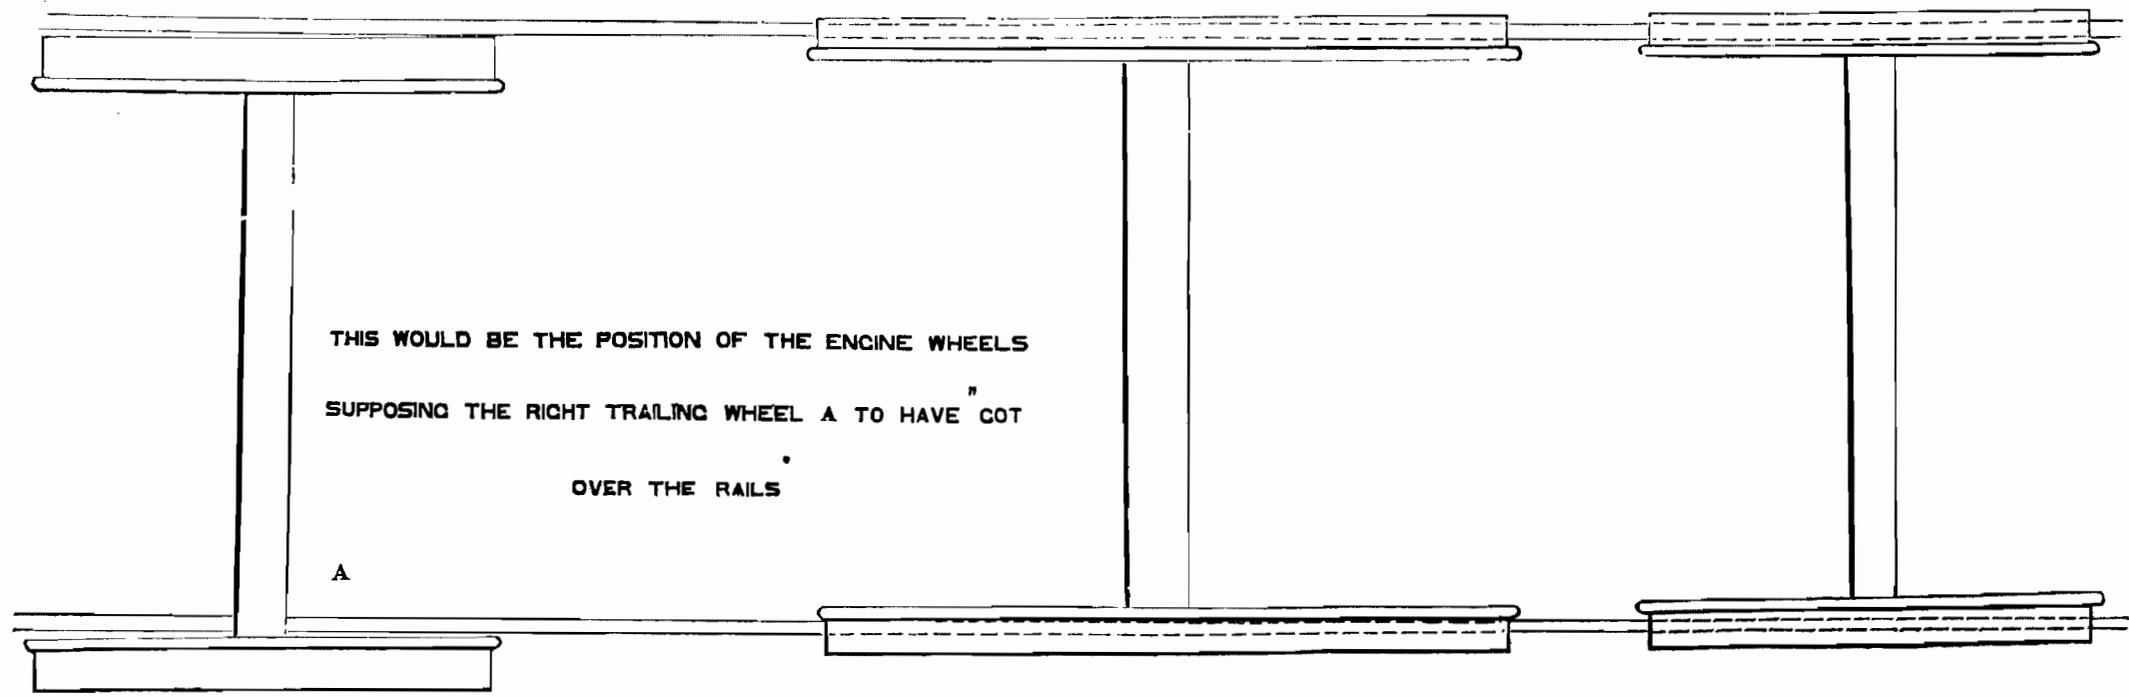
SKETCH No. 3.

I have sketched the position of the wheels of one of these engines followed by its tender, passing over a light permanent way; it will be seen that while one rail is pressed down by a weight of $21\frac{1}{2}$ tons, the rail immediately behind it bears a weight of only $6\frac{1}{2}$ tons; the effect of such unequal loads upon a slight permanent way, loosely fitted as I have described the Southport line to have been, must necessarily be to cause some inequality in the levels of the two rails, so that the trailing wheels of the engine have to jump at every joint from a higher level to a lower. It was, I am convinced, from the circumstance of one of the wavy motions of the engine coinciding at the point marked A in the former sketch with one of these jumps at a joint that caused the right-hand trailing wheels of the engine to cross over the right-hand rail.

THIS WOULD BE THE POSITION OF THE ENGINE WHEELS
 SUPPOSING THE RIGHT TRAILING WHEEL A TO HAVE "COT"
 OVER THE RAILS

To the Lancashire and Yorkshire Railway Company I would suggest that engines of the peculiar construction I have described are not safe upon a very light permanent way, and that if they continue to use such engines upon the Southport line it is probable that some more serious disaster may occur.
