Ministry of Transport.

Railway Accidents.

On the Derailment of a Passenger Train,
which occurred on the 3rd November, 1924,
near Lytham, on the London, Midland and
Scottish Railway, as the result of the failure
of an engine tyre.

DERAILMENT AT LYTHAM (L.M. & S. RLY.)

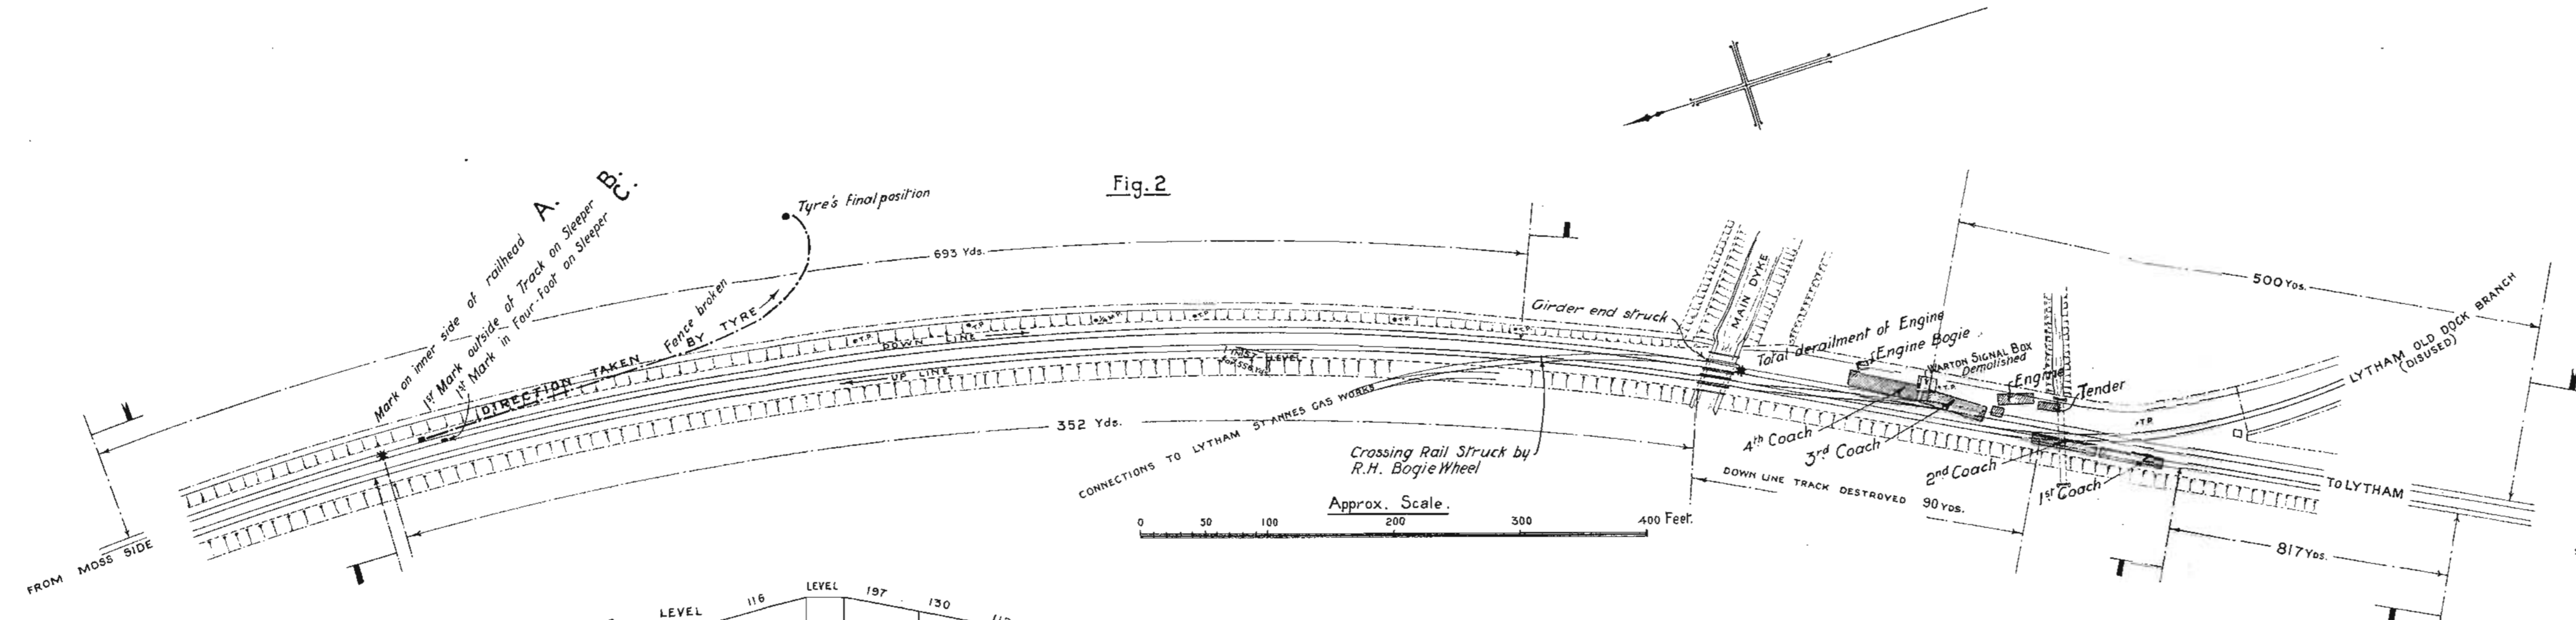
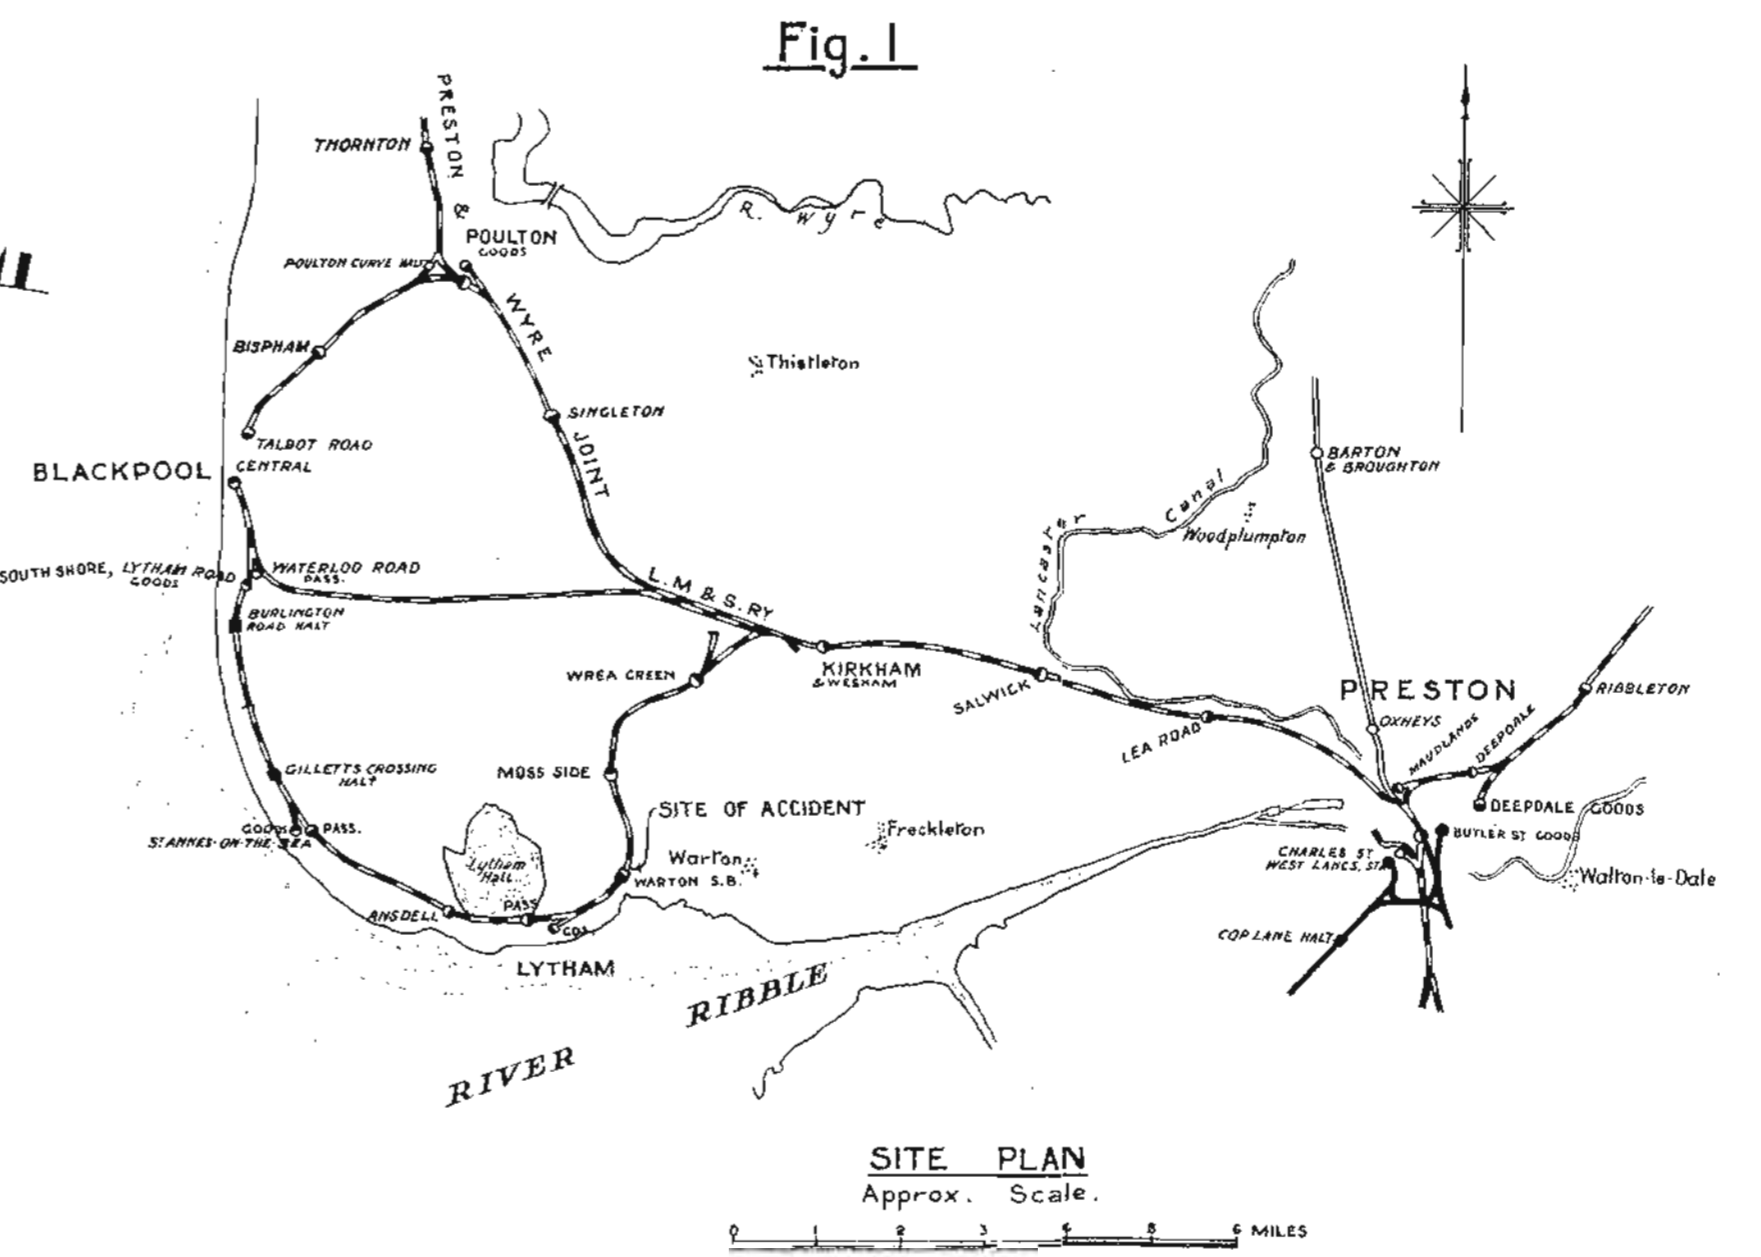
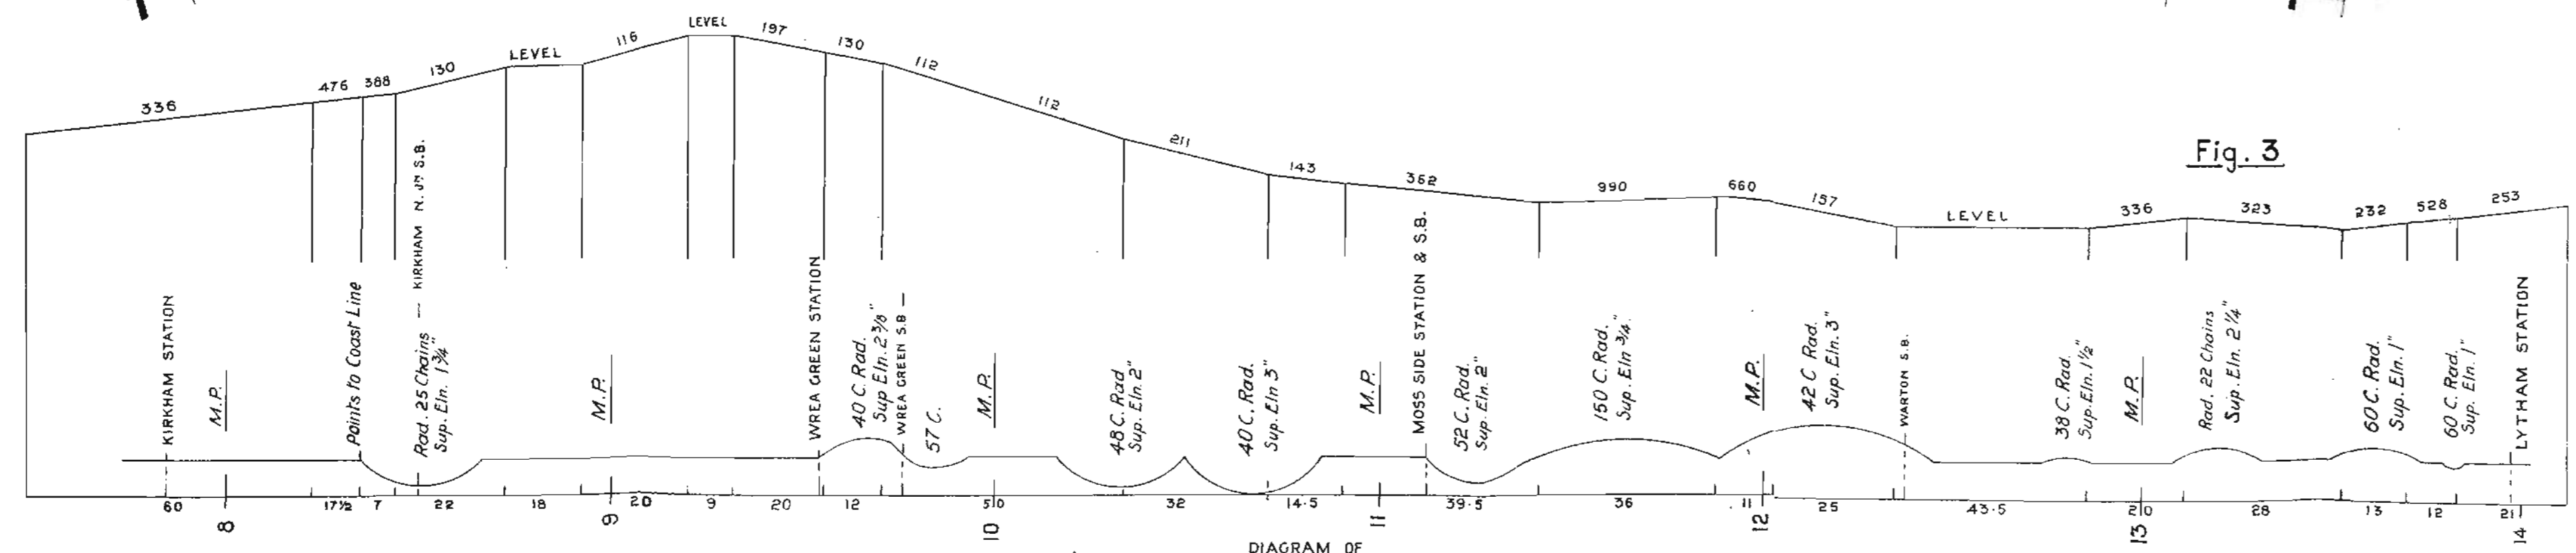
DIAGRAM OF GRADIENTS & CURVES FROM KIRKHAM TO LYTHAM
SCALE: 3 INCHES TO 1 MILE.

The tyre of the left-hand leading engine bogie wheel was found in a field east of the railway, about 50 yards from the down track, and 120 yards measured along the line, from the mark A. From marks found between the hedge and boundary fence of the railway, and on the turf in the field, the path taken by the tyre, after it left the wheel centre, has been plotted on Plate I, Fig. 2, and is shewn thereon by a chain dotted line.

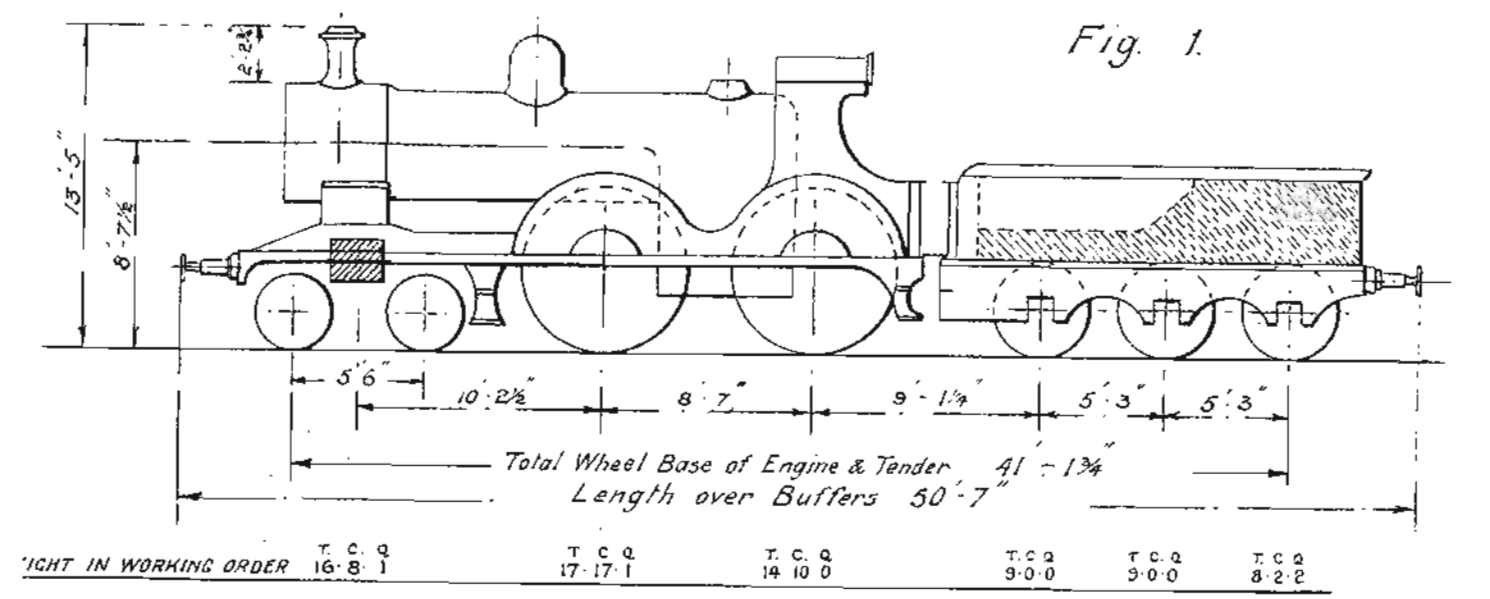
8 WHEELED BOGIE PASSENGER ENGINE (SCHMIDT SUPERHEATER)
No 1105.

11.—Engine No. 1105 (see Fig. 1, Plate II) was built in 1891, and is stated to have been thoroughly maintained. It was last in Horwich Works for general repairs on September 2nd, 1924, and was turned out of the shops after repair on October 24th, 1924. It had therefore been out of the works only ten days before the accident. A list of repair work executed will be found in Appendix III. Details of the steel bogie wheel, with dimensions and method of fastening, will be found on Plate II, Figs. 3 and 4. It will be noted that the tyre, originally 3 inches in thickness, measured at the time of the accident $2\frac{7}{16}$ inches.

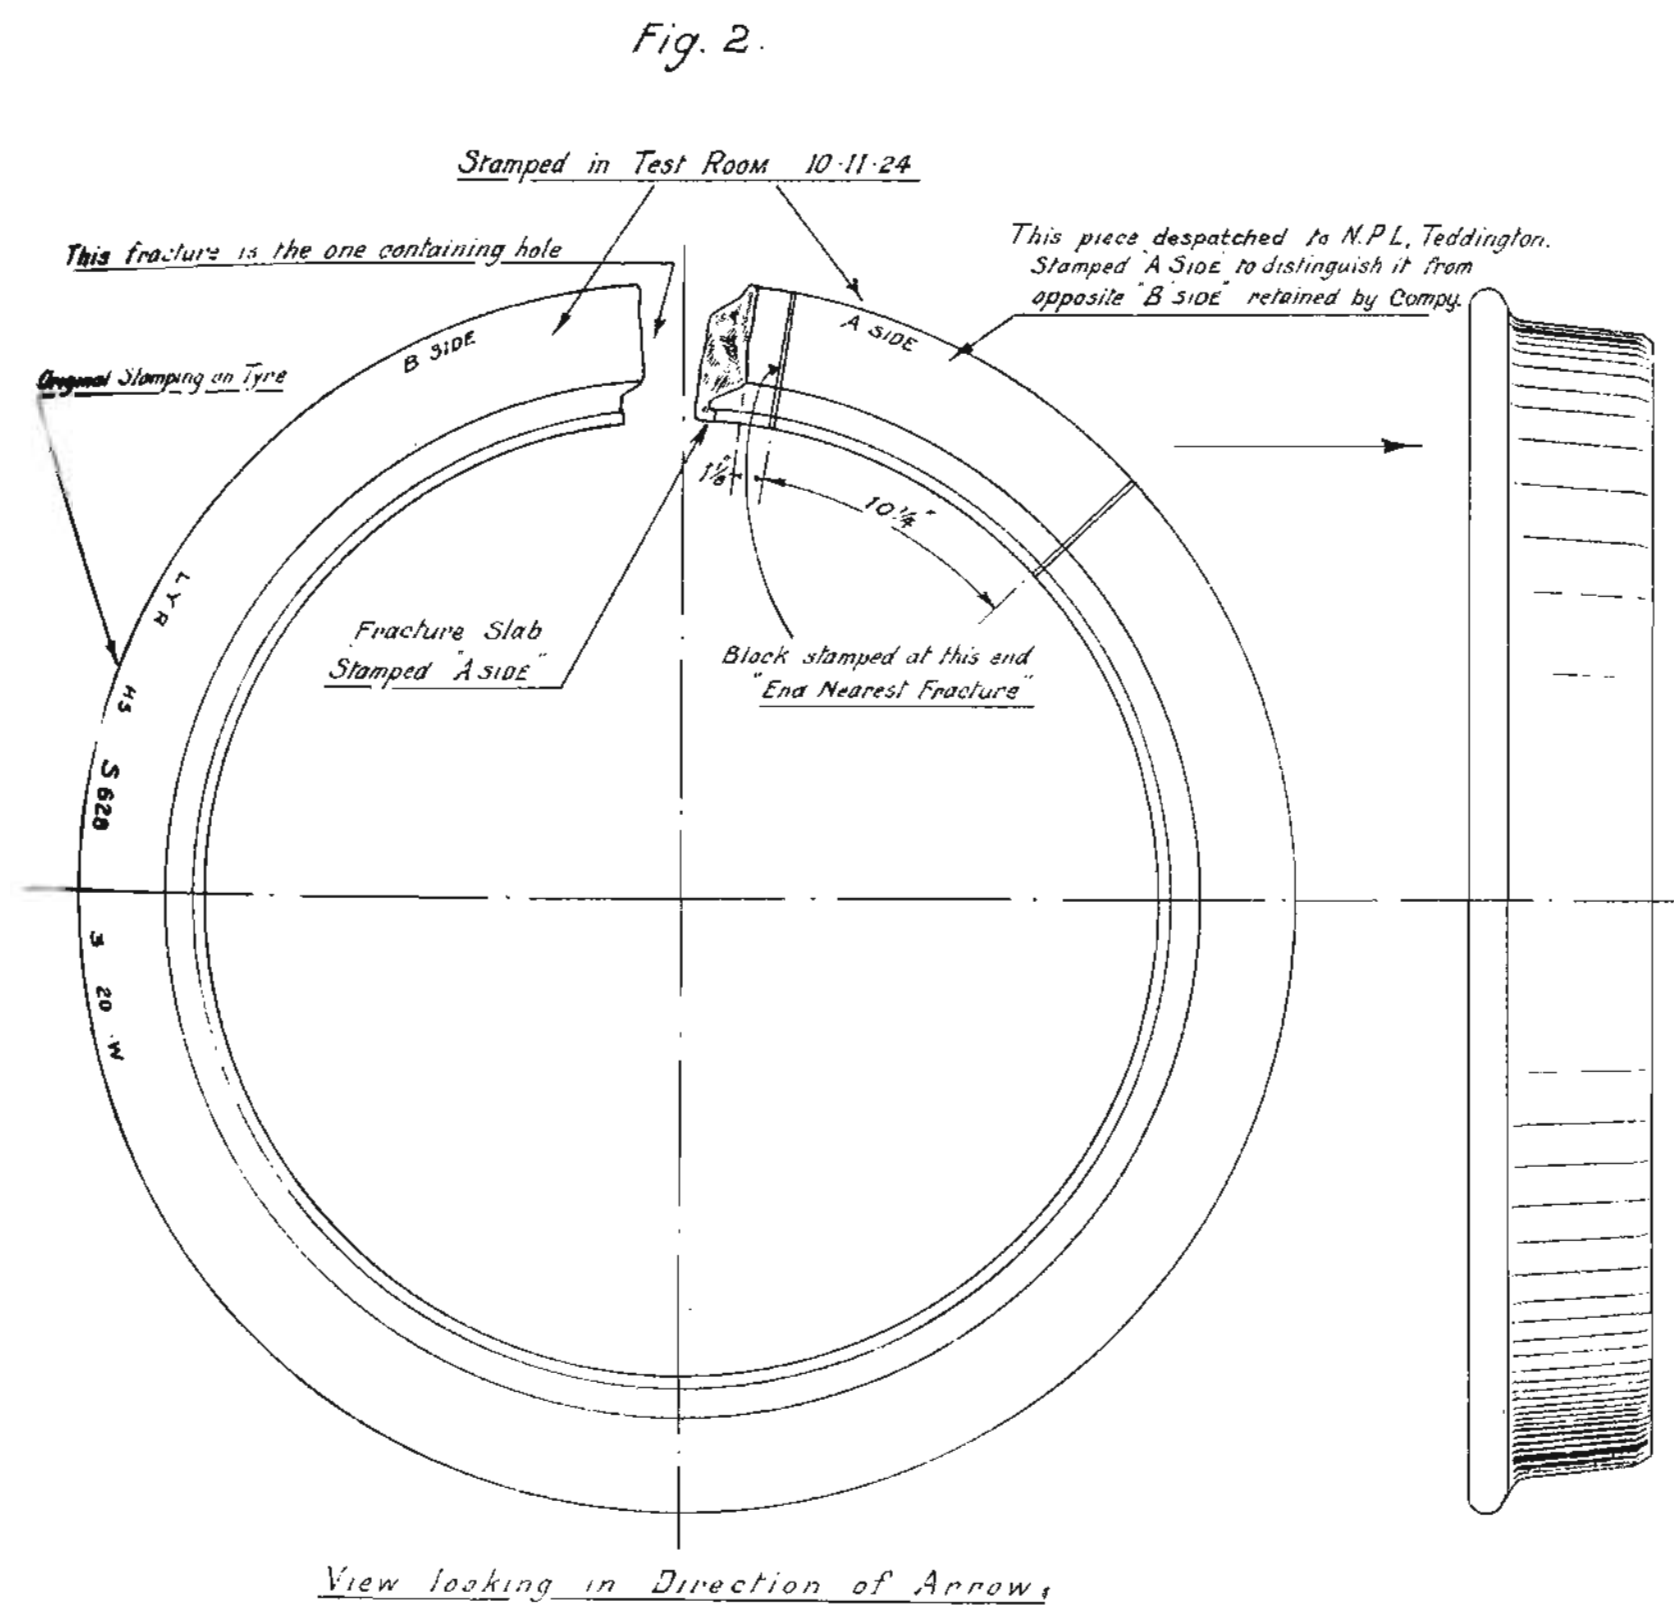
SKETCH OF BROKEN TYRE S628 3.20 W.

The tyre was found to be broken at one place (see Plate II, Fig. 2) at a point intermediate between two stud screw holes. A space of about 3 inches separated the two surfaces of the fracture. A flattening was found on the outside of the periphery of the flange of the broken tyre, which is a maximum at the point of fracture, and tapers off contrary to the direction of rotation, finally disappearing about $6\frac{1}{2}$ inches from the fracture. The length of this flat roughly corresponds with the length of the scrape on the rail head at the mark A. All five stud screws shewed signs of shearing.

The fractured surfaces of the tyre (see Plate III) shew the existence of a large defect in the centre of the tread of the tyre, which is outlined ABC and has an area of something over 1 sq. inch, due to the existence of a blow hole cavity in the metal.

8. I think there can be no doubt regarding the circumstances which led up to the final derailment of this train. The inherent weakness, due to the cavity in the tread of the tyre of the left-hand leading engine bogie wheel, when the thickness of the steel had been sufficiently reduced by wear and turning, was the primary cause of the disaster. The tyre possibly broke some distance before the wheel reached the mark A. Under rolling effect, of longer or shorter duration, dependent upon the time the five set screws in the rim of the wheel took to shear or work loose, the tyre opened out until it became loose enough to slip on the wheel centre, and be pushed out of its vertical plane on the wheel by the pressure of the flange against the rail. The upper portion of the lip of the tyre would thereby be forced outwards from its groove in the rim of the wheel. The rotating wheel centre would then ride over the flange of the inclined tyre, and the tyre become free of the wheel. It is quite likely that the mark A on the rail head, and the corresponding flattening on the periphery of the flange of the tyre were caused by this over-riding of the tyre by the wheel centre. The mark B was, I think, made by the tyre, after escaping from the wheel, bumping on the sleeper, the under-cutting of the timber being caused by the inclined plane to the vertical at which the tyre was moving when it left the wheel. The mark B could not have been made by the rim of the derailed tyreless wheel, otherwise there would most certainly have been a mark on the same sleeper in the four-foot way, made by the flange of the right-hand wheel. I gather from the above described marks on the sleepers, chairs, spikes, and trenails, which were found southward of B, that the bulk of the total weight carried by the engine bogie (about 12 tons), after the leading wheels were derailed, was transferred to the rear axle, and that any weight, clearly variable from time to time in amount, which came upon the front axle was carried by the tyred right-hand wheel—the left-hand tyreless wheel being practically in a floating condition. The engine must have travelled round the curve in this condition for a distance of about 300 yards, at a speed of perhaps 50 miles an hour. The marks in the four-foot way, made by the derailed right-hand bogie wheel, clearly shew the tendency of the front of the engine to move outwards on the curve, and that the rounding effect was being produced by the flanges of the engine driving wheels acting on the engine frame. It is remarkable that the movement of the engine round the curve, with its two leading wheels off the rails, should have been so little different from what was normal that it failed to attract the attention of the men on the footplate. But as already observed, the evidence shews that this was the case. It appears that the obstruction caused by the rail crossing the down road, and the proximity of the cast iron bridge girder to the near hand rail, were the immediate cause of the complete derailment of the train and the final disaster.

Fracture reveals presence of large defect (Plate III shews extent of defect as outlined in black).

Examination in the immediate region of the defect shews that there are many minute cavities and inclusions extending from the main cavity. From the arrangement of these it would appear that the walls of the cavity formerly larger in size were folded into the material during the manufacture of the tyre, without complete welding. The strength of the material in the region of the cavity has therefore been considerably reduced. No evidence has been found that the cavity at any point reached the outside of the tyre, so that its presence during manufacture would not be readily observed.

The presence of a defect of this size is sufficient to account for the failure.
