Rail Accident Investigation Branch

# Rail Accident Report

**Derailment in Summit tunnel, near Todmorden,  
West Yorkshire  
28 December 2010**

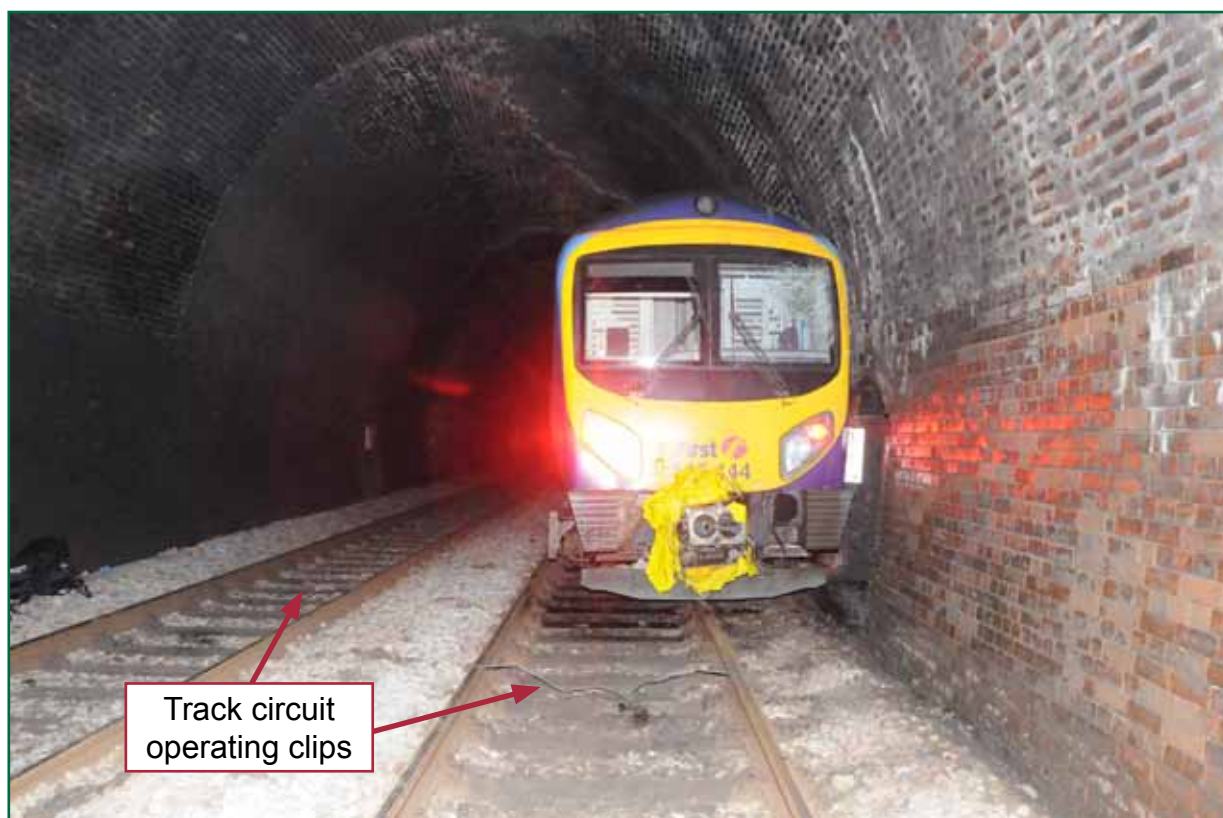
- 29 About four seconds after impact, the driver applied the train's *emergency brakes*. The train ran derailed for 254 metres, with the front left hand side of the train striking the tunnel wall in several places, before coming to a stop under ventilation shaft 11 (figure 6). The train remained coupled and upright, and it did not foul the adjacent line.

Figure 6: Train 1P02 after it had stopped (courtesy of British Transport Police)

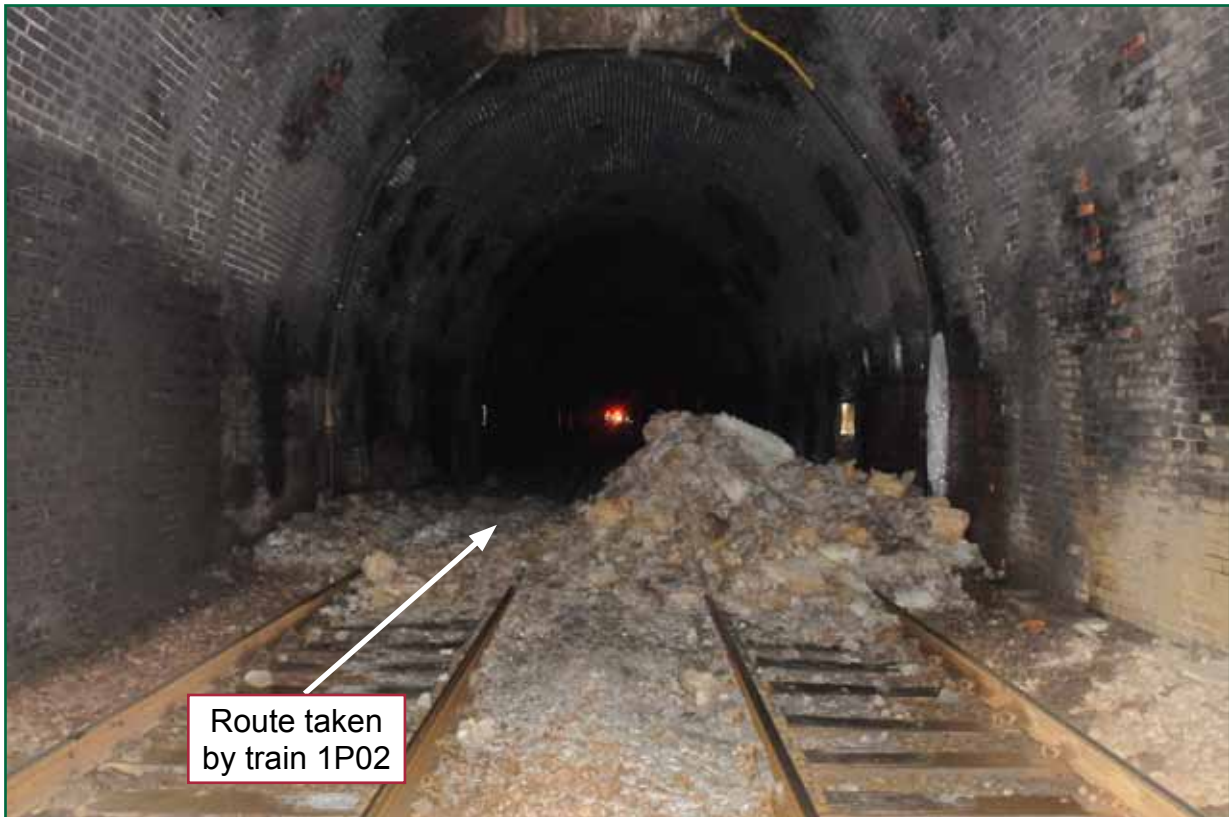
- 60 When the driver first spoke to the signaller after the accident, he reported that his train had derailed after hitting a large pile of ice on the track. Afterwards, a significant amount of ice was found underneath ventilation shaft 10 (figure 8). The RAIB estimated that there was between 20 and 25 tonnes of ice on the track (figure 9).
- 61 A smaller, although still significant, volume of ice was also found underneath ventilation shaft 11 (figure 10). After the accident, further ice could be seen in the bottom of both of these shafts (figure 11).

Figure 8: General view of the pile of ice found below ventilation shaft 10 after the accident (courtesy of British Transport Police)

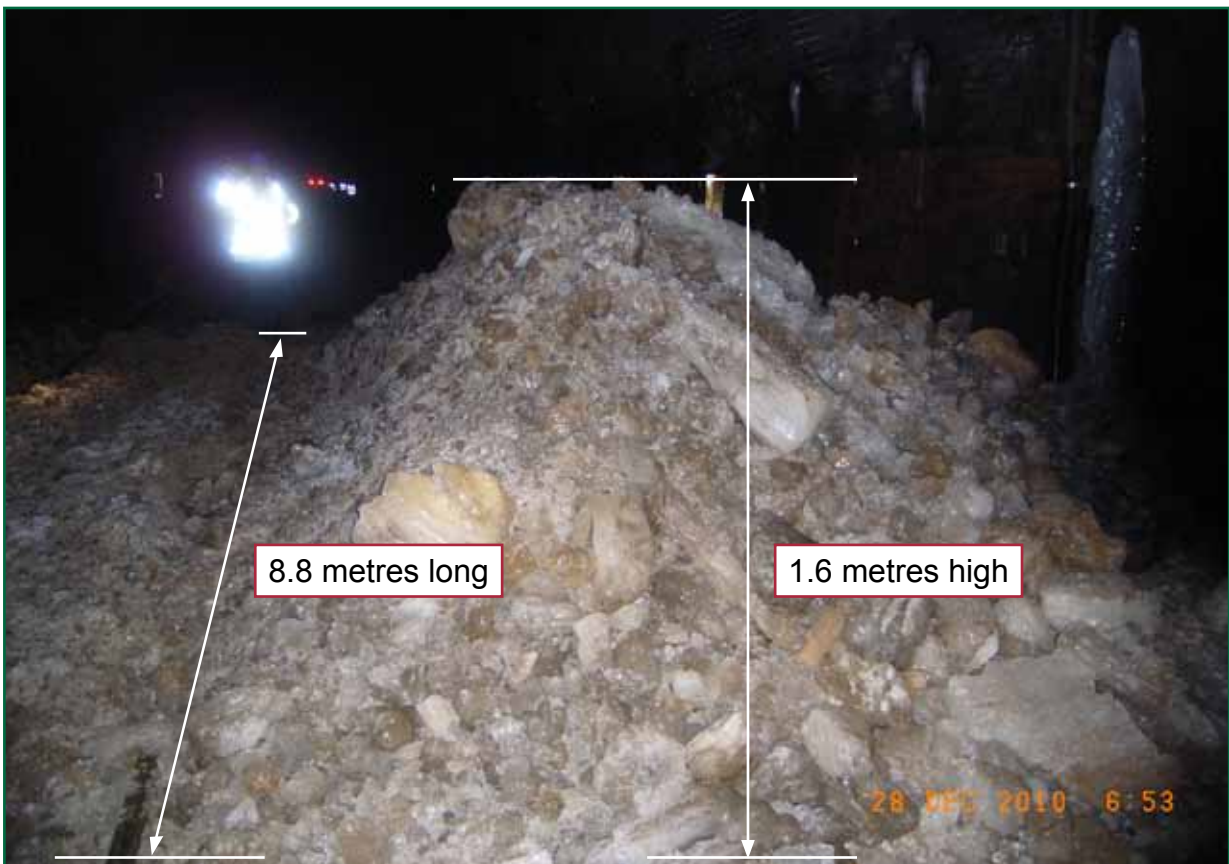
Figure 9: Close up view of the pile of ice after the accident, with height and length shown

- 65 A thaw began on 27 December when the ambient air temperature in the vicinity of the tunnel rose above 0°C at about 01:00 hrs. From about 04:30 hrs to the time of the accident, this outside air temperature stayed above freezing. The warmer outside air entered the tunnel over time but it is not known precisely how quickly the air temperature inside the ventilation shafts rose. As the air inside the ventilation shaft warmed up, the ice began to melt. Once it began melting, over a period of time it broke away and fell onto the tracks below. The pile was formed by many pieces of ice, of a range of sizes (figure 9).

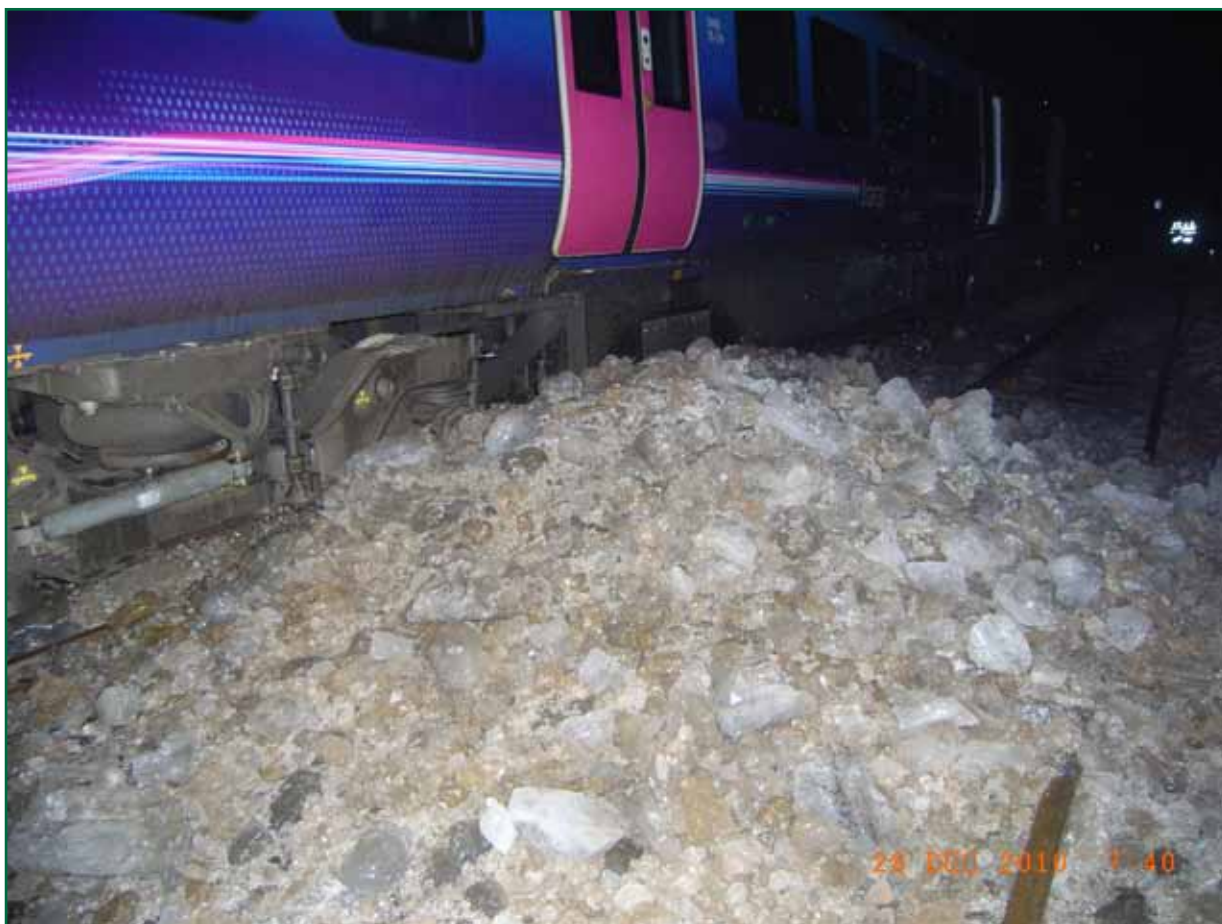
Figure 10: The pile of ice found under ventilation shaft 11 next to train 1P02

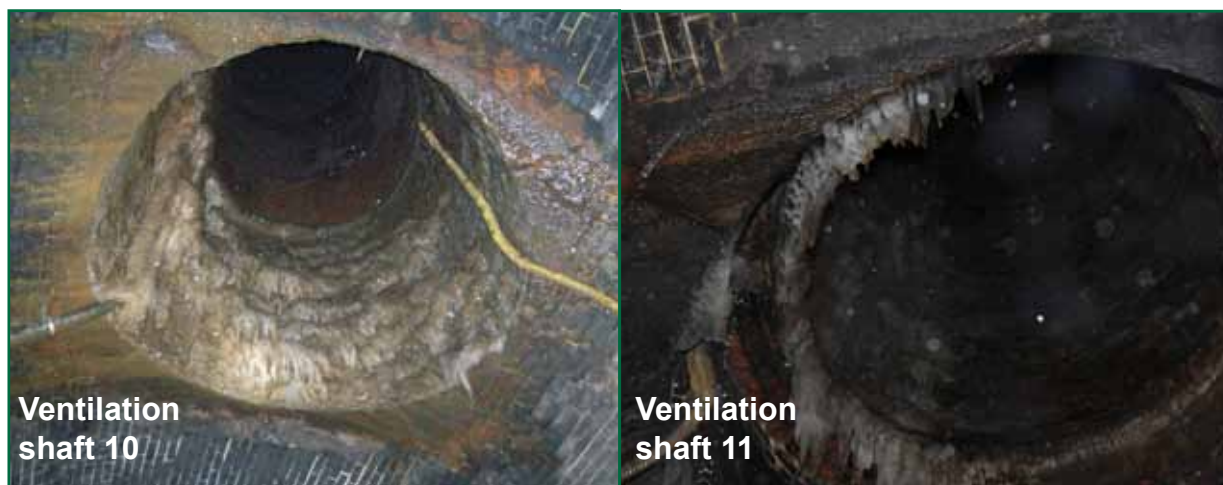
Figure 11: Views looking up at ventilation shafts 10 and 11 showing ice still present in the bottom of the shafts (ventilation shaft 11 photograph courtesy of British Transport Police)

- 66 It is not possible to be certain whether the ice found under ventilation shaft 10 was the result of one very large ice fall or whether it accumulated as a result of a number of smaller falls. The RAIB observed that ice was still present in ventilation shaft 10 after the accident (figure 11), so further falls were possible. Ice was also found under ventilation shaft 11, and more ice fell out of it and onto the top of the train while the passengers and train crew were waiting to be evacuated (paragraph 35). As the ice here was coming down as a series of falls, it is likely that the ice from ventilation shaft 10 fell in a similar way.

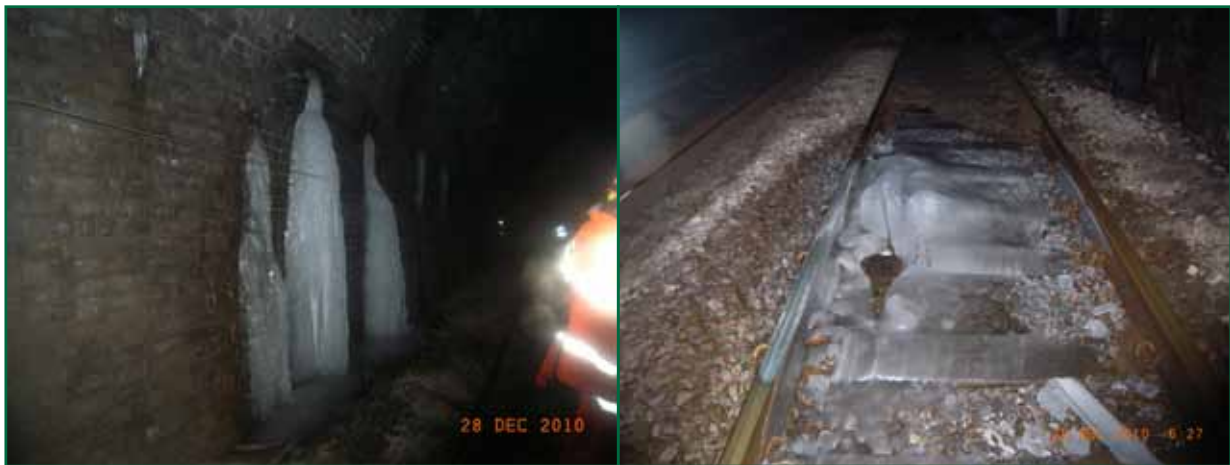
- 63 **Water running down the lining in ventilation shaft 10 froze and formed a large quantity of ice, which then began to thaw and fall onto the railway tracks below. This was a casual factor.**
- 64 The ice in ventilation shaft 10 was formed by water that froze as it ran down the lining of the shaft. This happened during a prolonged period of freezing weather conditions, when the ambient temperature fell below 0°C on 16 December and remained below freezing for the next 10 days. No trains ran through the tunnel for about 75 hours before the accident (paragraphs 24 and 25), so icicles that formed below the base of the ventilation shaft were undisturbed by trains. Also in other places where water was present, ice formed undisturbed on the tunnel walls and on the track (figure 12).

Figure 12: Ice formations found on the track and tunnel wall

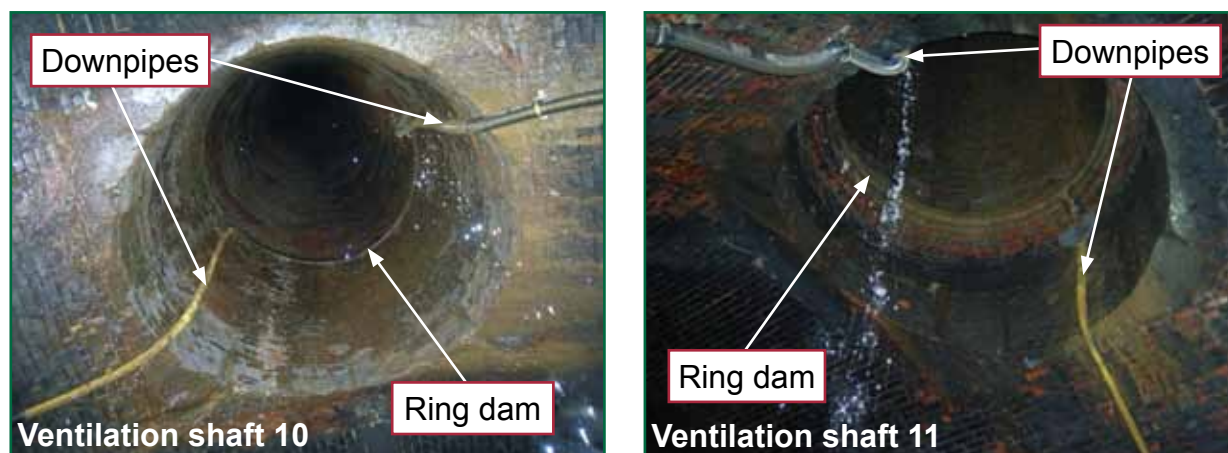
- 70 Witnesses told the RAIB that after the accident, water was pouring from ventilation shaft 11 onto the top of the train. While on site the RAIB also observed a lot of water flowing down the inside of ventilation shaft 10. During a follow-up site visit just over two weeks later, the RAIB observed water pouring from both of these ventilation shafts (figure 13). This water was overflowing the *ring dam*, running down the shaft's lining into the tunnel, and onto the tracks from the base of the shaft. Water was also cascading onto the tracks from a broken *downpipe* (paragraphs 140 to 143).

Figure 13: Water cascading from ventilation shafts 10 and 11 onto the tracks below

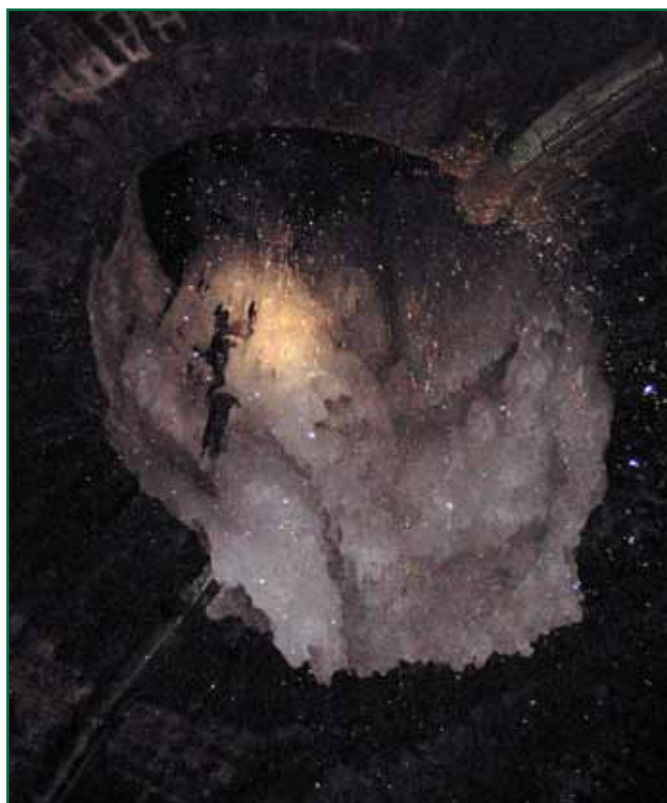
- 95 During the period of extreme cold weather at the start of December 2010, the Appleby track maintenance engineer noted ice forming in Blea Moor tunnel. He invited structures management staff to see the ice that had formed in one of the ventilation shafts (figure 15). The structures management staff looked at the ice formation and assisted the Appleby track maintenance engineer in deciding what the best way was to remove it without damaging the structure. The Appleby track maintenance engineer continued his contact with the structures management staff to actively look at ways to reduce ice formation in this tunnel and the methods of removing ice once it is found.

Figure 15: The ice formation seen hanging from the bottom of a ventilation shaft in Blea Moor tunnel in December 2010 (courtesy of Network Rail)

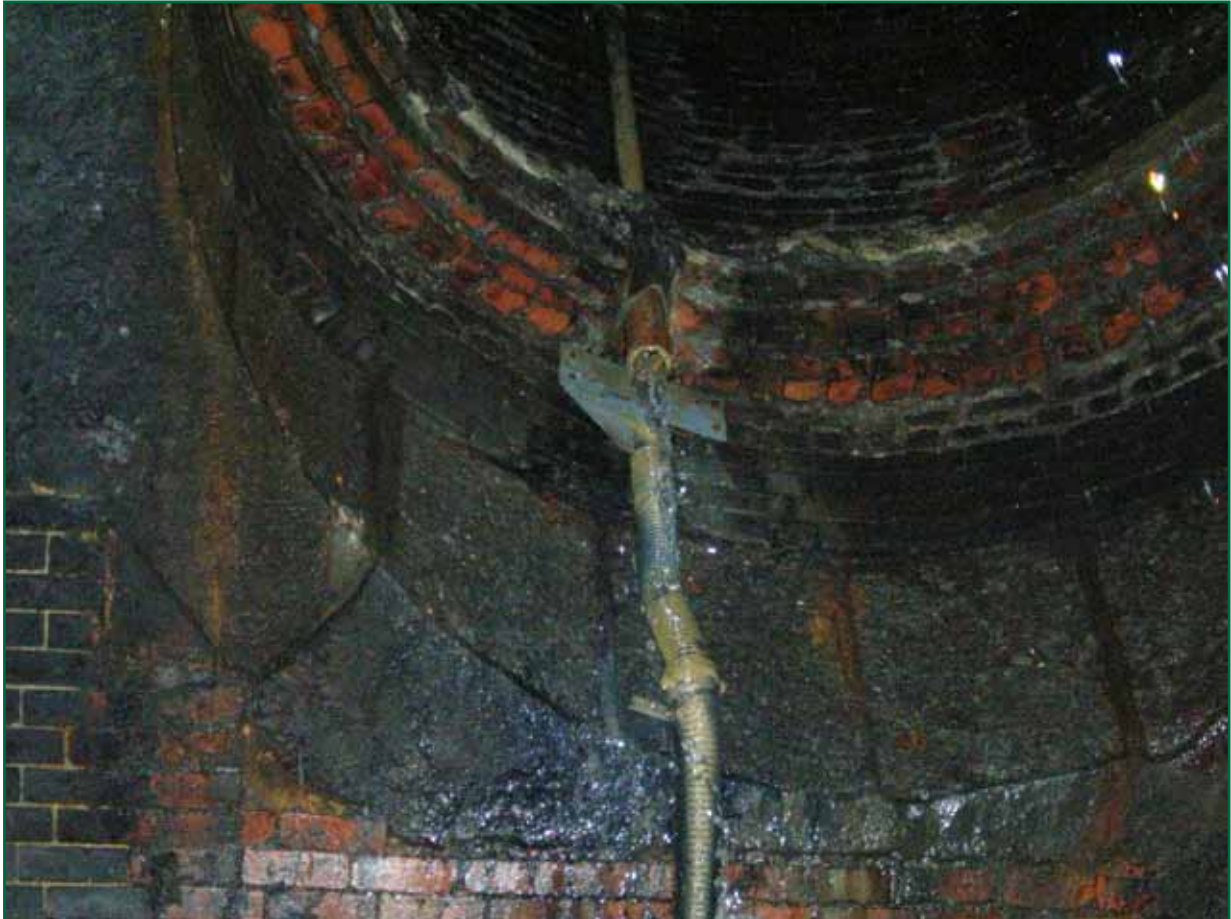
Figure 16: The broken downpipe in ventilation shaft 11

- 141 The broken downpipe was noted by a senior structures management engineer who was on site at time of the examination, and he entered this defect as a minor works item on CARRS the following week. However, it was not repaired before the accident because it was not classified as an urgent repair. Network Rail buildings and civils – asset management had reprioritised all non-urgent repairs to the next financial year starting in April 2011, because the minor works budget for LNW route for that financial year was already fully committed. The RAIB observed during a site visit in January 2011 that neither defect had been repaired.
