RAILWAY ACCIDENT

REPORT ON THE COLLISION

8th February 1961

ROYTON STATION

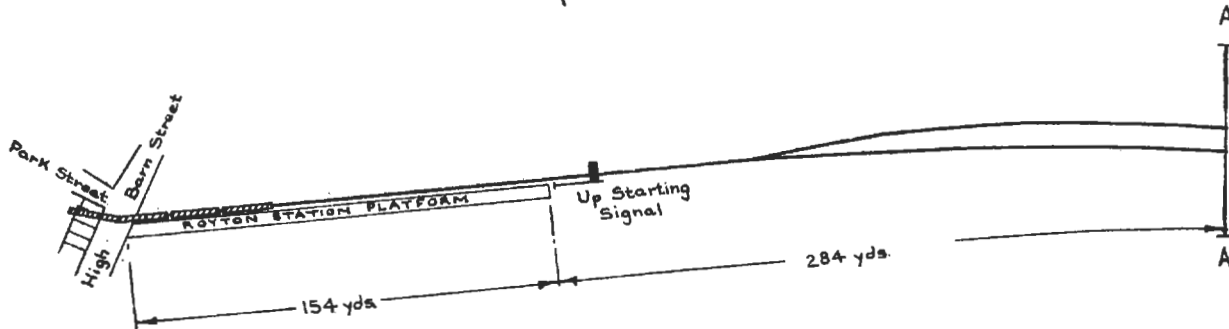
SITE SHOWING POSITION IN WHICH TRAIN
CAME TO REST

The train came to rest some 30 yards beyond the buffer stop, its leading coach lying athwart the foundations of what had been Nos. 13 and 15 High Barn Street with its front end projecting into their back yards and with some 14 feet of its rear end still across the street. The leading bogie of the second coach fell from under it into the street, but the front end of the coach did not drop and so overrode the rear end of the front coach, its buffers staving in the end panels. The trailing bogie of the second coach remained on the rails, as did both the two rear coaches which sustained very little damage.

3. The general layout at Royton Station, from the Turf Lane road overbridge on the junction side of the Royton Outer Home signal to the houses through which the train smashed, and the positions in which the coaches came to rest after the accident, are shown on the diagram (for simplicity the running lines only are shown, the numerous sidings having been omitted). Nos. 13 and 15 High Barn Street were typical two-storey terraced houses with brick cavity walls.

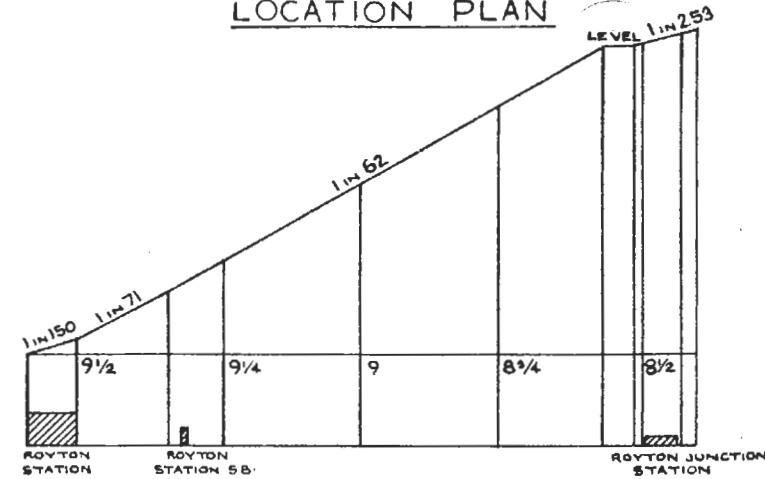
GRADIENT DIAGRAM

1. Royton is a small terminal station on a short spur that runs north-east from Royton Junction near Oldham (Mumps) on the Manchester (Victoria) - Rochdale main line. It is served by some 30 passenger and 3 freight trains each way each day. It has a single platform on an Up and Down line into which the separate Up and Down lines to and from Royton Junction converge.
2. The Down line from Royton Junction Station approaches Royton Station in a series of curves, the last of which is gentle and left-handed. The line is level through the Junction Station and then falls steeply at a gradient of 1 in 62 for some three quarters of a mile to Royton Junction signal box, 44 yards beyond which it eases slightly to 1 in 71 for some 293 yards to the east end of the platform, past which it continues to fall at 1 in 150 for 154 yards to the buffer stop.

The severity of the gradient from Royton Junction to Royton is clearly apparent to the eye, and a notice board on the left of the line leaving the Junction instructing drivers of freight trains to pin down wagon brakes is an apt reminder to a passenger train driver that he is running on to the incline. Gradients as steep as and steeper than 1 in 62 are common in the area: on the run that it was to have made from Royton to Manchester (Victoria) this train would have had to negotiate falling gradients of 1 in 44, 1 in 52, 1 in 55 and 1 in 47.
