MINISTRY OF TRANSPORT

**REPORT ON THE
COLLAPSE OF A FOOTBRIDGE
which occurred on
19th January 1952 at
KNOWSLEY STREET STATION, BURY
in the
LONDON MIDLAND REGION
BRITISH RAILWAYS**

2nd July, 1952.

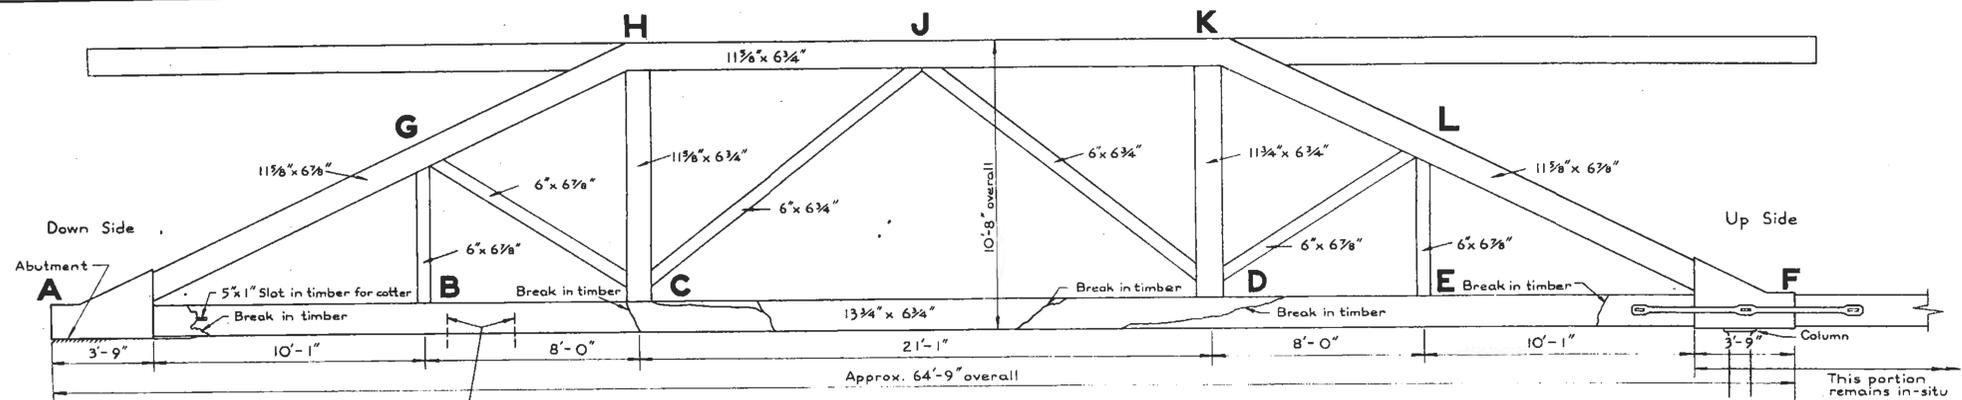
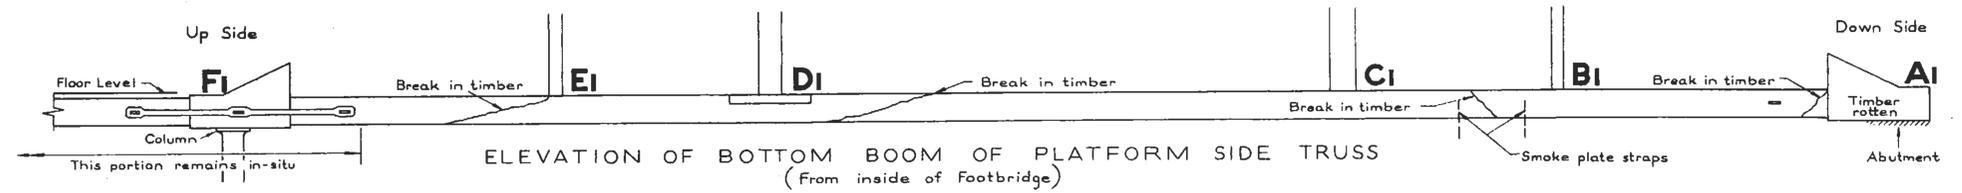
ELEVATION OF ROAD SIDE TRUSS
(From inside of Footbridge)

14. The bottom booms had fractured as shown in the elevations on plan B. The timber appeared generally to be in good condition, except that the wood enclosed by the bearings on the Down side was in an advanced stage of decay, and the rot extended to a lesser degree as far as the slots for the cotters; the wood in the bottom booms had also split in places as it aged and some rot had begun where soot and water had seeped in. The outside runners had been torn away from the bottom booms and were found still suspended to the boarding. Many of the 6 in. nails holding these runners to the booms had pulled away from them, others had fractured and some had been completely corroded before the accident occurred. Some of the nail holes in the bottom booms were elongated, indicating that the wood had been crushed by excessive bearing stress.

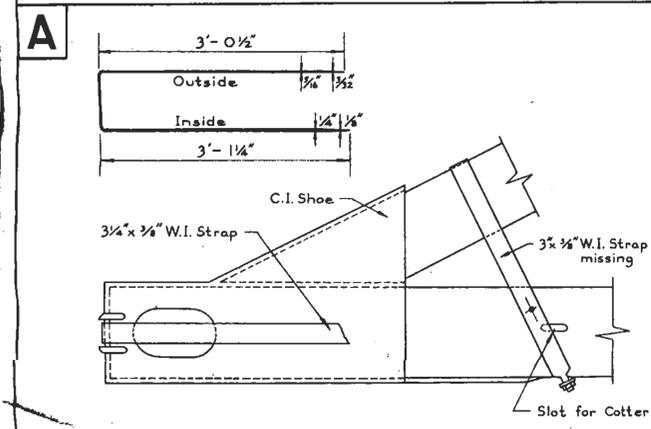
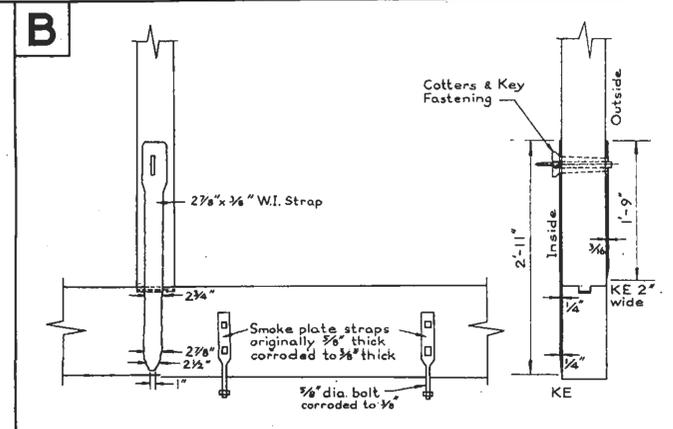
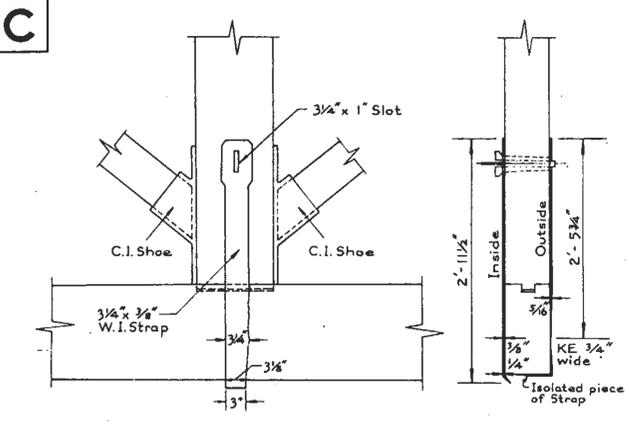
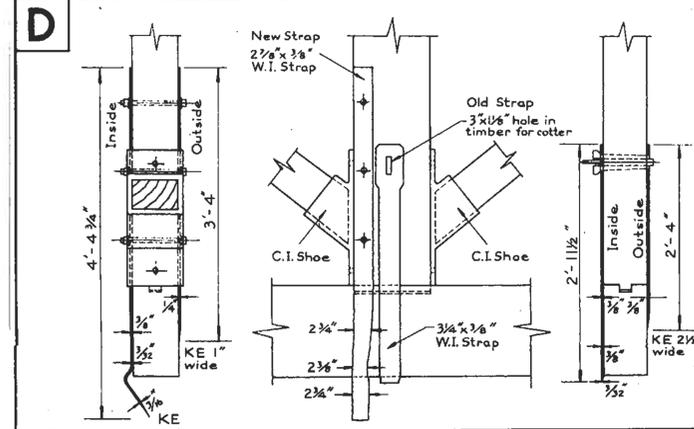
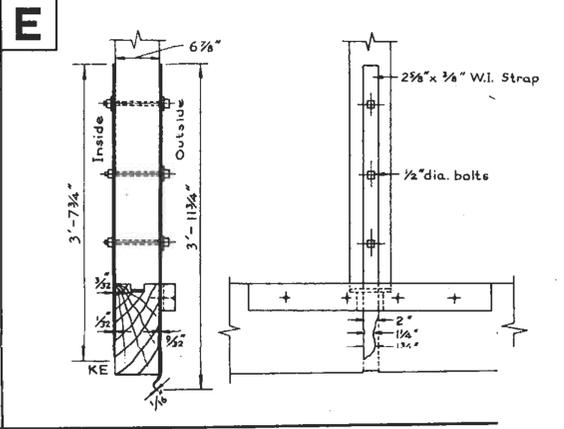
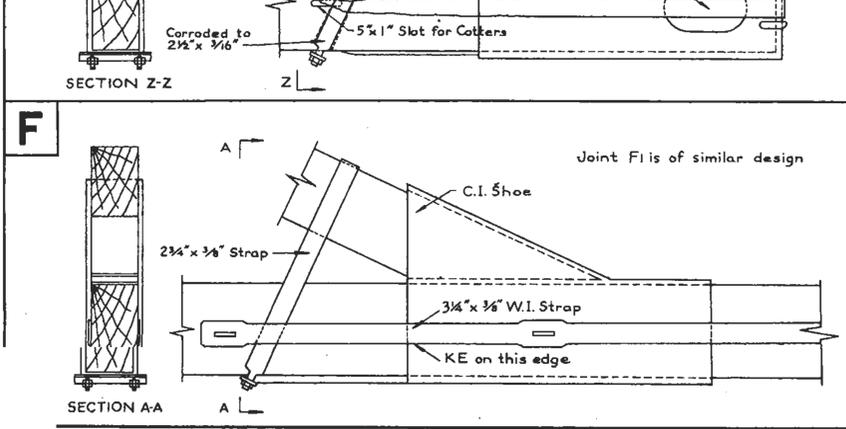
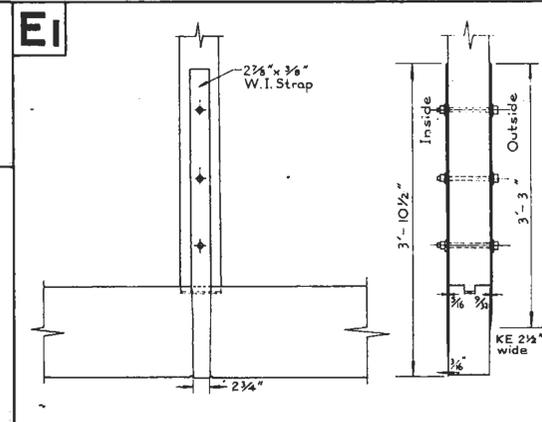
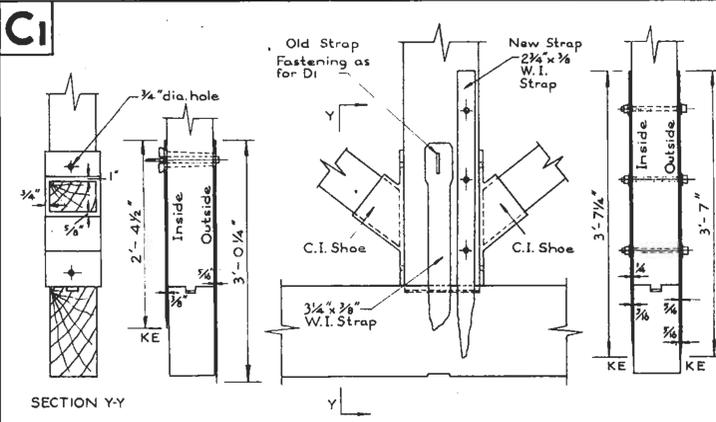
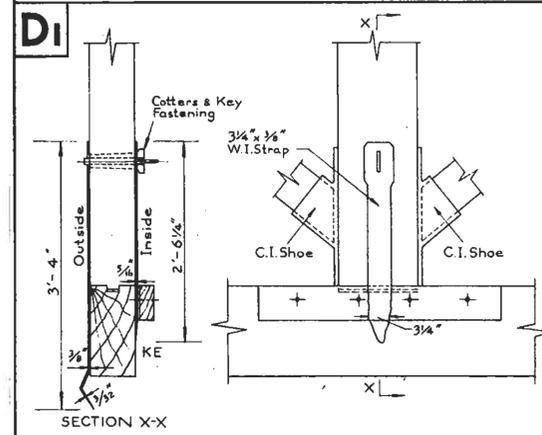
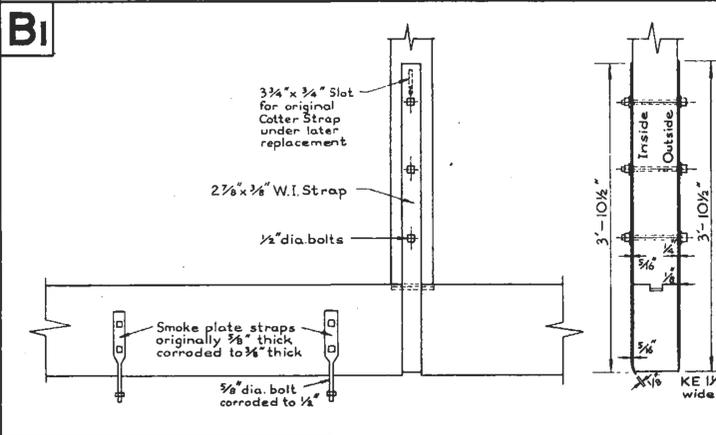
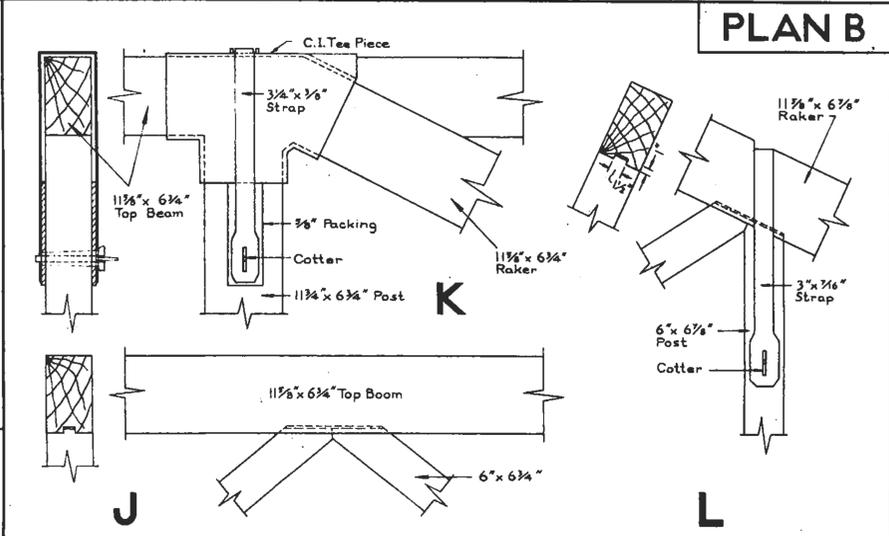
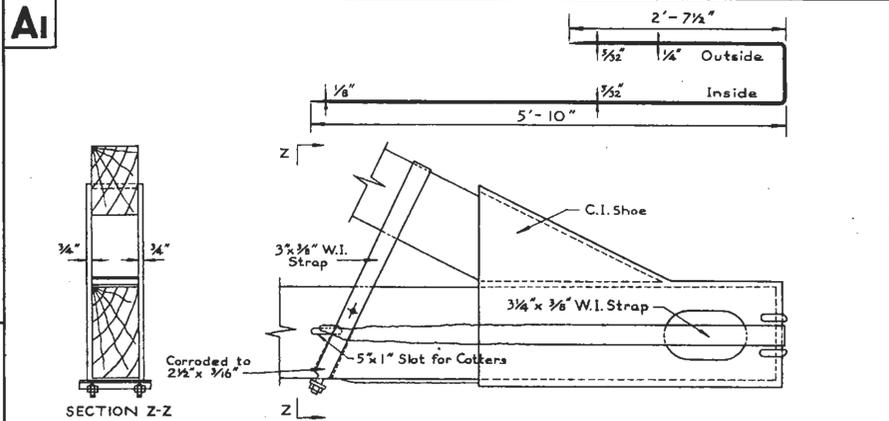
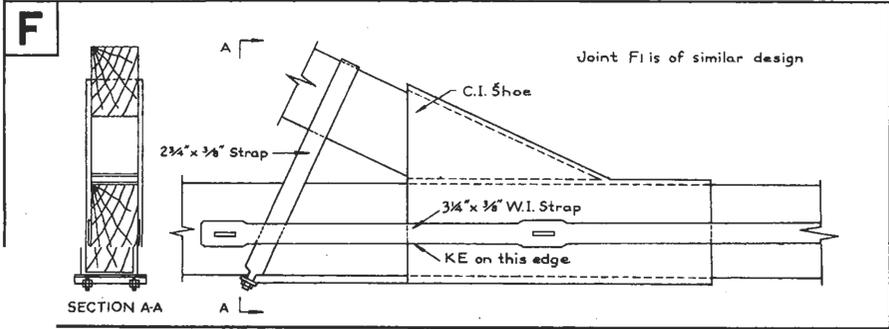
PLAN B

The original straps at the bottom of three of the four minor verticals had apparently been replaced by others which were held by bolts instead of cotters (see joints E, B.1 and E.1). Two of the main joints at the bottom of the queen post had also been reinforced with similar straps (see joints D and C.1). These newer straps were also made of wrought-iron and they had apparently been put up many years ago.

13. As already mentioned, the bottom booms of the trusses, together with the flooring, fell out, but the rest of the bridge stayed in position and was not removed until a few hours after the accident. Detailed drawings of the various joints as actually found are illustrated in plan B; all elevations have been taken from the inside of the bridge but an indication of the condition of the wrought-iron straps on the outside can be gauged from the cross sections. The actual thickness of the metal has been shown and where it has ended in a knife edge this has been indicated by the letters K.E.

The straps holding the bottom booms to the vertical members were in a deplorable condition; every one of them was badly corroded and none had been carrying any load; in some cases all that was left were two short lengths of wasted metal hanging from the vertical member. Both the horizontal straps on the Down side bearings were also corroded away; one of the raking straps was partially corroded and the other was missing. The straps on the Up side bearings were in better condition and were intact throughout although the bottom edges of the horizontal ones had wasted away in places. Straps for holding up a smoke plate were found on the inside of the booms at joints B and B.1; they were of steel and had probably been put in in 1945 (see para. 21); they had corroded in places from an original thickness of ½" to a minimum of ⅜".

21. A smoke plate consisting of a wooden frame, with asbestos sheets, had been fixed with steel bolts to the underside of the bridge over the Down Slow line at the place where engines stood to take water at the column on the platform. Wilson thought that this smoke plate was put up in 1945 but it deteriorated quickly and was taken down again 18 months to two years later; all that was left when the bridge gave way were the bolts which were found in the positions shown on plan B, joints B and B.1.
