# RAILWAY ACCIDENT

Report on the Derailment that  
occurred on 27th December 1973  
at Lower Darwen

IN THE  
LONDON MIDLAND REGION  
BRITISH RAILWAYS

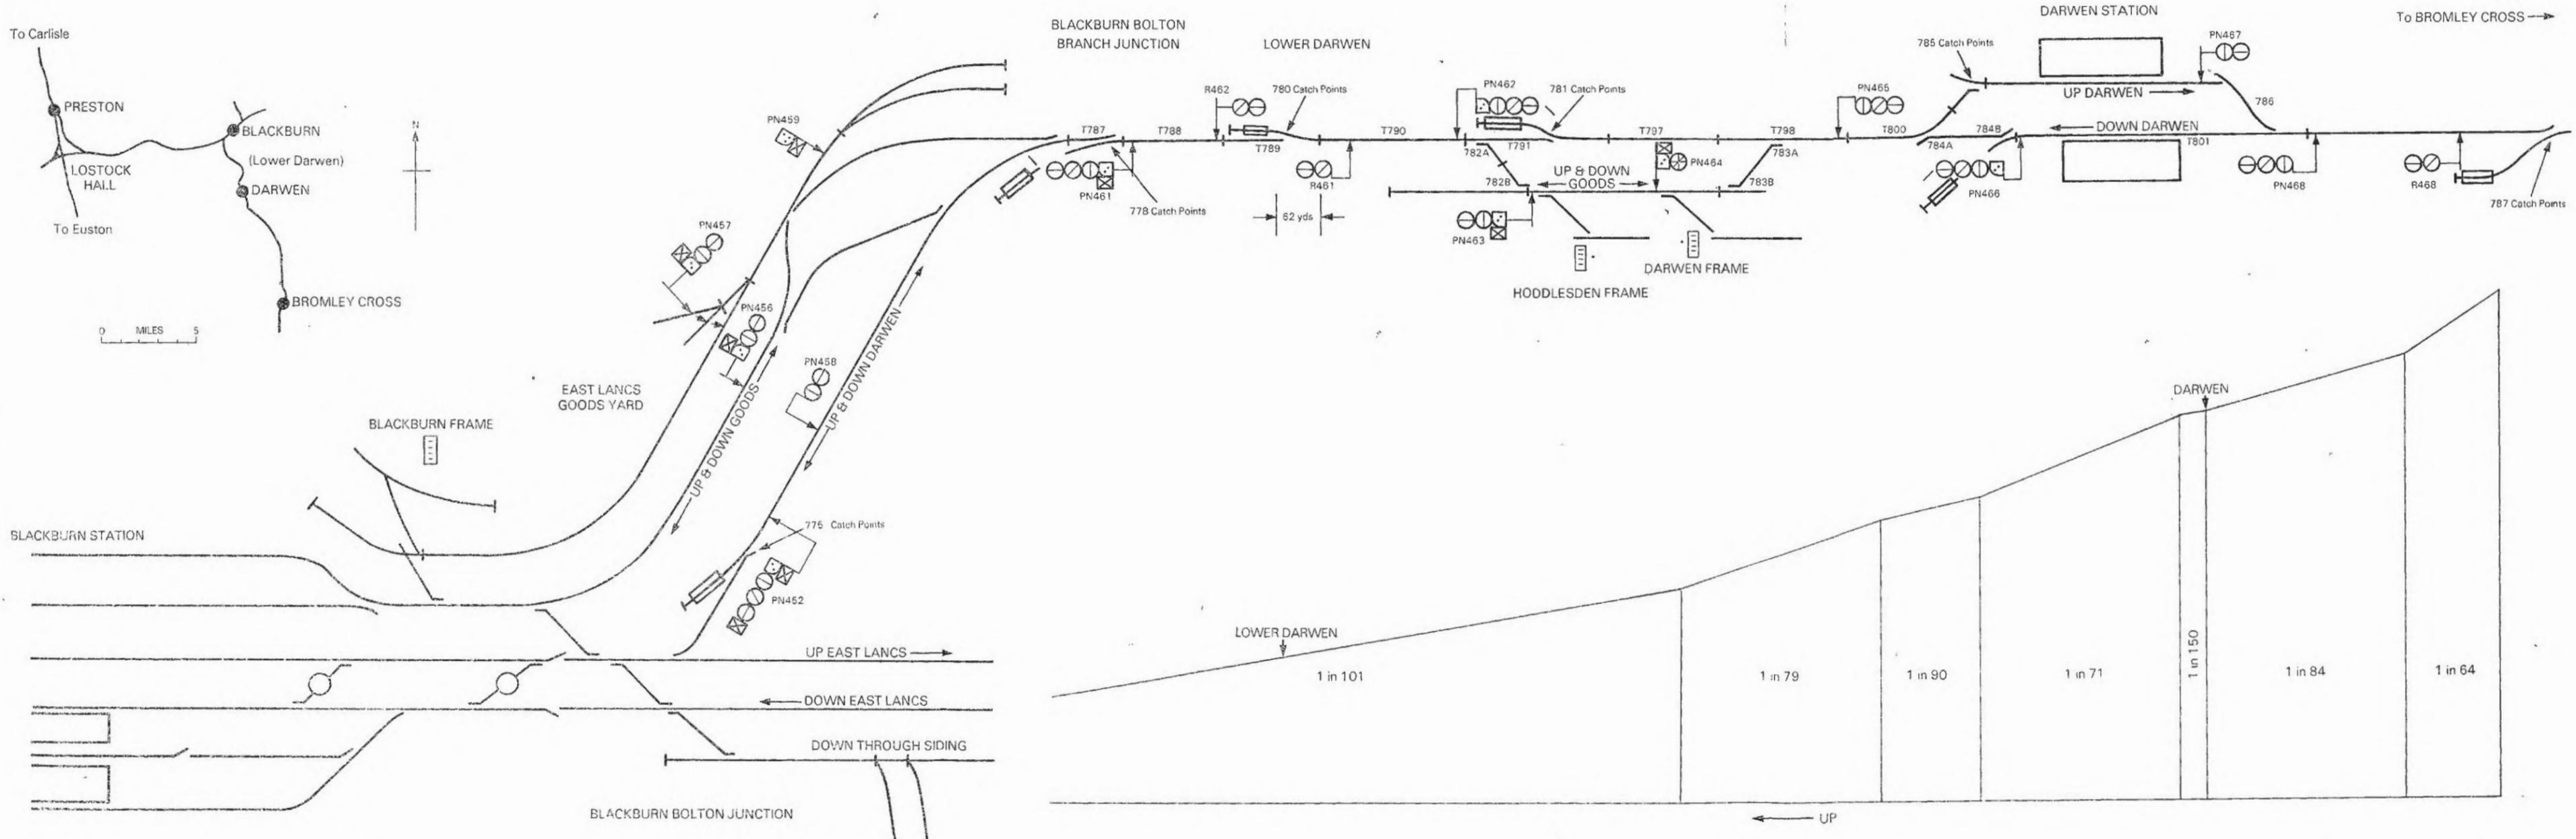
Fig 1

1. The line, which is shown at Figure 1 at the end of this report, is single from Bolton Junction, where it connects with the Up East Lancs Line, to Darwen Station where there is a passing loop, and thence to Bromley Cross. An Up and Down goods loop parallels the single line from Blackburn to Bolton Branch Junction, and the Huddlesden goods loop serves sidings west of the line north of Darwen. (Down is to the north.) The single line rises steeply from Blackburn and four sets of power-worked catch points have been provided between Blackburn and Darwen. No. 780, at which the accident occurred, lies about 2,995 yards north of Darwen station, and another set, No. 781, lies 1,595 yards north of the station and within the section of line paralleled by the Up and Down goods loop, so that the goods loop exit points connect with the single line some 120 yards north of No. 781 catch points.

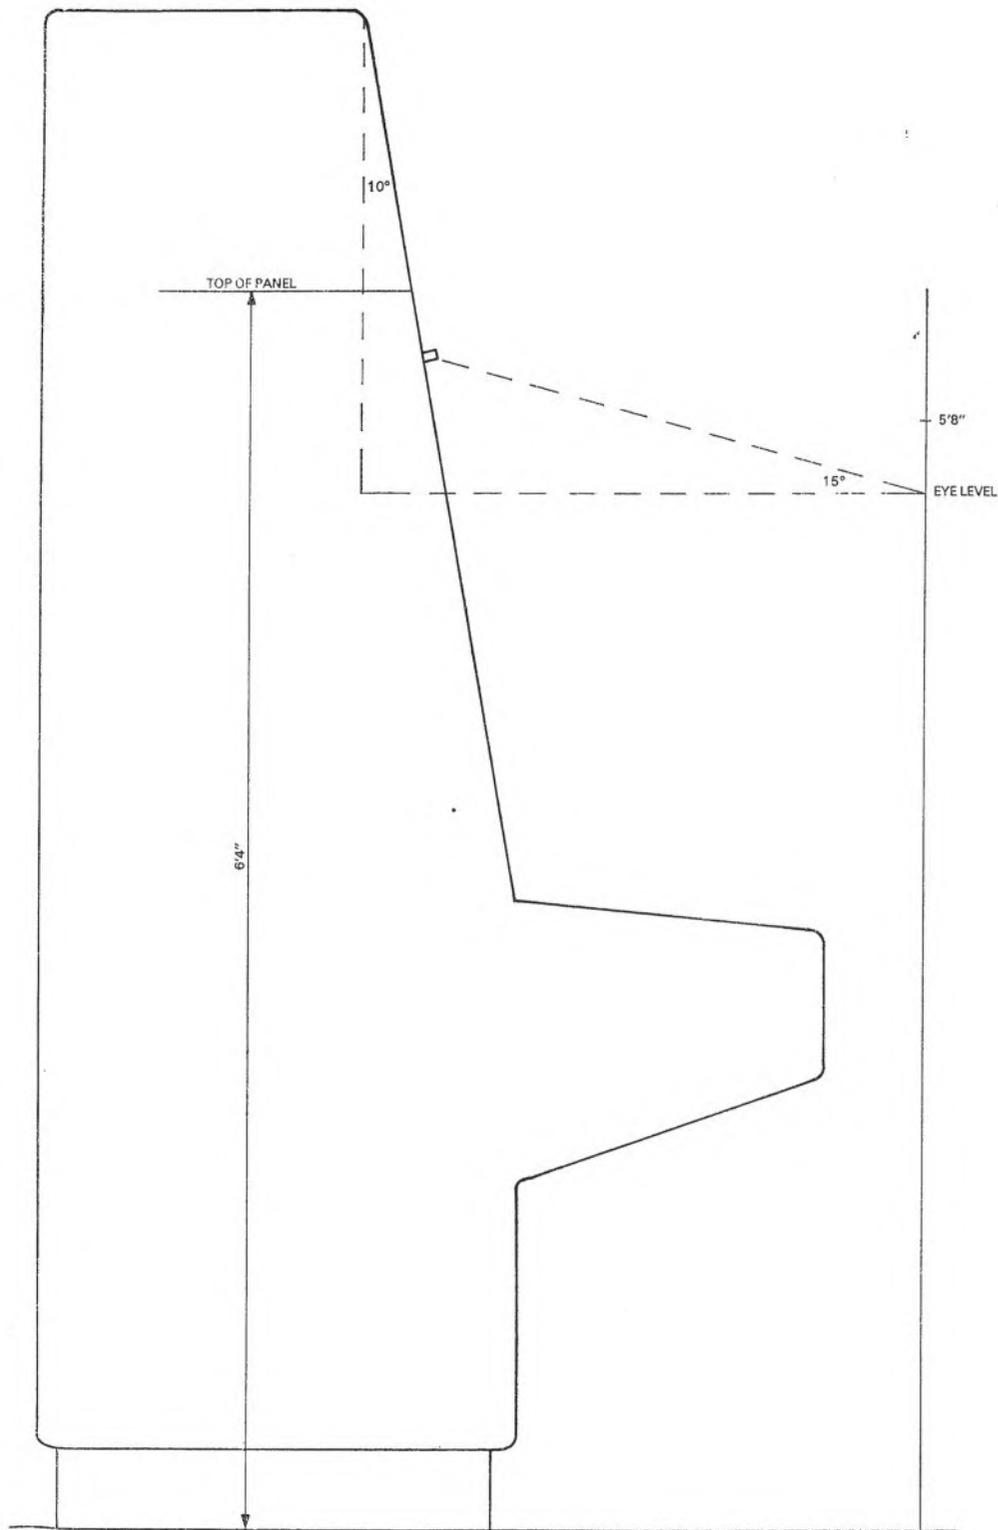
Fig 3

5. The panel (Fig. 3) is composed of 80 mm × 40 mm mosaic units placed at an angle of 10 degrees to the vertical, its top edge being 1930 mm (6 ft 4 in) above the floor. Beneath it there is a writing surface at an angle of 5 degrees to the horizontal some 480 mm wide and 950 mm (3 ft) above the floor. The panel faces the railway and the signal box windows. Desks are provided for the Area Controller, train regulators and other staff who, when seated at their desks, are about 13 feet from the face of the panel. Figure 5 shows a part of section B which includes Darwen Station and signal PN 461 approaching Bolton Branch Junction. It shows the indicator placed just below the single line to the left of the goods loop which indicates the direction for which trains are signalled on the single line and the point switches situated in the third row of mosaic units from the top of the panel some 6 feet above the floor, including those which can be used to operate the automatic catch points in case of failure. In the mosaic unit above each of the latter there is a sealed release push-pull key.

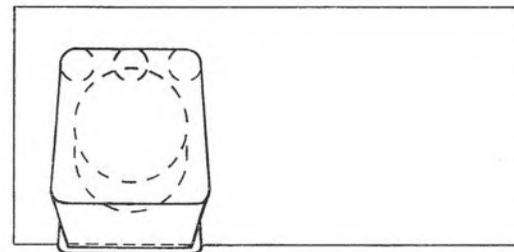
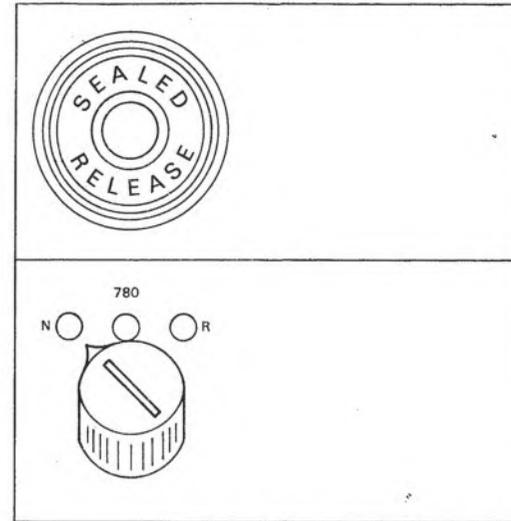
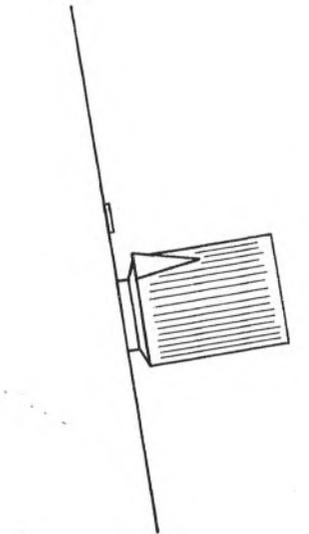
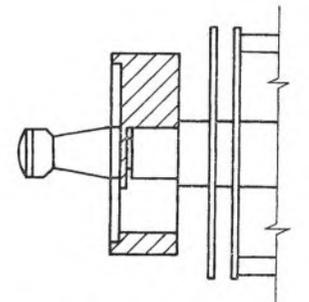
Fig 4

6. As shown in Figure 4, the point switches have a central position for automatic route setting and normal and reverse positions for setting points individually. The push-pull key above each catch point switch requires to be in the pushed-in (F) position for the point switch to be operative, and in the fully pulled out (T) position for the points to be automatically operated by the route setting procedure as described in paragraph 3. When the switch is in the T position a key-hole collar can be dropped over it to hold it out and a paper seal through which the button protrudes is then glued to the collar to seal it. Movement of the collar to release the button will break the paper seal on which the words "Sealed Release" are printed. The signalman on section B has eleven such releases along the top of his panel, and there are four more elsewhere on the Preston signal box panel. In addition to these fifteen sets, there are five sets of catch points within shunting areas also with sealed releases, which close automatically on signal clearance and track circuit occupation all on double lines of railway signalled for one direction working only.

23. Foulkes is a Class E signalman with 27 years' experience. He joined the new Preston Signal Box at its commissioning in November 1972 after a two-week's course of instruction. He told me that he had never previously worked in a power signal box, nor had he ever worked a Tokenless Block section. He described the working of the single Darwen line as track-circuit block operated from Preston signalbox and he thought there was little difference between working the bi-directional lines through Preston station, and the Darwen line. He had never been involved with automatic catch points prior to coming to Preston, and he did not remember seeing any in the Derby box where he had been trained. He thought that they had been mentioned on the course, but not in any great detail. He was able to describe to me their method of working, but he agreed that it had only become clear to him since the accident. He told me that during the afternoon he had trouble with 788 catch points near Entwistle Station but he had overcome it by operating the point switch. The signal technician had not been called and he had made no entry in his register. He agreed that he should have recorded the breaking of the sealed release on 781 catch points but that he had not done so. He had not discussed pilot working with Mr Hammill because he had hoped that the signal technician would have been able to put the trouble right quite quickly, as he had on other occasions. Signalman Foulkes is 5 feet 8 inches tall and he told me that he has to stand back on his toes to see the point indication lights above the switches at the top of the panel, particularly when reminder appliances are placed over neighbouring switches. (See Fig. 4.)

Signalmen have cut tops off

POINTS SWITCH VIEWED FROM 25° BELOW  
WITH REMINDER APPLIANCE

POINTS SWITCH VIEWED HORIZONTALLY

58. A signalman operating a power signal box must rely entirely on panel indicating lights for his knowledge. With reminder appliances placed over point operating switches at the top of the panel, the signalman cannot easily see the point indicating lights, and I recommend that those at the top of panels should be placed below their switches and not above them as at present. Points should be numbered consecutively along a line so that their switches, which should remain positioned in numerical order, shall more logically apply to the points they operate.

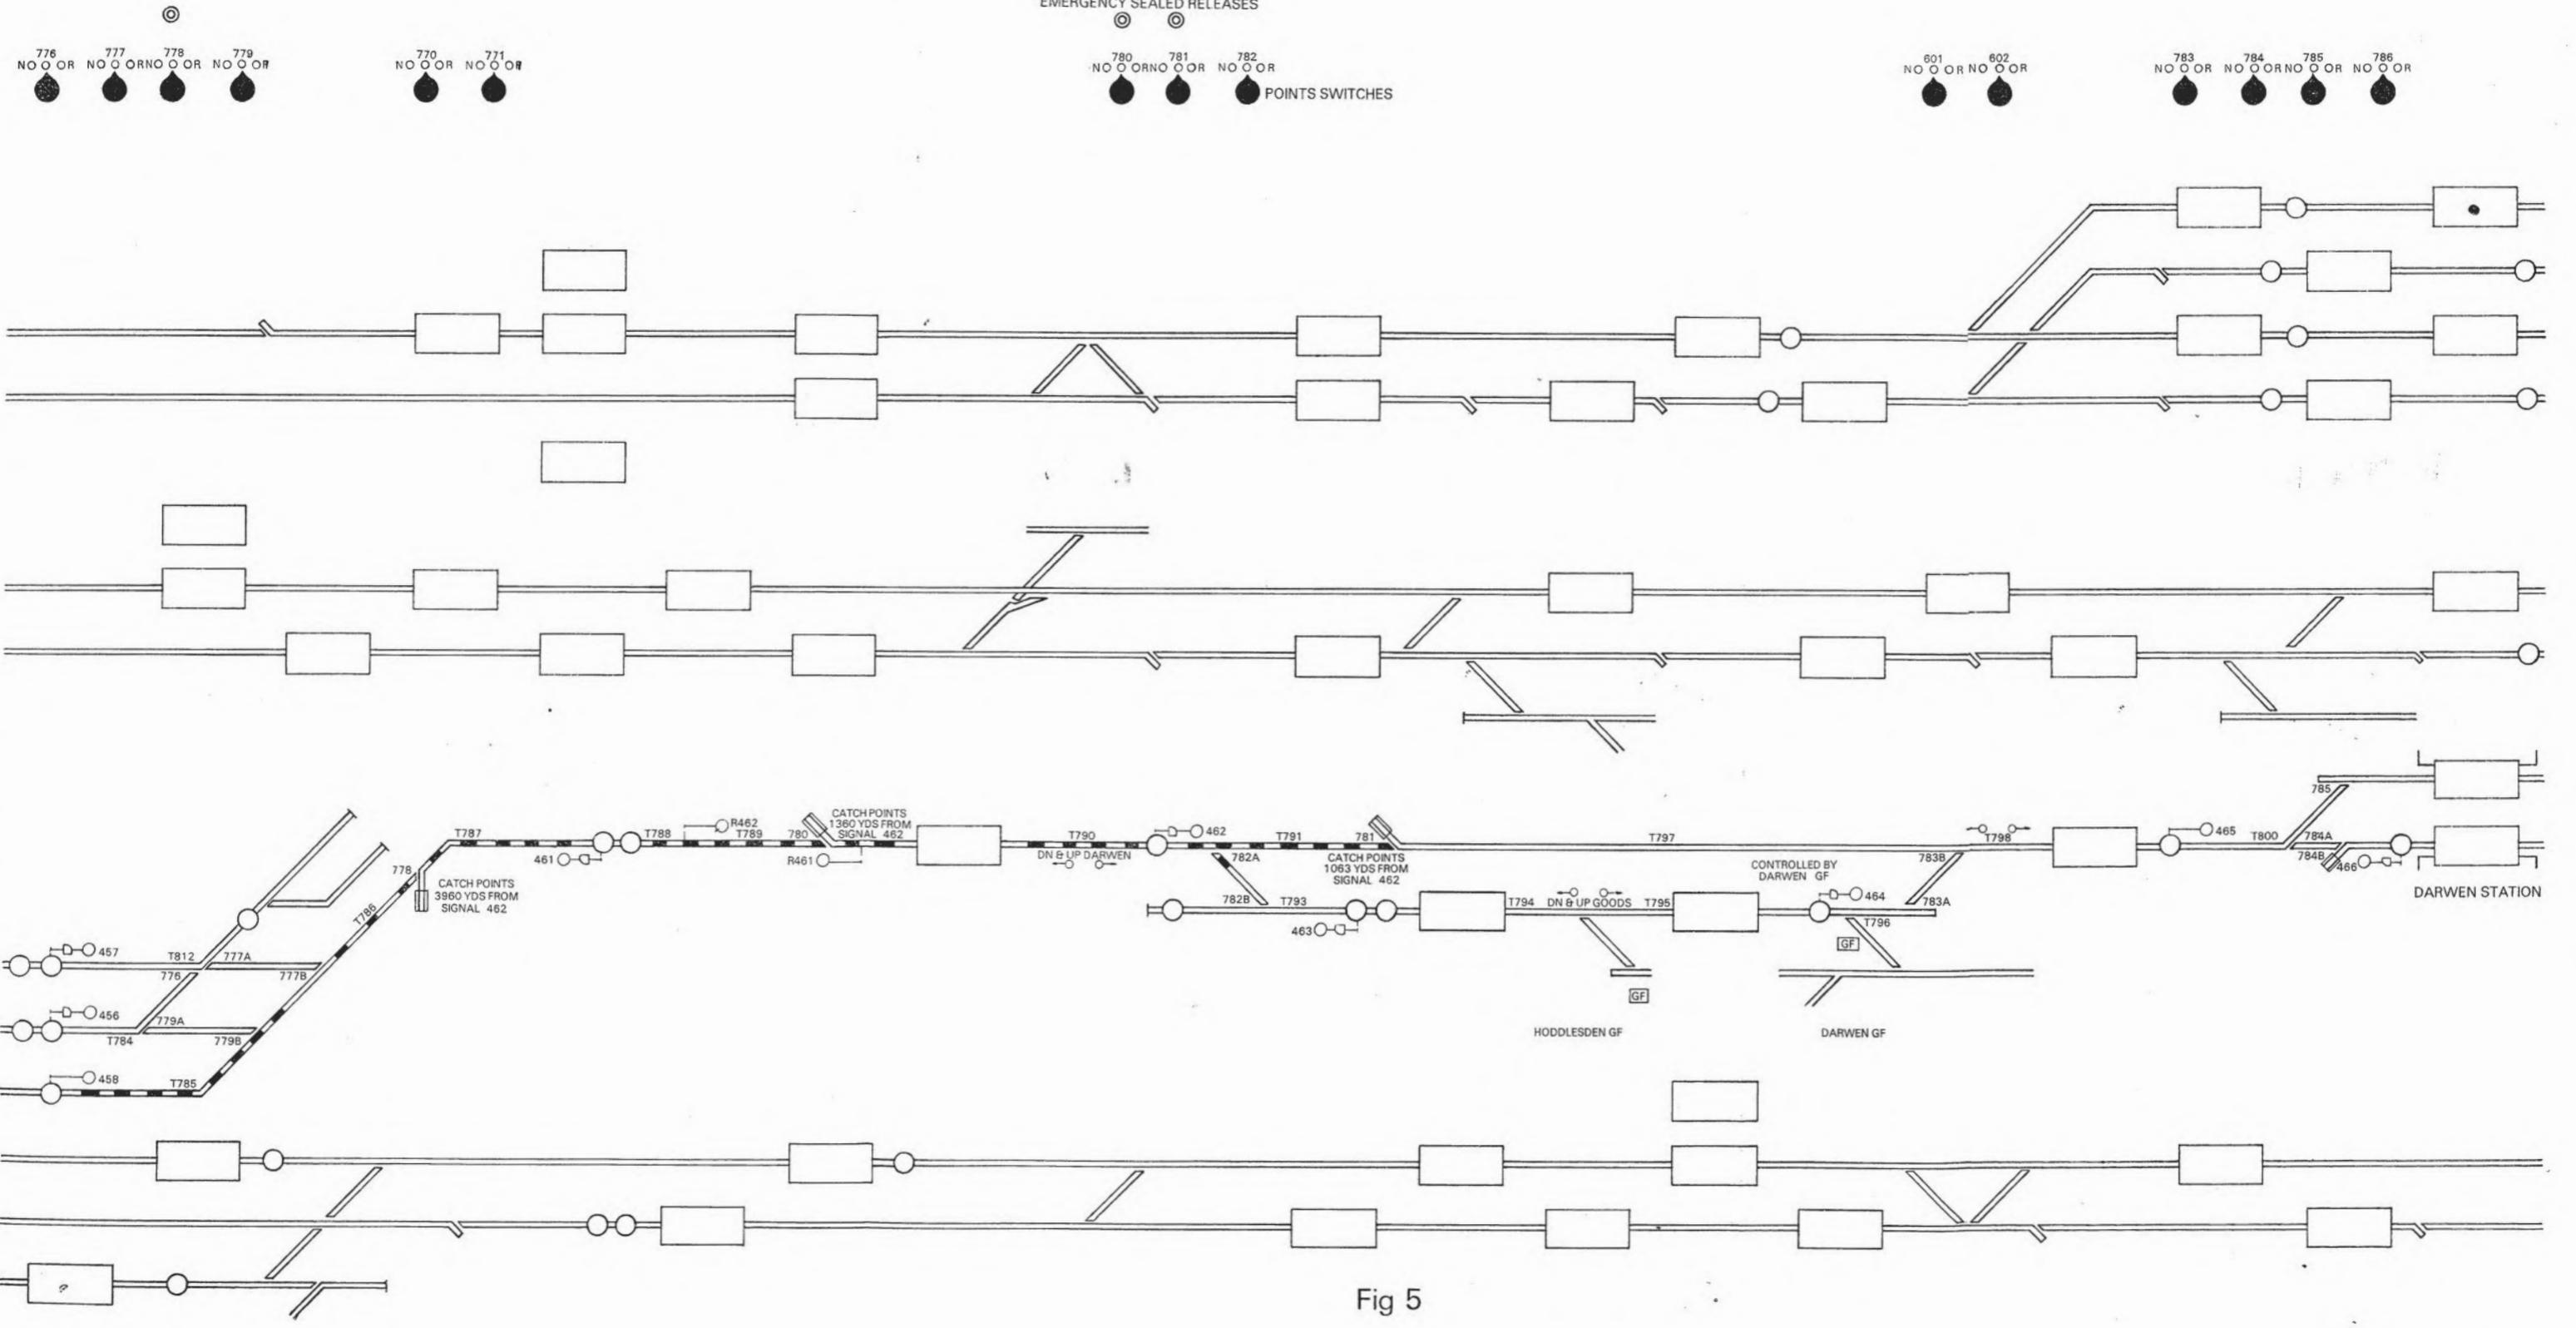
Fig 5

7. Individual or groups of track circuits are separately indicated on the panel using different colours and those on the Darwen line are coloured alternately green and brown. The minimum number of route setting lights in a track circuit is two although most have at least three. The track circuits on the Darwen line are shown in Fig. 5 and are indicated as follows:

TC 785	8 lights	green background
TC 786	3 lights	brown background
TC 787	5 lights	green background
TC 788	2 lights	brown background
TC 789	4 lights	green background
TC 790	6 lights	brown background
TC 791	8 lights	green background (one being on the goods loop exit)

Two of the lights of TC 789 are only lit when catch points 780 are set reverse.
