LANCASHIRE AND YORKSHIRE RAILWAY.

I AM directed by the Board of Trade to transmit to you, for the consideration of the Directors of the Lancashire and Yorkshire Railway Company, the enclosed copy of the report made by Colonel Yolland, the officer appointed by the Board of Trade to inquire into the circumstances connected with the explosion of the boiler of the engine of a passenger train at Halshaw Moor station, on the Lancashire and Yorkshire Railway, on the 31st January last.

*To accompany Colonel Tolland's Report on
accident on 31st January from Explosion
of Locomotive Engine Boiler at Halesham Moor
Station on Lancashire & Yorkshire Railway.*

SECTIONS THRO THE CENTRE OF FIRE BOX N^o 115 ENGINE

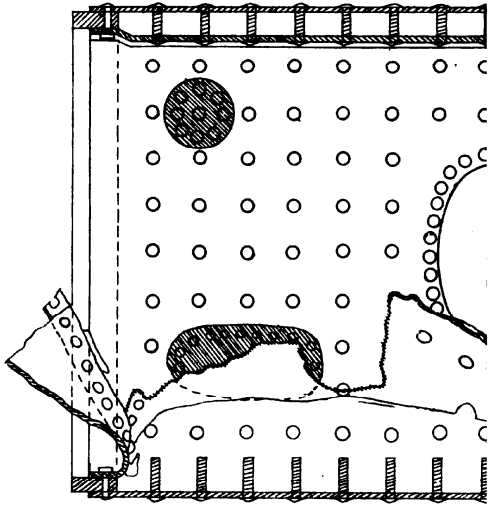
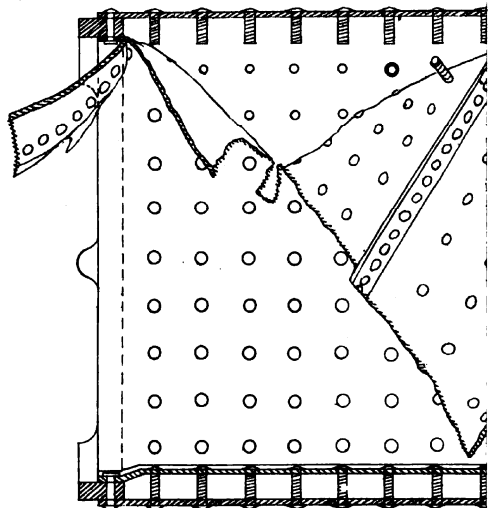
The fire-box, of which there are two transverse and two longitudinal sections given in the accompanying diagram, which has been furnished me by the indoor superintendent of the locomotive department of the Lancashire and Yorkshire Railway (Mr. Yates), at my request, is 3 feet 6 inches long by 3 feet $4\frac{1}{2}$ inches wide, and 4 feet 3 inches high; it is of copper, the sides and top being in one plate 12 feet 9 inches long by $\frac{1}{2}$ inch thick originally. The fire-box door was thickened with $\frac{3}{8}$ -inch plate 3 ft. 1 in. by 2 feet in addition to the front plate, also $\frac{1}{2}$ inch thick. The tube plate is of $\frac{3}{8}$ inch thick, where the tubes occur, and elsewhere it is $\frac{1}{2}$ inch thick, with an outside flange of $\frac{1}{2}$ inch thick and $2\frac{1}{2}$ inches wide.

The copper plate of the fire-box, and the iron plate of the outer shell, were secured in their proper position (about $2\frac{1}{2}$ inches apart) by 99 stays. On the left-hand side of the fire-box, where the explosion commenced, 90 of these stays were of copper 1 inch in diameter and 5 inches apart from centre to centre, and 9 of iron of the same dimensions. Of these the iron ones had all been fractured, and remained in the copper plate, while the copper ones had been

drawn through the copper plate, and these remained in the iron plate of the outer shell. The fractured iron stays were not near the part which first gave way, and the fractures were probably the result, and not the cause, of the explosion.

The thickness of the copper plate, originally $\frac{1}{2}$ inch, had been reduced by wear to less than $\frac{1}{4}$ of an inch along the line of first fracture, A, B, through the third horizontal row of stay-holes. The rivetting on the inner heads of the copper stays had been burnt away at this part; and the thickness of the plate having been so greatly reduced, the thread of the screws possessed small powers of holding, to retain the copper plate in its position.

There were two patches in the front plate, one circular, of small size, 6 inches in diameter, in the right-hand lower corner; the other, 15 inches long by 7 inches wide, in the left-hand lower corner—one patch 14 inches by 12 inches in the right-hand side plate, and one patch of irregular shape $14\frac{1}{2}$ inches long by 7 inches wide in the left side plate. The explosion was not in any way connected with these patches. The engine had repeatedly had repairs effected in the fire-box, and among the last, in February 1867, 57 copper stays were put in in the fire-box, and others were repaired in different parts: in May 1867 two rows of new stays were put in, and in December 1867 some repairs were made in the fire-box stays, and the bottom corners and patches were repaired.

It is also stated that the boiler was tested by hydraulic pressure up to 130 lbs. on the square inch in March 1867, before the engine was sent out of the shop, and no leak was discovered; and it is also distinctly stated by both the driver and the fireman that there was no leakage in the fire-box up to the time of the explosion, and there is no appearance of any having existed. The rule which is said to be adopted in the Lancashire and Yorkshire Railway locomotive shops is, that when a copper fire-box is known to be reduced in thickness to $\frac{1}{2}$ of an inch it is then condemned, taken out, and replaced by a new one; but it appears desirable that a more careful examination should be made in order to ascertain the thickness of the copper plates when engines have been running for such a length of time, and for such long distances as No. 115 engine, where the plate had been reduced at one part to less than one-fourth of the original thickness. The Locomotive Superintendent, at my request, caused a hole to be drilled in the plate at the right side of the fire-box, and here the thickness had been reduced to somewhat under a quarter of an inch; so that it is apparent that the engine must have been running for some considerable time with an insufficient margin as regards the strength of the fire-box.
