**RAILWAY ACCIDENT AT HUDDERSFIELD**

A report on a collision that occurred  
on 6 November 1989

I report for the information of the Secretary of State for Transport, in accordance with the Direction dated 11 December 1989, the result of my Inquiry into the head-on collision between two passenger trains that occurred at 21.56 on Monday, 6 November 1989, at Huddersfield in the then Eastern Region of British Railways.

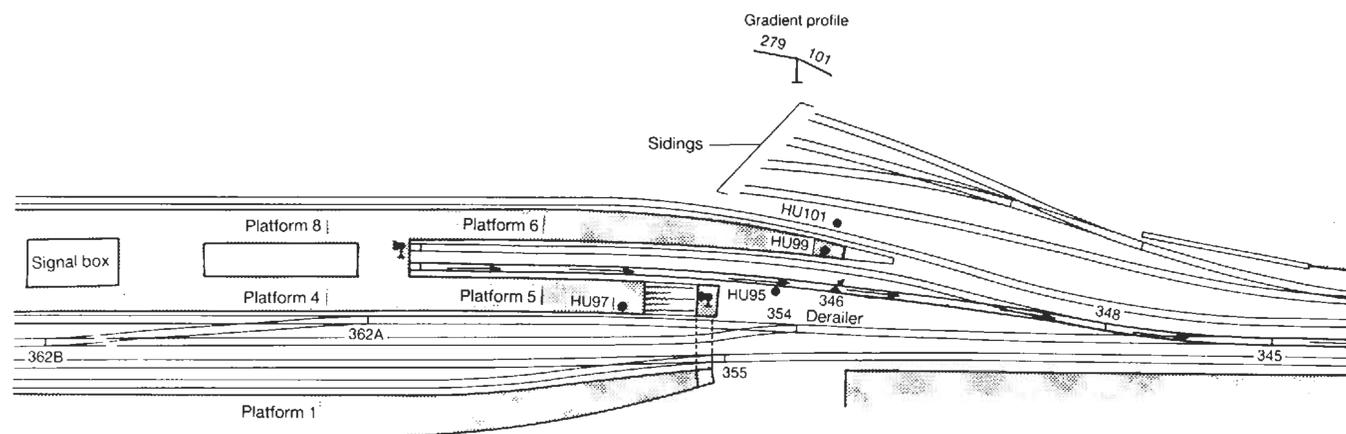
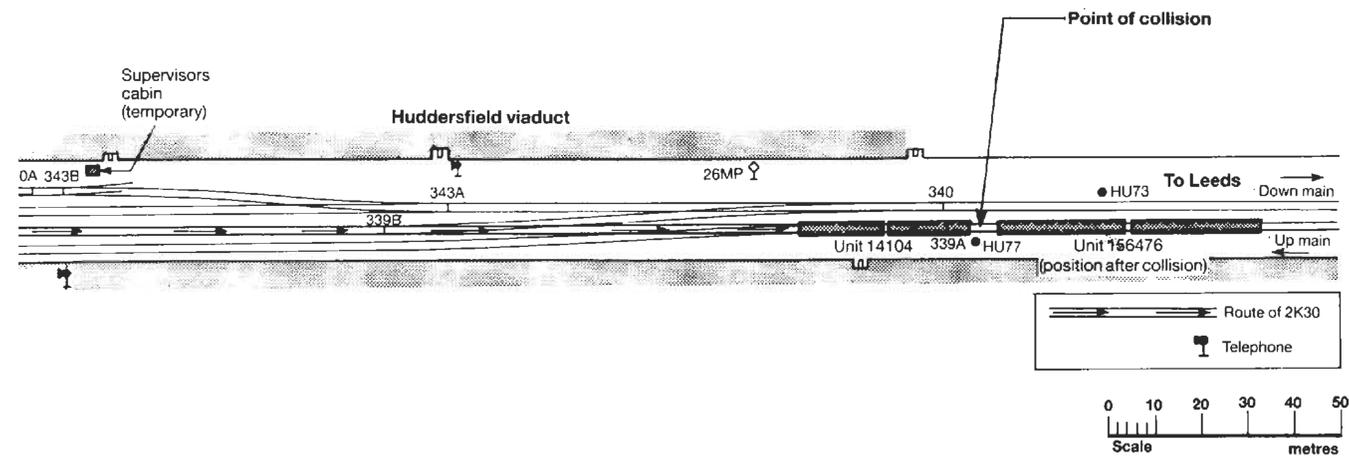
Figure 2 Site plan

2 The primary running lines at the east end of the station comprised an Up Main line (from Leeds direction) and a Down Main line (towards Leeds). The collision occurred at Signal HU77, when the Wakefield train had travelled some 314 metres. The location is depicted at Figure 1. Figure 2 shows the general layout.
