MINISTRY OF TRANSPORT & CIVIL AVIATION

RAILWAY ACCIDENTS

**REPORT ON THE COLLISION**  
which occurred on  
15th August 1953 at  
**IRK VALLEY JUNCTION,**  
near **MANCHESTER (VICTORIA),**  
in the  
**LONDON MIDLAND REGION**  
**BRITISH RAILWAYS**

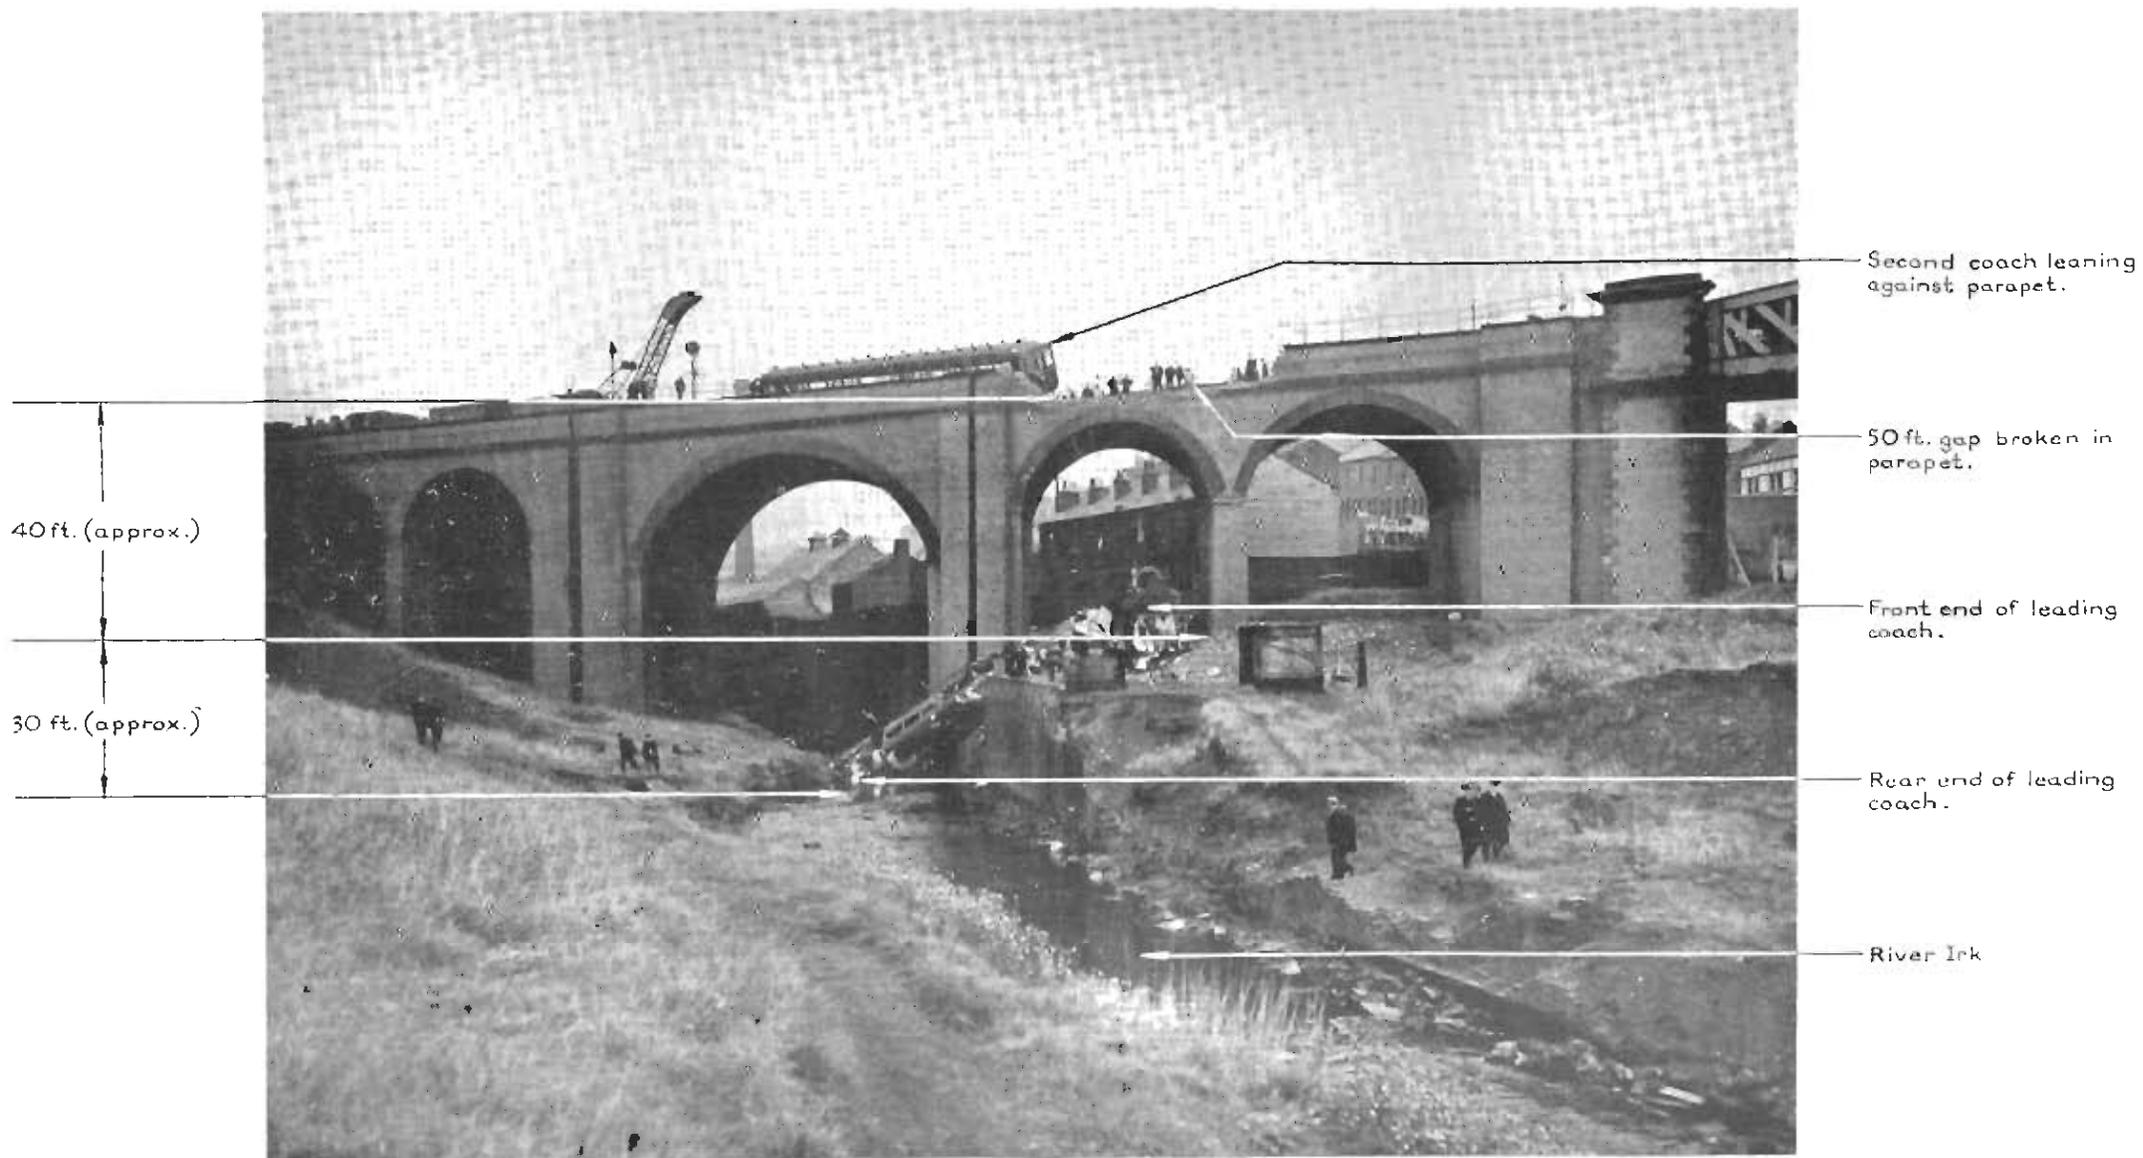
GENERAL VIEW FROM THE WEST OF THE WRECKAGE OF THE 7.20 a.m. ELECTRIC TRAIN

7. The first impact occurred about 2 yards north of the diamond crossing. The electric train struck the engine on its left hand side about 6 feet behind the buffer beam and overturned it. As the engine fell over, the leading electric coach came in contact with the wheels and under gear of the engine. It also struck the leading coach of the steam train, derailing it and forcing it over at an angle of about 45° against the viaduct parapet; it then hit the second coach, and derailed the front bogie. The leading electric coach was diverted to the right across the Down line and struck and smashed through the Down side parapet of the viaduct. After hanging for a matter of seconds the rear end coupling broke, and it fell into the valley below. The second electric coach stopped short of the gap in the parapet against which it was leaning at an angle of about 60°. The leading bogie of the third electric coach was derailed, but the other coaches of that train and the rear two coaches of the steam train remained on the rails.

8. The majority of the casualties occurred in the leading electric coach which was wrecked beyond repair. The second coach was also heavily damaged with severe distortion of the whole underframe.

The photograph opposite shows the gap in the parapet of the viaduct and the leading coach of the electric train lying in the valley below.

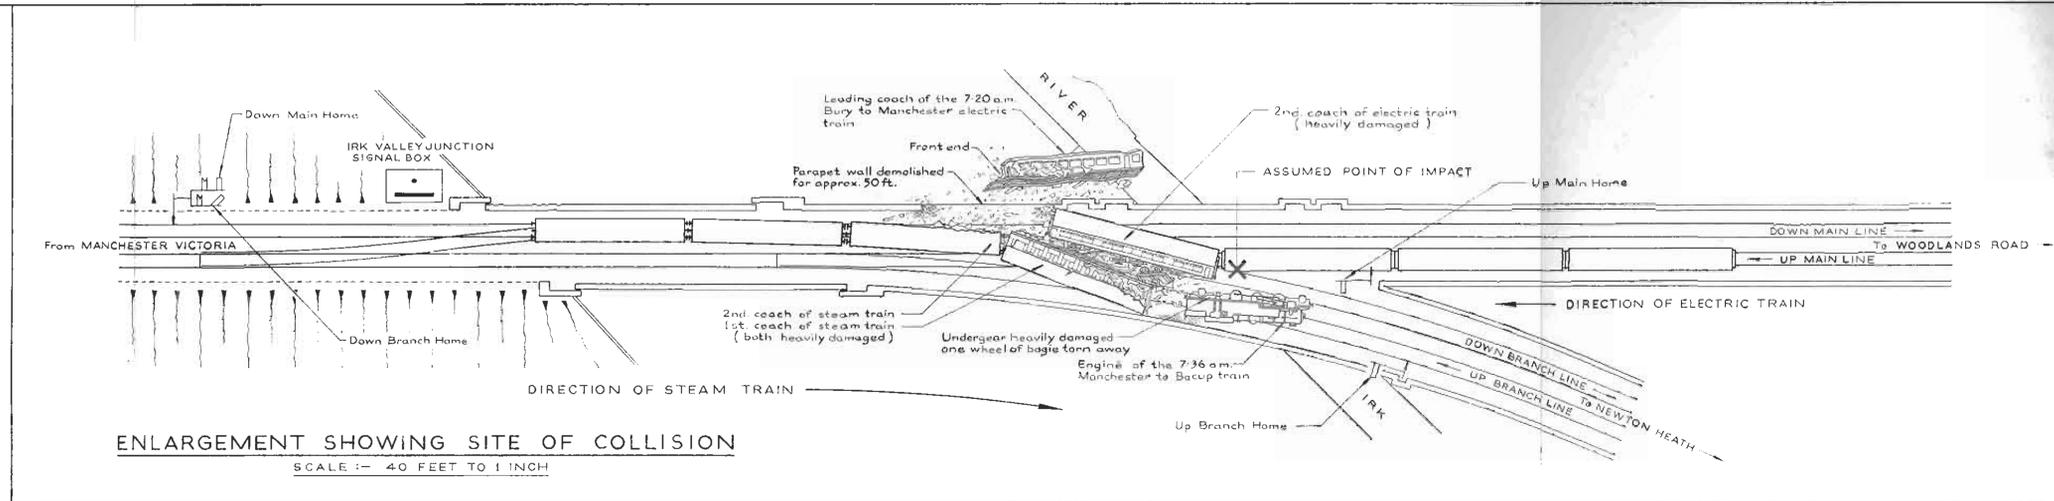
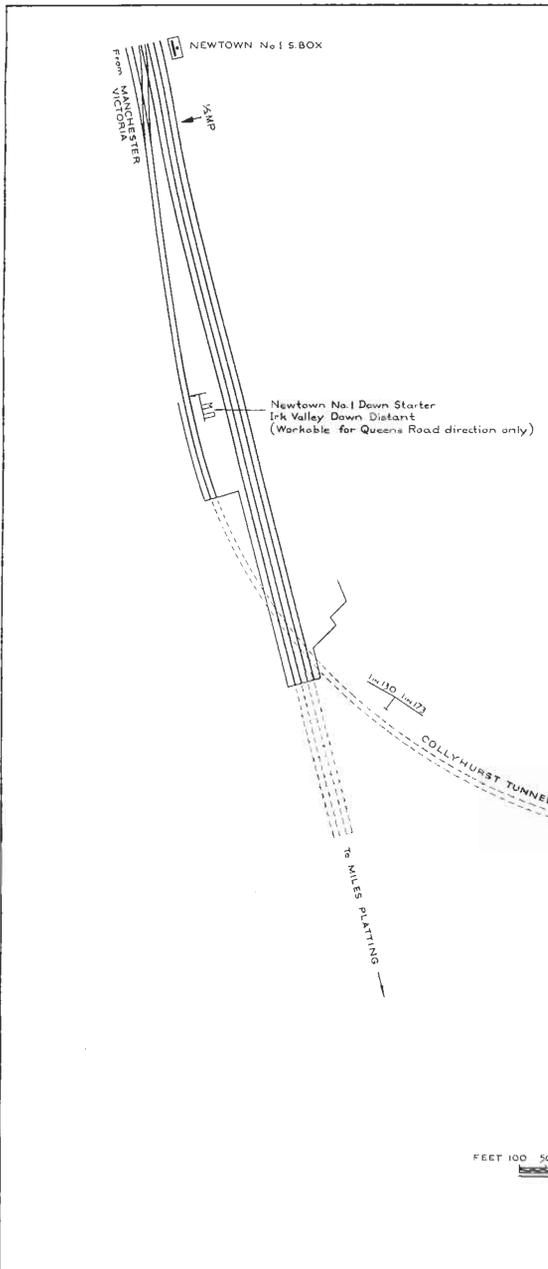
**COLLISION AT IRK VALLEY JUNCTION  
MANCHESTER**  
**15th. AUGUST, 1953**

2. The plan shows the layout of the site and the arrangements at Irk Valley Junction signal box.
3. The line from Manchester to Bury is  $9\frac{3}{4}$  miles long and it was electrified in 1914 on the side contact third rail system at 1,200 volts D.C. After leaving Manchester it passes under the main steam lines in a tunnel and then rises steeply over Collyhurst No. 1 Viaduct and crosses the River Irk and another steam line by Collyhurst No. 2 Viaduct. It then falls at 1 in 44 to Queens Road signal box and thereafter continues to undulate through Woodlands Road and Crumpsall to Bury.
4. Irk Valley Junction lies on Collyhurst No. 2 Viaduct just over one mile from Manchester and it is the point where the steam trains to Bacup branch off the main electric lines, on another viaduct.

It is a simple double line junction and it is controlled from a nearby signal box. It is equipped with a single home signal for each of the three directions and with a starting signal on the Up line to Manchester. The Up Main home signal is 21 yards from the diamond crossing and 122 yards from the box. There are Up Main inner and outer distant signals, worked by separate levers, situated respectively under the Queens Road Up starter and Up home signal, at distances of 283 and 621 yards from the Up home signal protecting the converging junction. The clear sighting distances of the inner and outer distants are 180 yards and 150 yards respectively, but with no train on the Down line, the outer distant can be seen from 391 yards. Again with no train on the Down line, the Up Main home can be seen clearly from the cab of an electric train just before passing through Queens Road overbridge, at a distance of 441 yards.
