MINISTRY OF TRANSPORT

REPORT ON THE ACCIDENT

which occurred on the
10th December, 1947, at

MANCHESTER (VICTORIA)

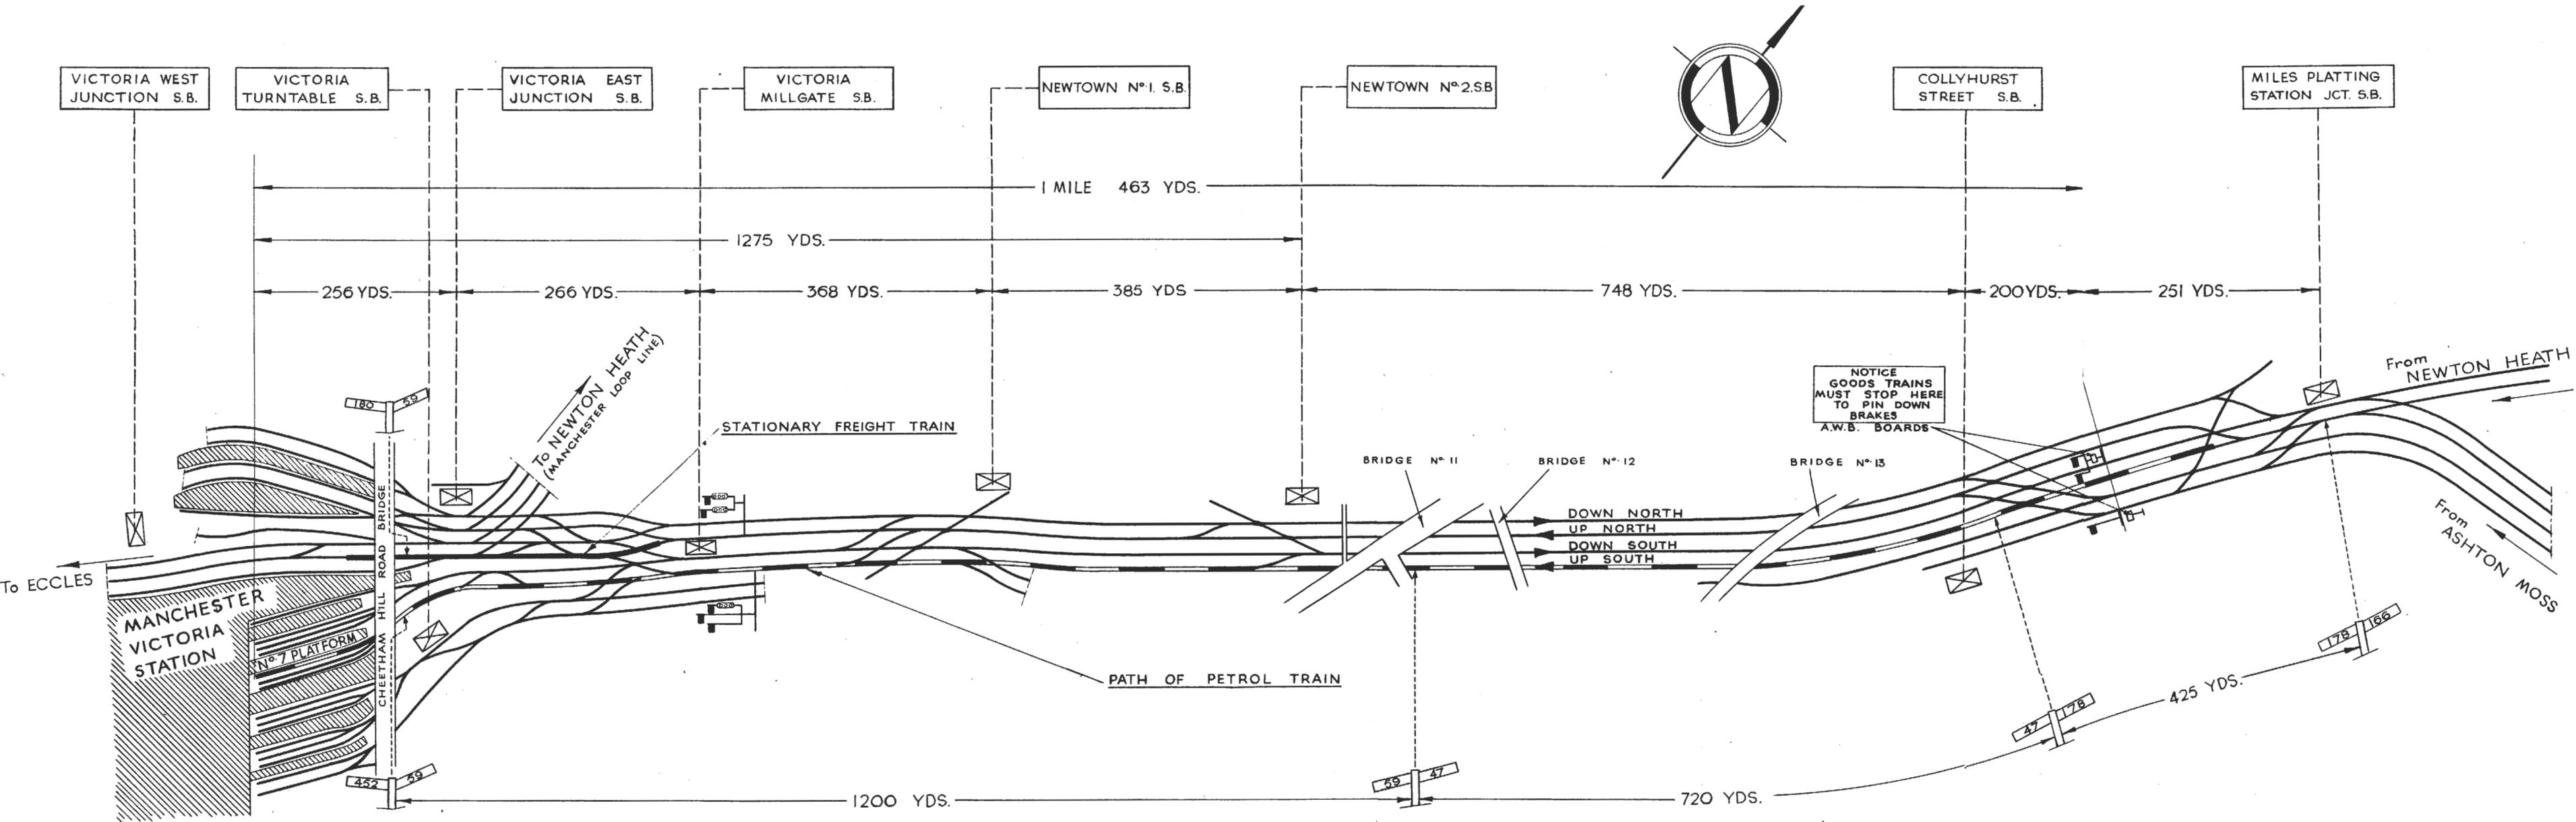
COLLISION AT MANCHESTER (VICTORIA).

The layout of tracks from Miles Platting to Manchester (Victoria), together with relevant signal boxes, signals, gradients, etc., is shown in the accompanying diagram.

The line from Ashton Moss converges with that from Newton Heath at Miles Platting Station Junction. From here to Collyhurst Street Signal box, there are six tracks and then four lines descend the incline in a westerly direction past Newtown No. 2, Newtown No. 1 and Victoria Millgate boxes. These lines are named in order from North to South:—Down North, Up North, Down South and Up South; the petrol train was routed on the last named.

2. Approaching Miles Platting, the Ashton Moss line is on a falling gradient of 1 in 166, which changes to 1 in 178 at the junction. At Collyhurst Street box, the steep incline commences with a gradient of 1 in 47 for the first 720 yards, changing at Bridge No. 11 to 1 in 59 for a further 1,200 yards as far as Cheetham Hill Road overbridge. Thereafter the gradient rises at 1 in 452 into the terminal platforms and at 1 in 180 on the main lines into the through station.
