LONDON MIDLAND AND SCOTTISH RAILWAY.

I have the honour to report, for the information of the Minister of Transport, in accordance with the Order of 24th January, 1935, the result of my Inquiry into the accident which occurred at about 6.26 p.m. on January 18th at Moses Gate, near Bolton, on the London Midland and Scottish Railway (former L. & Y. section).

MOSES GATE L.M.S. RLY.

Accident on 18.1.35.

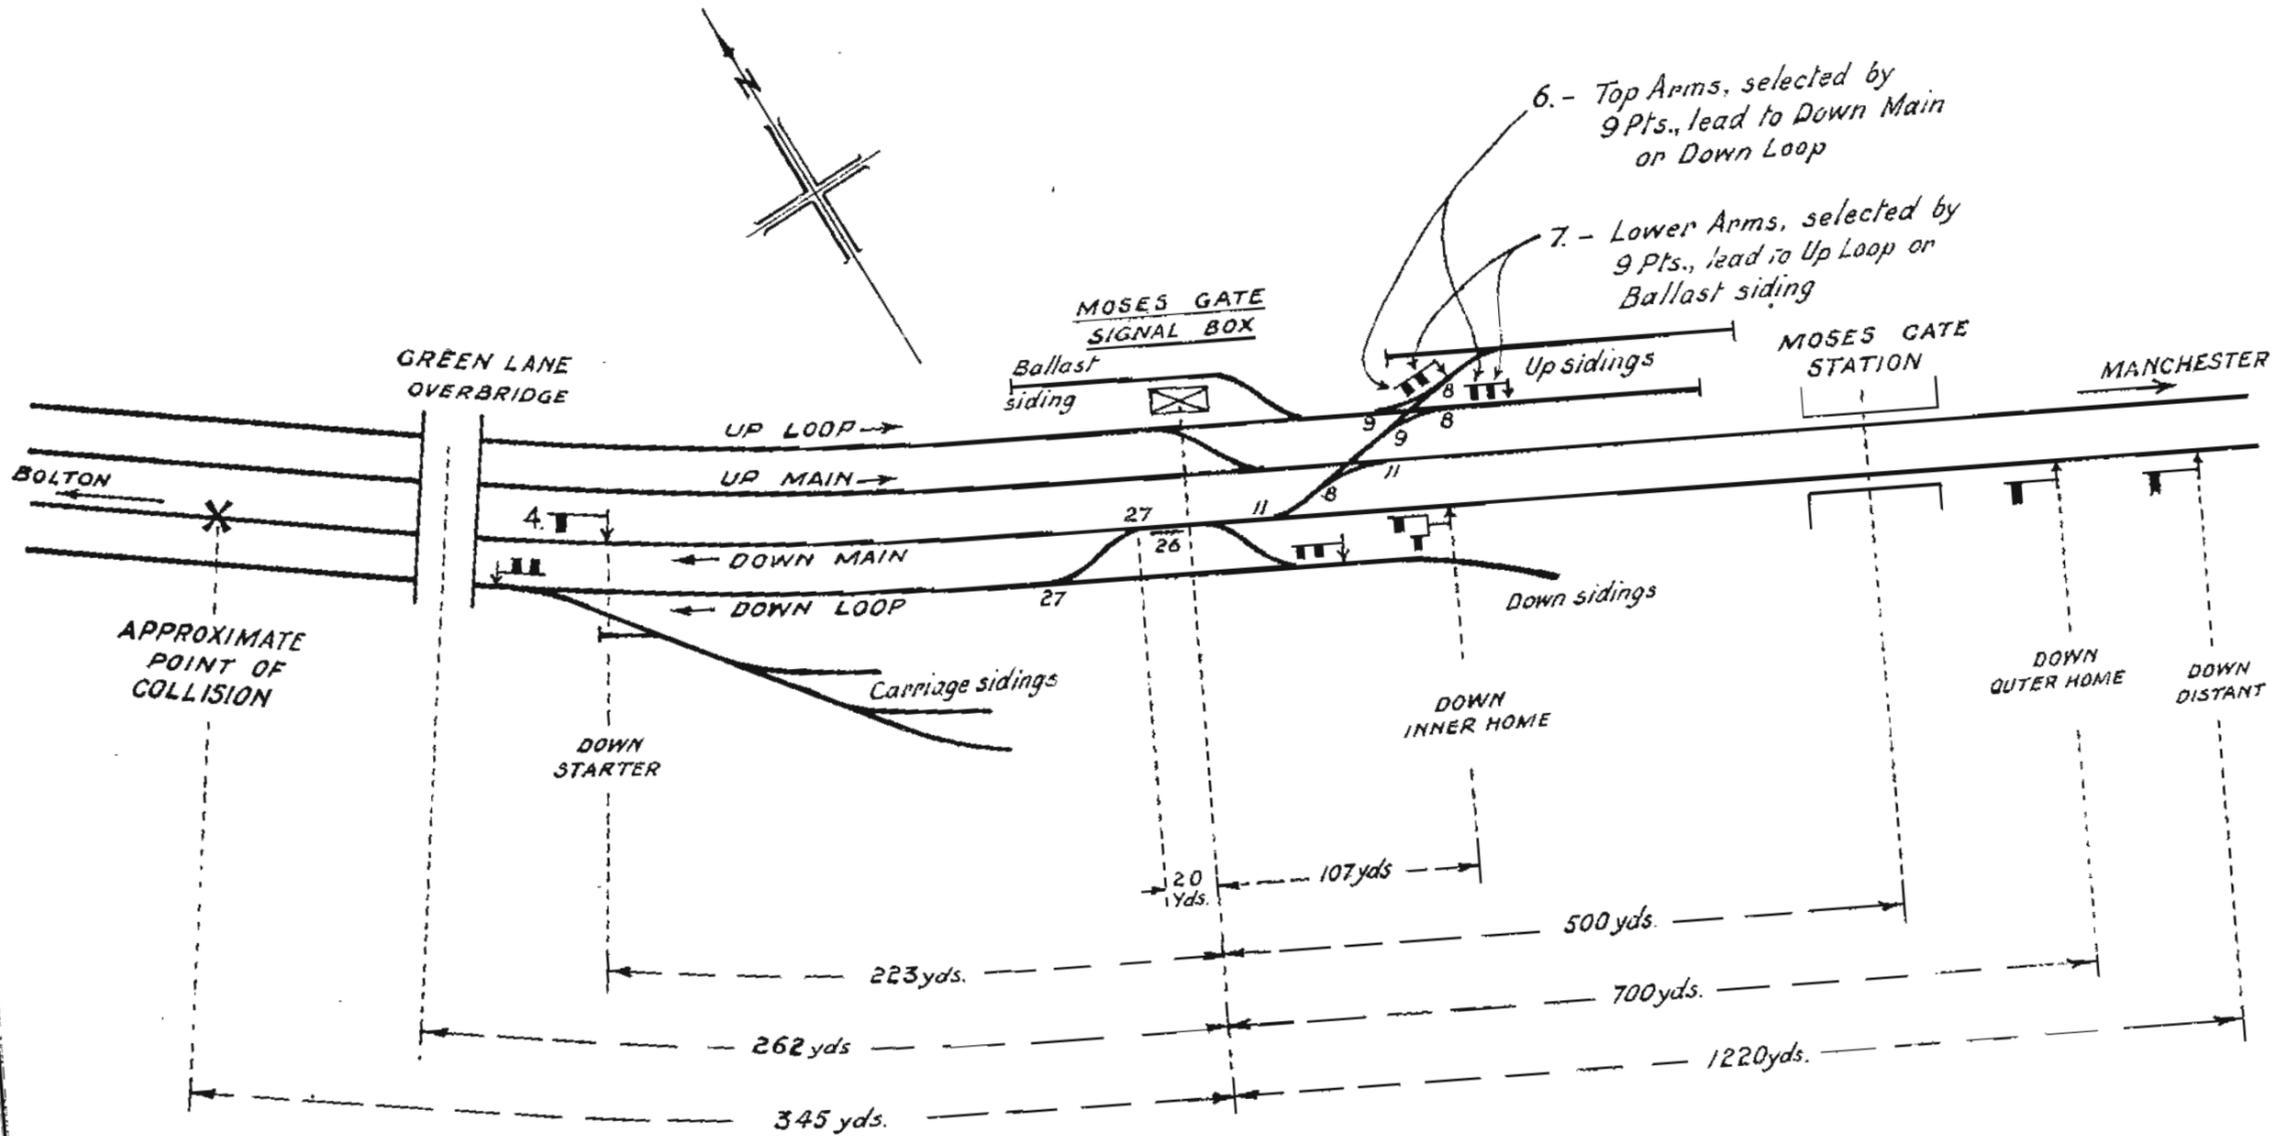
A diagram of the layout, showing the points and signals concerned, and approximate distances, is attached to this Report, from which it will be seen that one arm (No. 6) of each of the miniature semaphore signals controlling exit from the sidings on the up side, east of the signal box, applies to movements to both the down main line and the down loop. The position of the down starting signal (No. 4), between the up and down main lines, and of the backing signals at the carriage sidings points, between the down main line and the down loop, should also be noted. A gentle curve, right handed for down trains, and the girders of Green Lane overbridge, make it difficult to determine from the signal box on which line a train west of the bridge is standing. The carriage sidings lie roughly parallel with the down loop, the intervening space being some 10 yards. The nearest signal box to Moses Gate in the Manchester direction is that at Kearsley, about three miles distant. There are three intervening stations, at Kearsley, Farnworth, and Moses Gate, the running time for the section being about three minutes for non-stopping and eight minutes for stopping trains.

It is clear that the cause of this accident was the failure of signalman Knowles to set the road correctly before allowing the empty stock train to leave the up sidings, but it is difficult to account for this lapse on his part: he frankly acknowledged his responsibility and expressed his sincere regret. He is a man of 59, with nearly 41 years service, during 37 of which he has been a signalman: his record is a very good one.

The arrangement of the signals at the exit from the up sidings, whereby the same arm (No. 6) leads either to the down loop or to the down main line, depending upon the position of the facing points ahead, is not altogether a desirable one, especially as other signals having a similar function, such as that at the exit from the down sidings, are provided with separate arms for each of the two paths available. No recent alteration has been made to the signals in question: indeed signalman Knowles informed me that their two arms (Nos. 6 and 7) had had their present significance ever since he had been at Moses Gate, that is to say for some 30 years. But it appears likely that the provision of an additional arm at each signal location, or alternatively of separate interlocked levers in the frame to work the top arms, depending on whether No. 27 points are normal or reversed, might have prevented this accident; in this connection it should be borne in mind that at present No. 6 arm is a "right away" signal when the points are set for the down loop, and that it leads up to the starting signal (No. 4) when No. 27 points are normal. I therefore recommend that the Company should be asked to consider an alteration of the signalling on the lines suggested above.
