# LONDON, MIDLAND AND SCOTTISH RAILWAY.

I have the honour to report, for the information of the Minister of Transport, in accordance with the Order of the 15th October, 1931, the result of my Inquiry into the accident which occurred at about 4.11 p.m. on the 12th October, at Preston, on the London, Midland and Scottish Railway.

# DERAILMENT AT PRESTON (L.M.S.R.) 12-10-1931

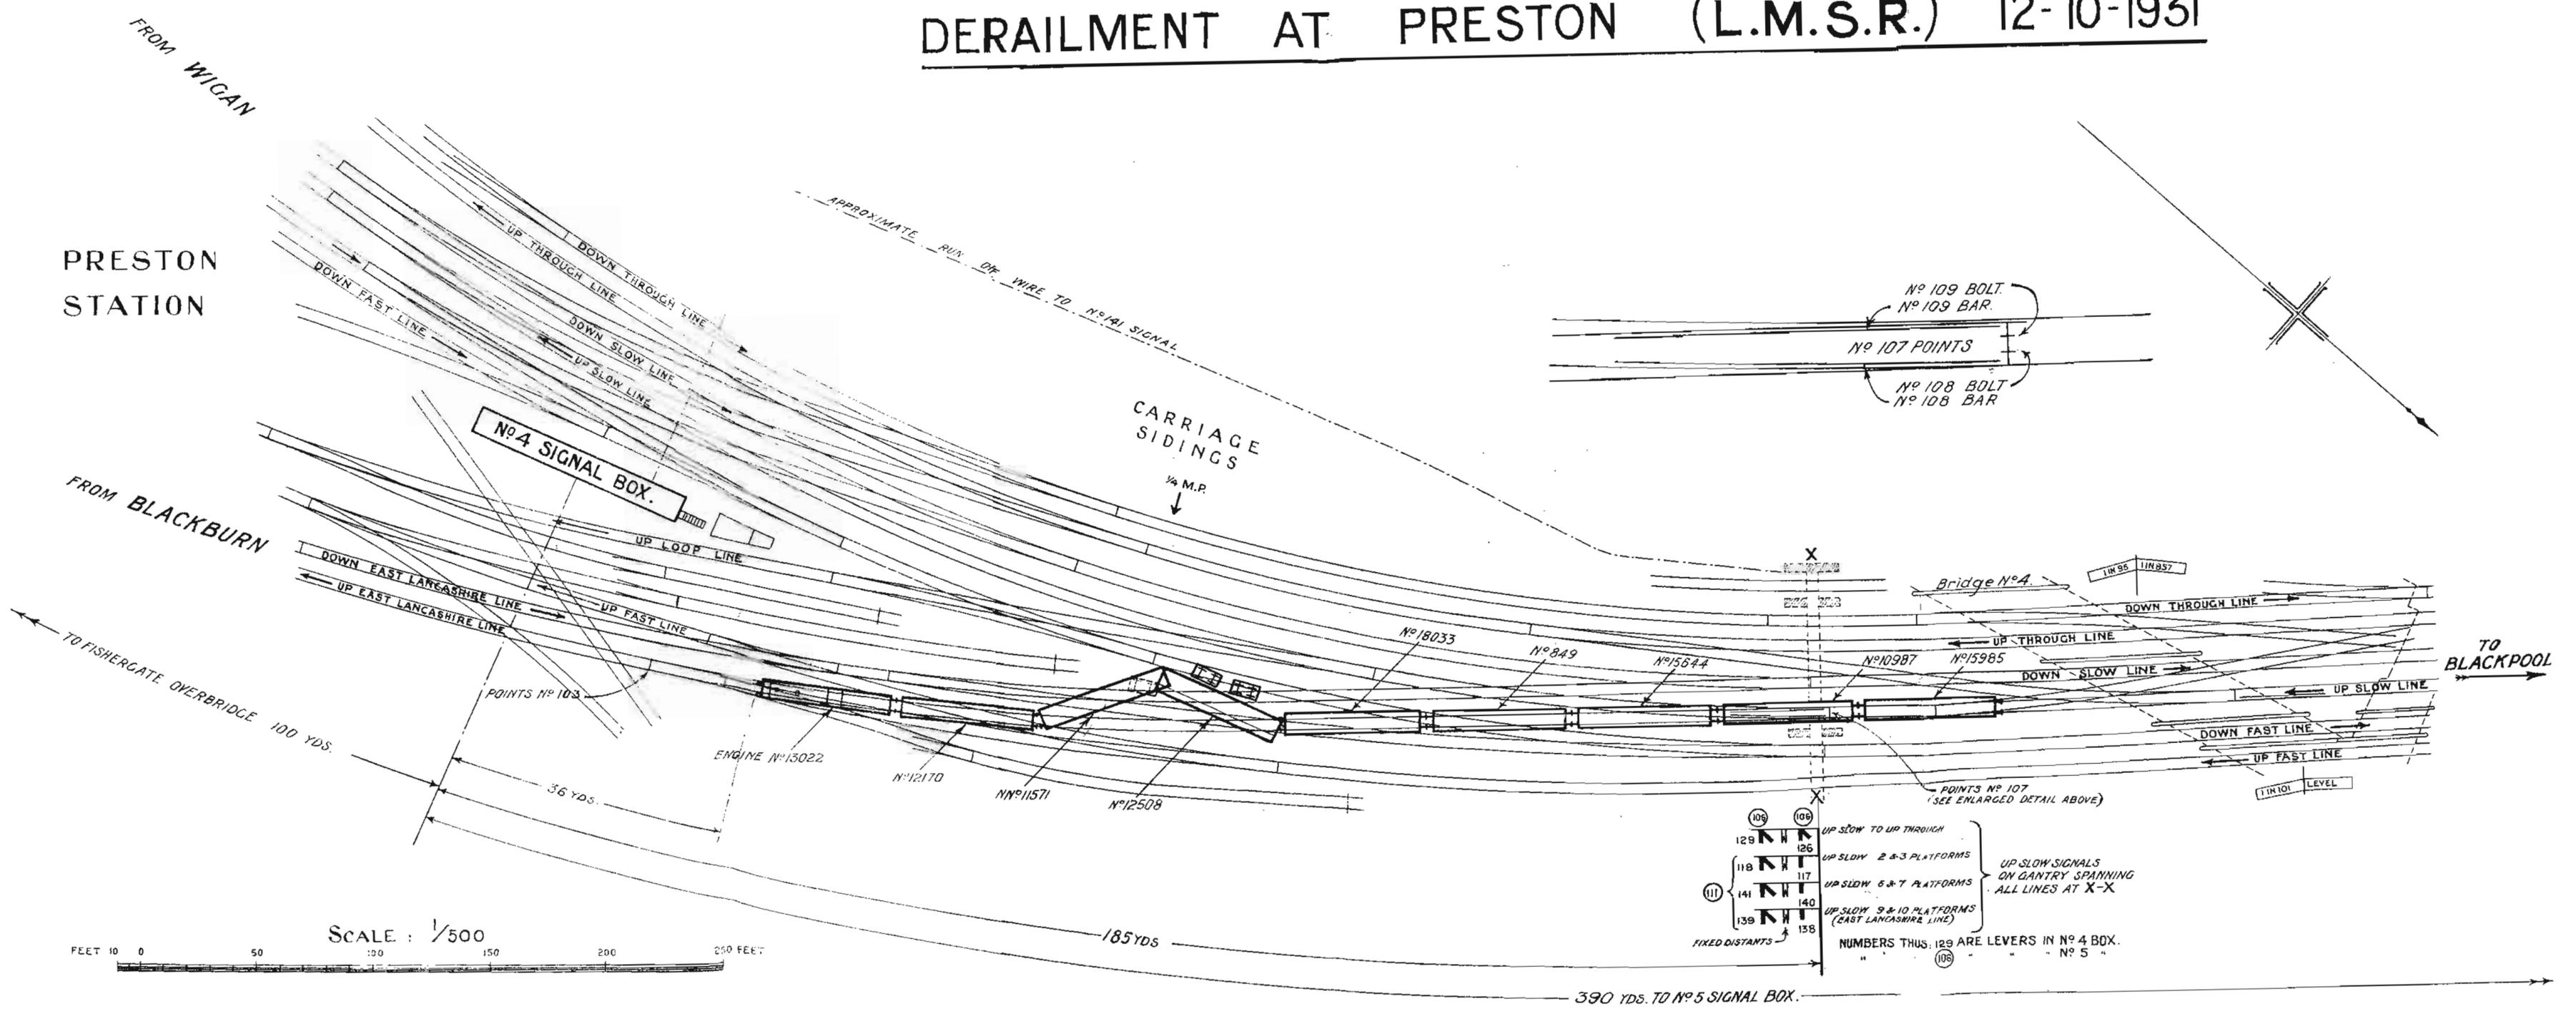
The layout of the lines concerned, with the position of the train after derailment, and relevant distances from No. 4 signal box, is shown on the accompanying plan. There are ten platform lines through the station, numbered from west to east; numbers 8, 9 and 10, on the east side, are known as the East Lancashire lines. Connections between the six running lines north of the station and the platform lines are worked from No. 4 signal box, situated about 100 yards north of the platforms; other crossover junctions, north of the signal gantry shown on the plan, are worked from No. 5 signal box, 390 yards north of No. 4. The crossover junction concerned in this derailment has facing points (No. 107) in the up slow line, worked from No. 4 box, and joins a connection from the up fast line to the up East Lancashire line, leading to Nos. 9 and 10 platforms, by trailing points (No. 103).

When the train came to a stand it was found that the engine and leading coach were on the rails, the second coach (No. 11571) was derailed and standing upright, the third coach (No. 12508) was derailed and leaning to the left at an angle of about 45 degrees, both bogies having been wrenched from below it and the body displaced. The remaining five coaches were not derailed.

The engine, the first, and the last five coaches of the train were standing on the connection from the up slow line to the East Lancashire line, that is to say, on the route which the train was intended to follow. The second vehicle, or at

any rate its leading bogie, had also apparently followed this route before derailment took place, while the marks on the track indicated that the leading bogie of the third vehicle (and possibly the trailing one of the second also) had taken the right hand road at facing points No. 107. The second and third coaches came to rest at an angle of some 30 degrees with their intended path, as shown approximately on the plan.

The first marks of derailment were on the check rails of both the diverging lines at the V-crossing ahead of No. 107 facing points. Both of these were marked heavily on their working edges, and bore wheel marks on their top faces. Ahead of this the sleepers of both lines were marked, and some 65 chairs were broken. The facing points themselves were undamaged, and required no repair or adjustment after the accident.

Movement of No. 107 facing points while the train was passing over them was undoubtedly the cause of this accident. It is evident that when Walsh first reversed them for the train, the engine must have been close to them, that they were then restored to normal between two pairs of wheels, and subsequently reversed again in the interval between two later pairs. Though he had no recollection of restoring and again pulling No. 107 lever, it is clear that Walsh must have done so; when he found he could not pull No. 109 lever to bolt the points it would be a natural action for him to work the point lever again to make sure that the points were properly home. As he was under the impression that the signals governing movement over the points were at danger, no blame can be attached to him for this, as the Company's regulations do not prohibit the movement of facing points in such circumstances after a train has been accepted.

In view of this, and having regard to the volume of traffic passing through Preston, the installation of modern equipment seems desirable, and I recommend that this point should not be overlooked when either the signalling or permanent way there becomes due for renewal.
