MINISTRY OF TRANSPORT

REPORT ON THE COLLISION

15th October, 1959

SMEDLEY VIADUCT SIGNAL BOX
near **MANCHESTER**

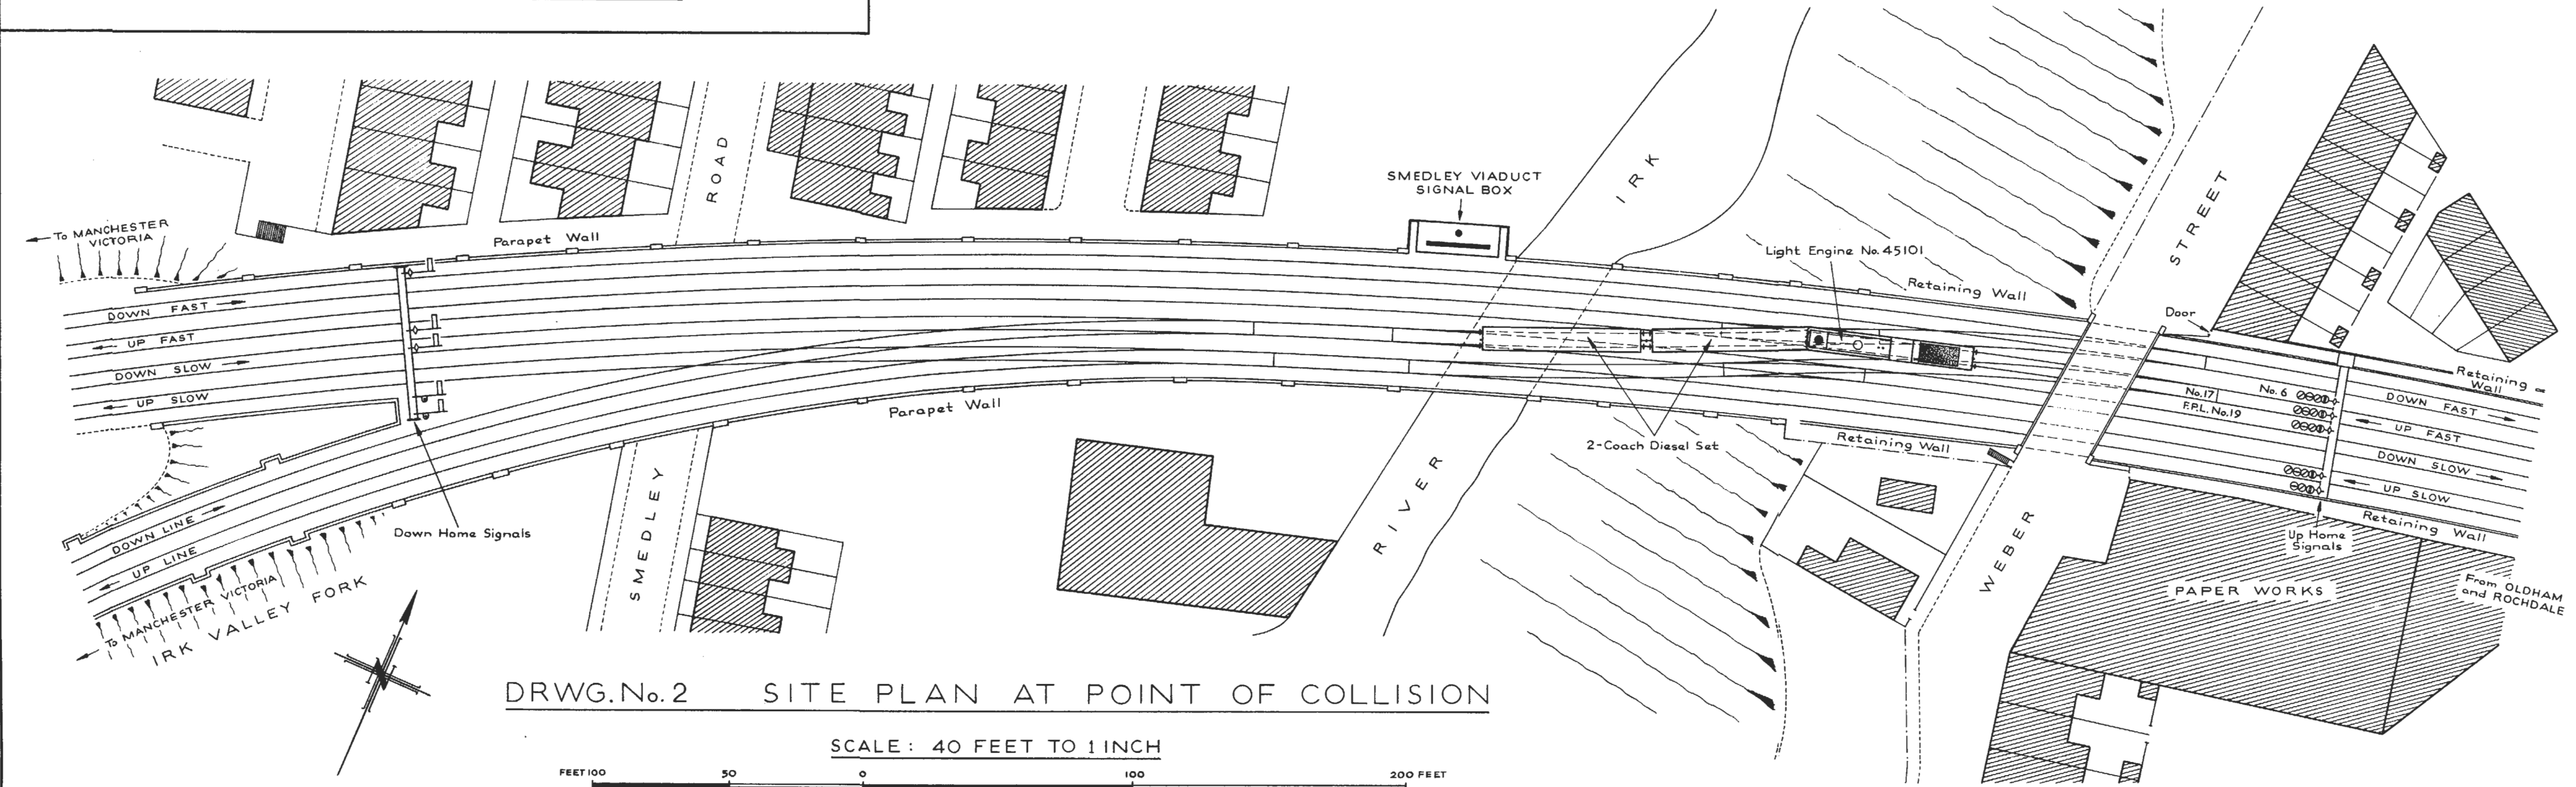
DRWG. No. 2 SITE PLAN AT POINT OF COLLISION

6. Dg. No. 2 shows the scene of the collision on the viaduct which is nearly 200 yards long and about 60 feet high where it crosses the River Irk. The Irk Valley Fork makes a double line junction with the Up and Down Slow lines which are to the left of the four-track main route looking towards Manchester; on the country side of the junction there are facing crossovers from the Up Fast to the Up Slow line and from the Down Slow to the Down Fast line on which

9. The position of the relevant signals is indicated on Dg. No. 2. They are semaphores, except the Up home signals which were converted to colour lights in 1936 because of the poor view offered to enginemen as their trains come through the tunnel. The colour light signals are fixed above the lines to which they apply on a signal bridge of lattice construction which spans the cutting on the country side of Weber Street bridge. The Up Slow line has separate 3-aspect signals for the fork and for the through line, and the Up Fast line has separate 3-aspect signals for the fork, for the crossover leading to the Up Slow, and for the through line. The two signals for the through lines each have a stand-by auxiliary yellow lamp. Berth track circuits are provided at the signals.

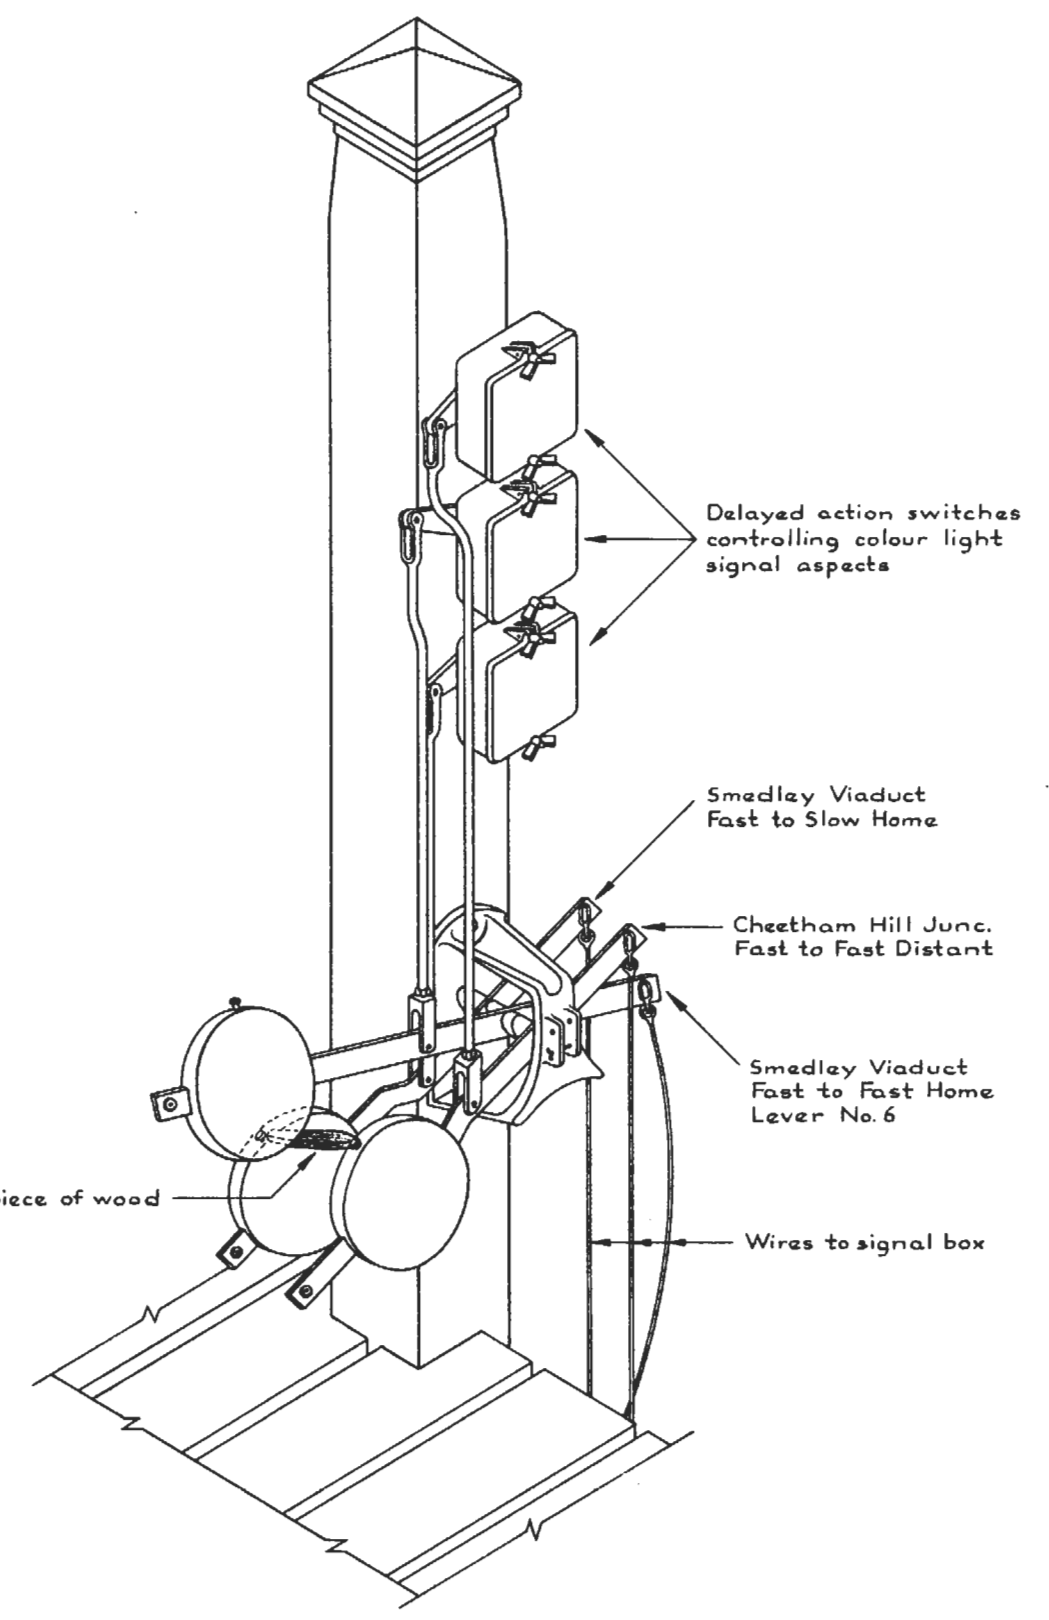
DRWG No. 3
VIEW OF OBSTRUCTION
IN WEIGHT BARS

18. Signal Lineman G. Gleaves arrived at Smedley Viaduct signal box within ten minutes of the accident. He saw that the Up Fast home signal lever No. 6 was normal in the frame but that the weight bar repeater for this signal was in the "OFF" position. He then accompanied Signal Inspector P. Fletcher and Telegraph Inspector B. Palin, who had arrived shortly after him, to inspect the signal. They saw No. 6 signal showing a yellow aspect, and then inspected the group of balance weights and bars for the home signals. The weight bar for this signal was found to be in the off position with the weight resting on a small piece of charred wood which had been placed under it across the weights of the bars on either side (see Dg. No. 3). Mr. Palin confirmed that when the wood was removed the weight descended to the on position and that the signal aspect changed to red.

26. The direct cause of the accident was mischievous interference with signal equipment, probably by children. I have no doubt whatever that the engine on the Up Fast line was fully under control and that Driver Taylor would have stopped it without difficulty at the home signal if it had been at danger. A contributory cause was Signalman Gillson's failure to carry out the Block Regulations governing the acceptance of trains at this junction.

27. The exact moment when the tampering with the signal weight bar took place was not discovered. I do not therefore reject Signalman Gillson's evidence that he saw the repeater return to the "ON" position when he replaced the Up Fast home signal lever in the frame after the previous engine passed at about 4.3 p.m., though I think it more likely for the piece of wood to have been placed under the weight when it was raised while the signal lever was in the pulled position to give the signal for that engine than for the weight to have been lifted by hand and for the wood then to have been placed under it.

33. The Up home signals are to be repositioned as a part of the modernisation of the East end of Manchester (Victoria) station which is to be put in hand shortly. In the meantime arrangements have been made to convert the existing signals to electrical operation with track circuit controls as a measure to avoid interference by trespassers.
