DEPARTMENT OF TRANSPORT

RAILWAY ACCIDENT

Report on the Derailment and Fire that occurred on 20th December 1984 at Summit Tunnel

IN THE
LONDON MIDLAND REGION
OF BRITISH RAILWAYS

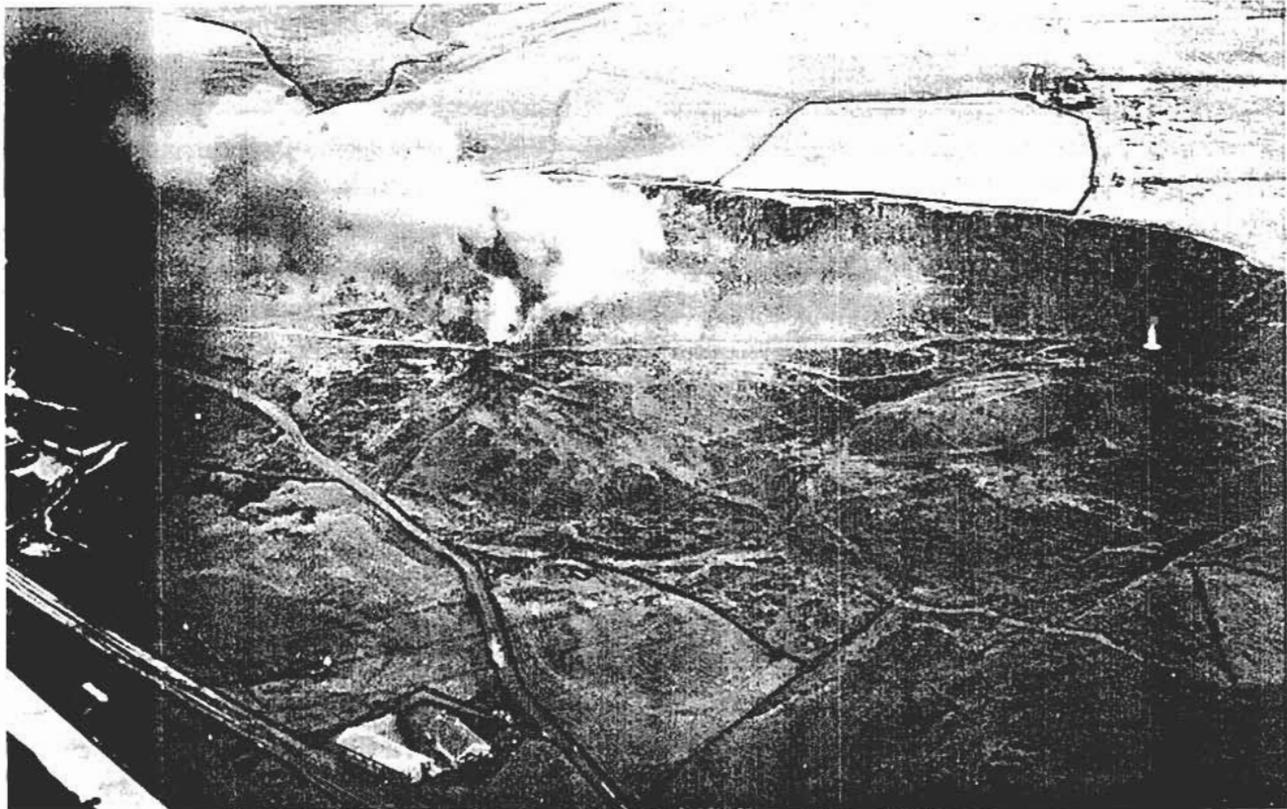
PHOTOGRAPH 1. Flames from Ventilation Shafts 8 and 9 at about 13.30 on 20th December 1984.
Photograph Courtesy of West Yorkshire Fire Service.

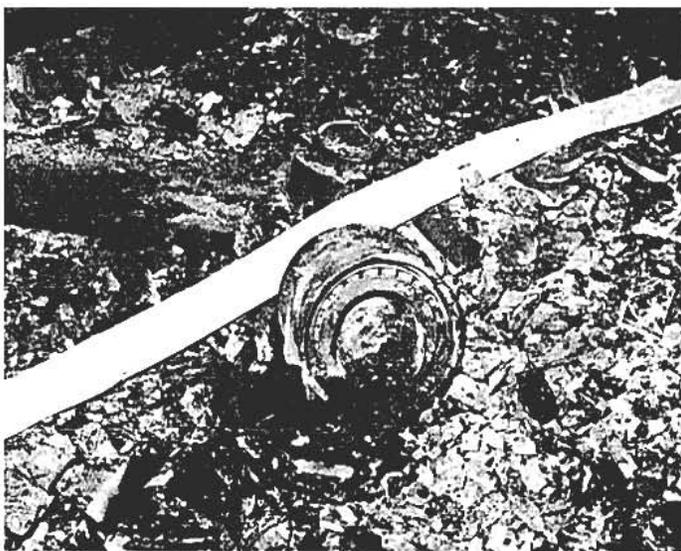
15. Both tracks were badly damaged and distorted and there were breaks in the rails here and there. On one bogie a wheel had slipped from its seating on the axle as a result of being expanded by the heat of the fire and due to the bogie being on its side so that the axle was tilted towards the vertical and the expanded wheel had slid down it. None of the damage that I saw, however, was inconsistent with what one might have expected to have occurred when a train of heavy bogie tank wagons loaded with petroleum first derailed and then caught fire. When I arrived at the leading end of the fourth vehicle I noticed considerable damage to the six-foot side wheel tread of the leading axle consistent with it having run along the sleepers for some distance striking base plates. The cess side wheel, on this axle, was close to the tunnel wall but it was possible to see that the axle journal end and roller bearing axlebox were missing (Photograph 2). It was immediately apparent that the unloading of the cess side wheel that would have occurred when the journal failed and the consequent freedom of movement of the broken stub end of the axle within the bogie horn guides would have allowed the cess side wheel flange to attack and climb the rail and thus cause the initial derailment. The damage to the track caused by this wheelset would quickly have brought other wheels into derailment. We then searched back along the track amongst the tangled wreckage of the train and the piles of heat damaged brick from the tunnel lining that had spalled and in places was laying between two and three feet deep over the tunnel floor. In such circumstances we were extremely fortunate to come upon the missing axlebox complete with bearings and broken journal end laying by the tenth tanker which was on its side (Photograph 3).

PHOTOGRAPH 3. Axlebox and Broken Journal End from the 4th Tank Wagon found laying adjacent to the 10th Tank Wagon.
Photograph courtesy of British Railways.

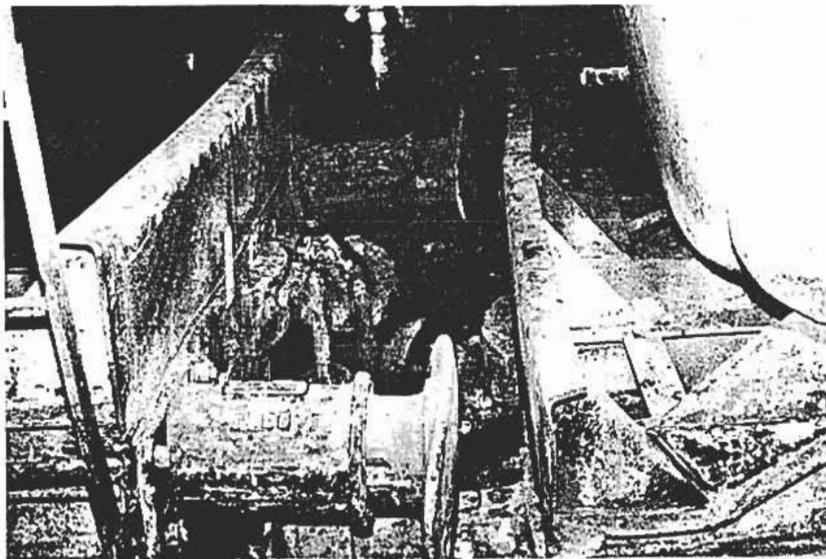
PHOTOGRAPH 5. The Buffer Override Protection Channels worked successfully.
Photograph courtesy of Mr D.G. Reid.

which were on their sides might have sustained prior to the fire. All the wagons were fitted with buffer override protection channels and these appeared to have prevented buffers from coming into contact with tank end shields except where tank wagons had overturned; no tank had been punctured by a buffer (Photograph 5).

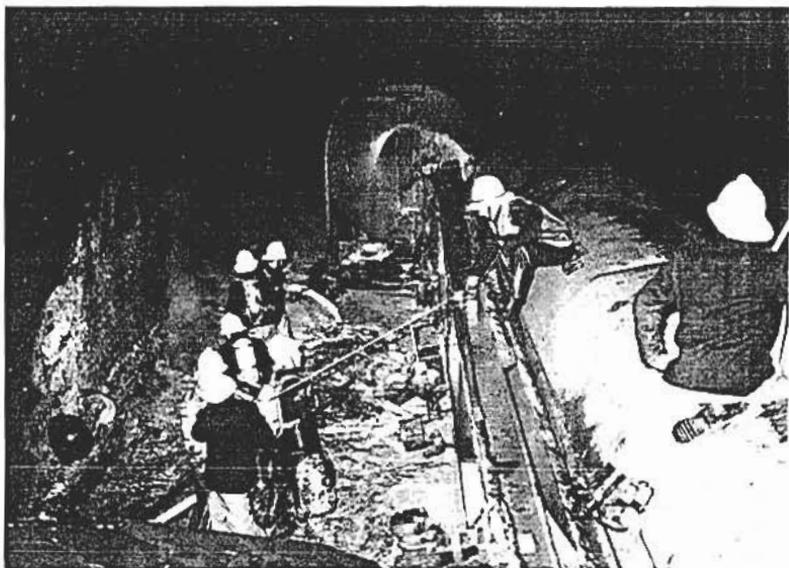
59. At the West Yorkshire end the distance into the tunnel was not so great and the gradient was favourable. A fire fighting attack was set up using a cooling jet and a foam blanket. The Divisional Commander who took charge of the incident described the fire as 'a lazy fire being fed by petroleum spirit leaking from derailed tank cars'. The fire fighters progressed until they had extinguished visible fire around the rearmost seven rail tankers (Photograph 6).

PHOTOGRAPH 6. Fire Fighters at Tank Wagon No 10 and beyond in the Early Stages of the Fire.
Photograph courtesy of West Yorkshire Fire Service.

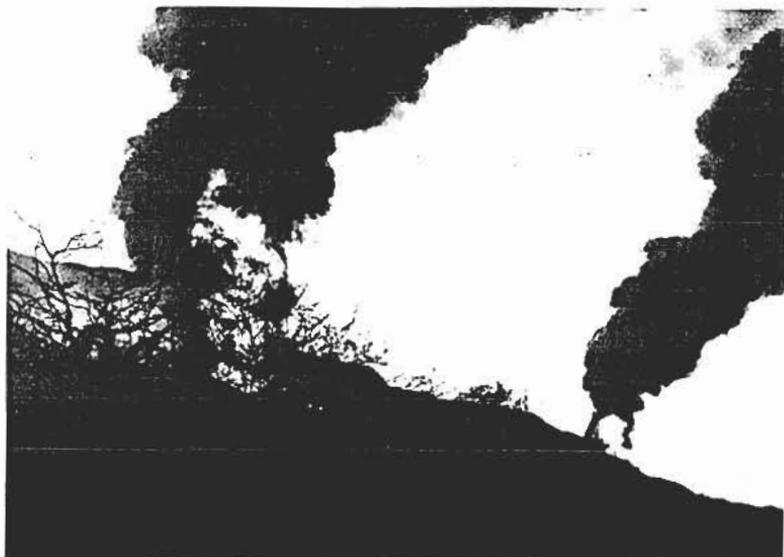
PHOTOGRAPH 7. Flames from Ventilation Shafts 8 and 9 at about 10.00 on 20th December 1984.
Photograph courtesy of West Yorkshire Fire Services.

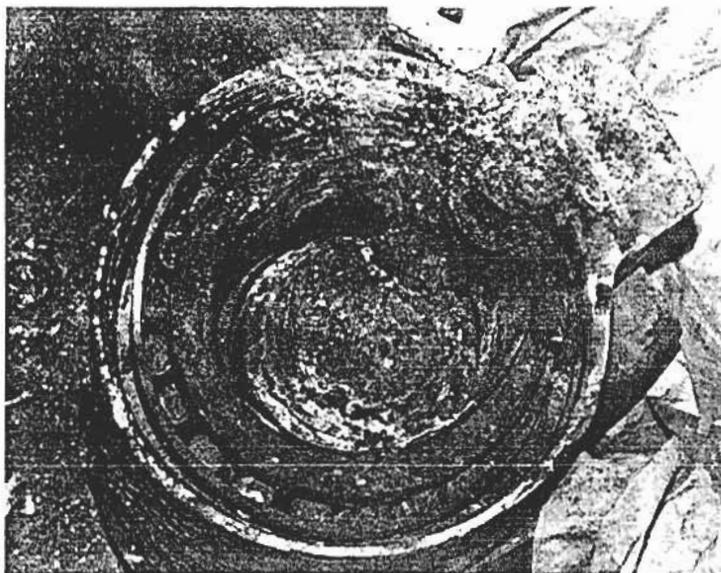
46. The investigation concluded that the journal failure resulted from the seizure of the axlebox which was probably the result of its incorrect assembly or fitting on the journal. The investigation did not bring to light any need to revise bearing maintenance or assembly procedures but it served to illustrate that these procedures must be rigorously followed. Details of the findings are at Appendix A.

Photograph 8 shows the axlebox with the broken journal inside and Photograph 9 the outer end of the bearing with the inspection plate removed to reveal the outboard bearing and locking cap. In both views displaced or misshapen rollers can be seen together with their damaged cages. A general arrangement drawing of the axlebox assembly mounted on the journal is at Fig 3 at the back of this report.

PHOTOGRAPH 8. Axlebox and Journal as removed from Summit Tunnel.
Photograph courtesy of British Railways.

4. the importance of following bearing manufacturer's procedures for repair and assembly be re-affirmed to all staff throughout the railway industry who have a responsibility for this work.

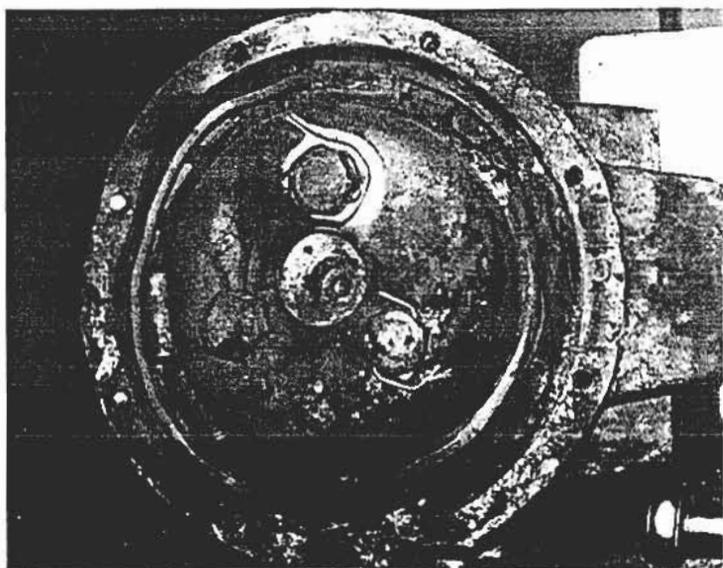
The locking cap bolts which can be seen in Photograph 9 were found to be fractured, the locking wire broken and the cap itself was friction welded onto the journal end. Sections through the parts of the bolts still in the journal end revealed that none of them had bottomed in their threads. Examination of the fracture surface showed they had failed by a ductile shear mechanism.

PHOTOGRAPH 9. Axlebox with the Inspection Plate removed.
Photograph courtesy of British Railways.

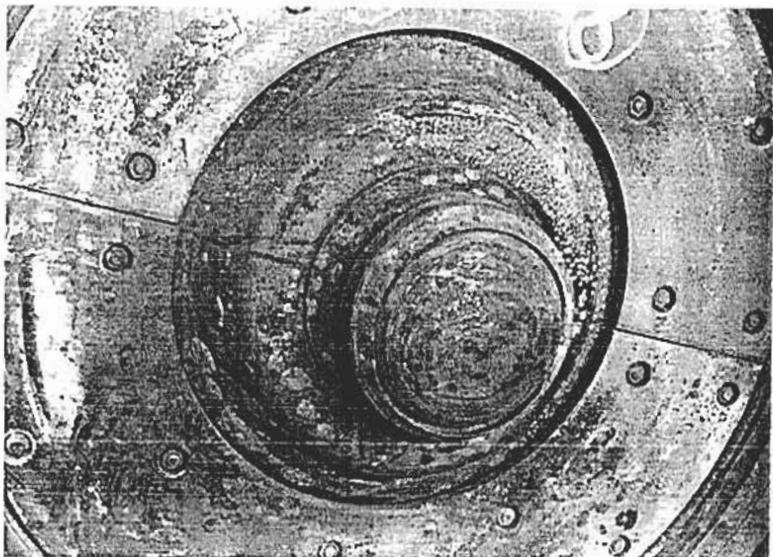
When the assembly was dismantled it was found that the nominally 150mm diameter journal varied from between 151mm in diameter where it was covered by the end cap to 92mm at the point of fracture. On the axle stub of the wheelset the bearing abutment ring still remained in position (Photograph 10). This was removed and the stub end sized beneath the abutment ring seat. Four measurements of the journal diameter were taken in this area, all were greater than the nominal 150mm and it was evident that the hot axle stub had received a blow causing the end to mushroom. The broken journal was offered to the stub and the dimension from the abutment ring seat to the axle end was taken. This was found to be 10mm greater than the nominal 208mm. From this information and examination of the fracture surface it was concluded that the failure was due to ductile shear fracture and that the reduction in diameter of the journal was due principally to tensile necking and not metal removal due to abrasive wear.

The wheels themselves showed no signs of flattening, indicating that they had continued to roll until derailment occurred. However, their surfaces became so damaged during derailment that accurate measurement of their diameter was not possible. That they were in comparatively new condition is evidenced in Photograph 10 where the last turning size groove can be clearly seen.

PHOTOGRAPH 10. Fracture Face of Broken Journal. Abutment Ring is still attached.
Photograph courtesy of British Railways.

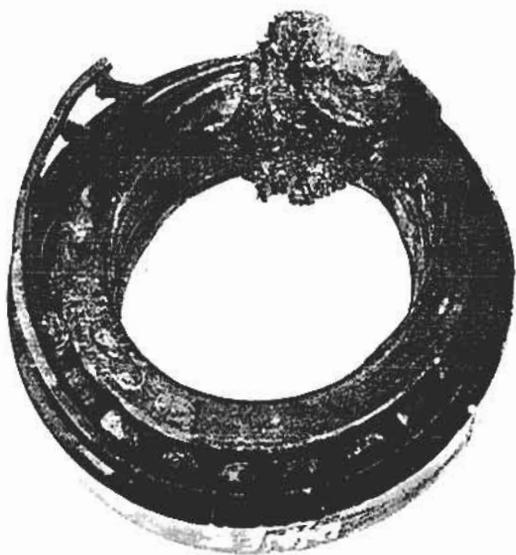
PHOTOGRAPH 11. Inboard Bearing showing the deposited metal and scour marks on the Inner Race.
Photograph courtesy of British Railways.

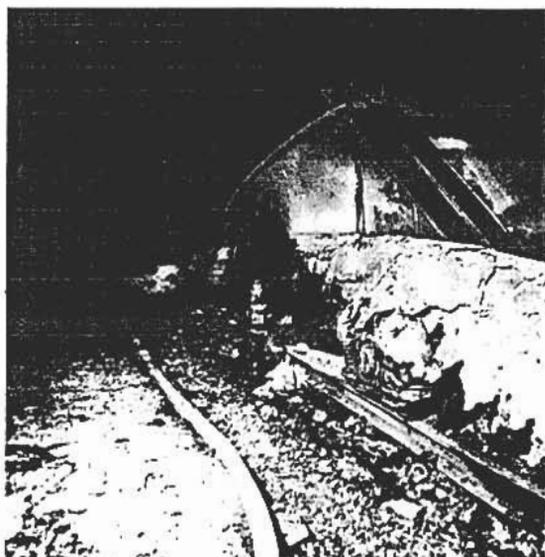
PHOTOGRAPH 13. Vehicle 5, showing melted parts of the Barrel.
Photograph courtesy of the Health and Safety Executive.

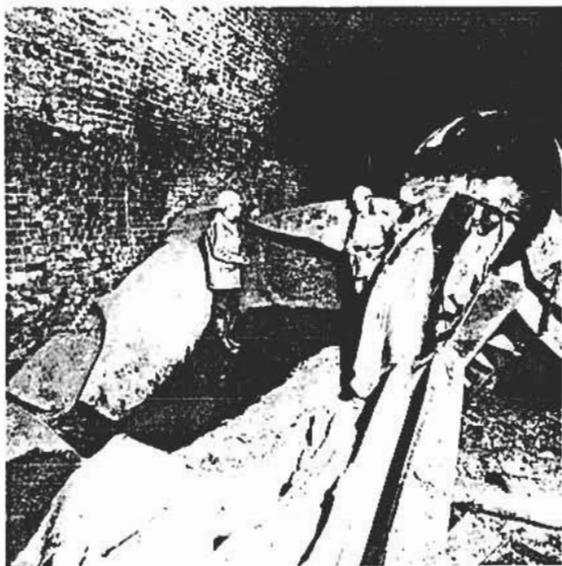
PHOTOGRAPH 16. Vehicle 10 which had burst along its length.
Photograph courtesy of the Health and Safety Executive.

5. In general, the pressure relief valves on the rail tank wagons operated satisfactorily during the fire and the petrol vented as expected. One tank burst along its length probably as a result of being engulfed in a particularly hot region of the fire.

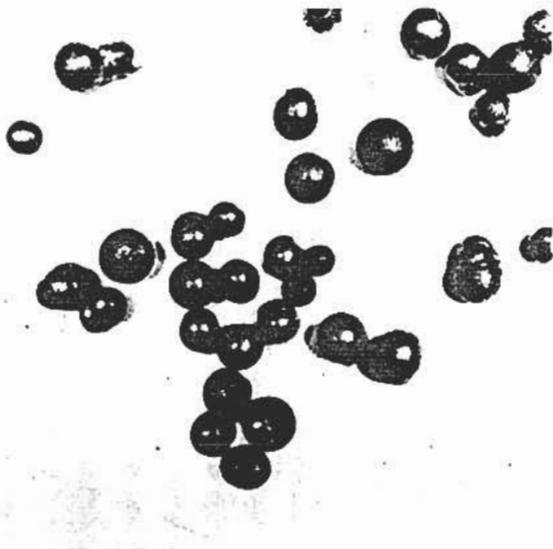
PHOTOGRAPH 17. Metal Spheres found on the surface in the vicinity of Shaft 9. (The largest sphere is about 7mm dia.)
Photograph courtesy of the Health and Safety Executive.

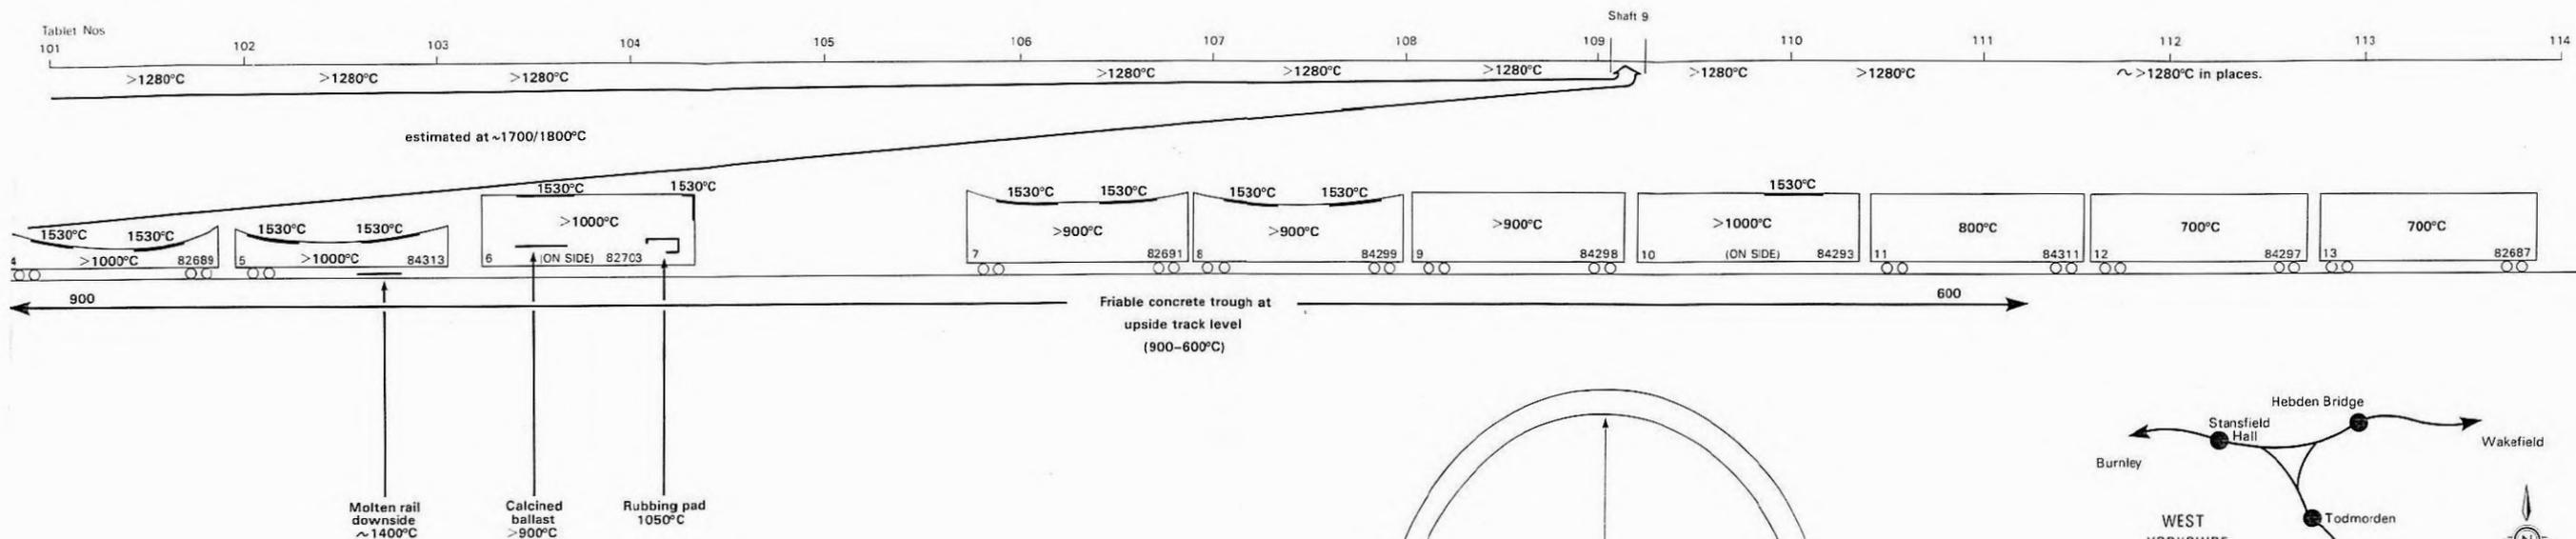
Fig. 2

The results obtained above indicate that there was no uniform temperature attained during the fire. A mean temperature in the region of 1300°C is indicated with temperatures higher at the roof than at ground level but local areas of the fire reached much higher temperatures. A temperature of 1530°C was clearly attained at the top of some of the barrels and a ground temperature of 1400°C was attained in the region of the melted rail.

ELEVATION: WITH PROBABLE TEMPERATURE RANGES DURING HEIGHT OF FIRE

SPOT TEMPERATURES RELATE TO IDENTIFIABLE PHYSICAL DEGRADATION
