MINISTRY OF TRANSPORT

RAILWAY ACCIDENTS

REPORT ON THE COLLISION
which occurred on
13th May 1950 at
WHITEHOUSE WEST JUNCTION
Nr. Preston
in the
LONDON MIDLAND REGION
BRITISH RAILWAYS

LONDON MIDLAND REGION
 Collision at Whitehouse West Junction, Preston
 13th May, 1950

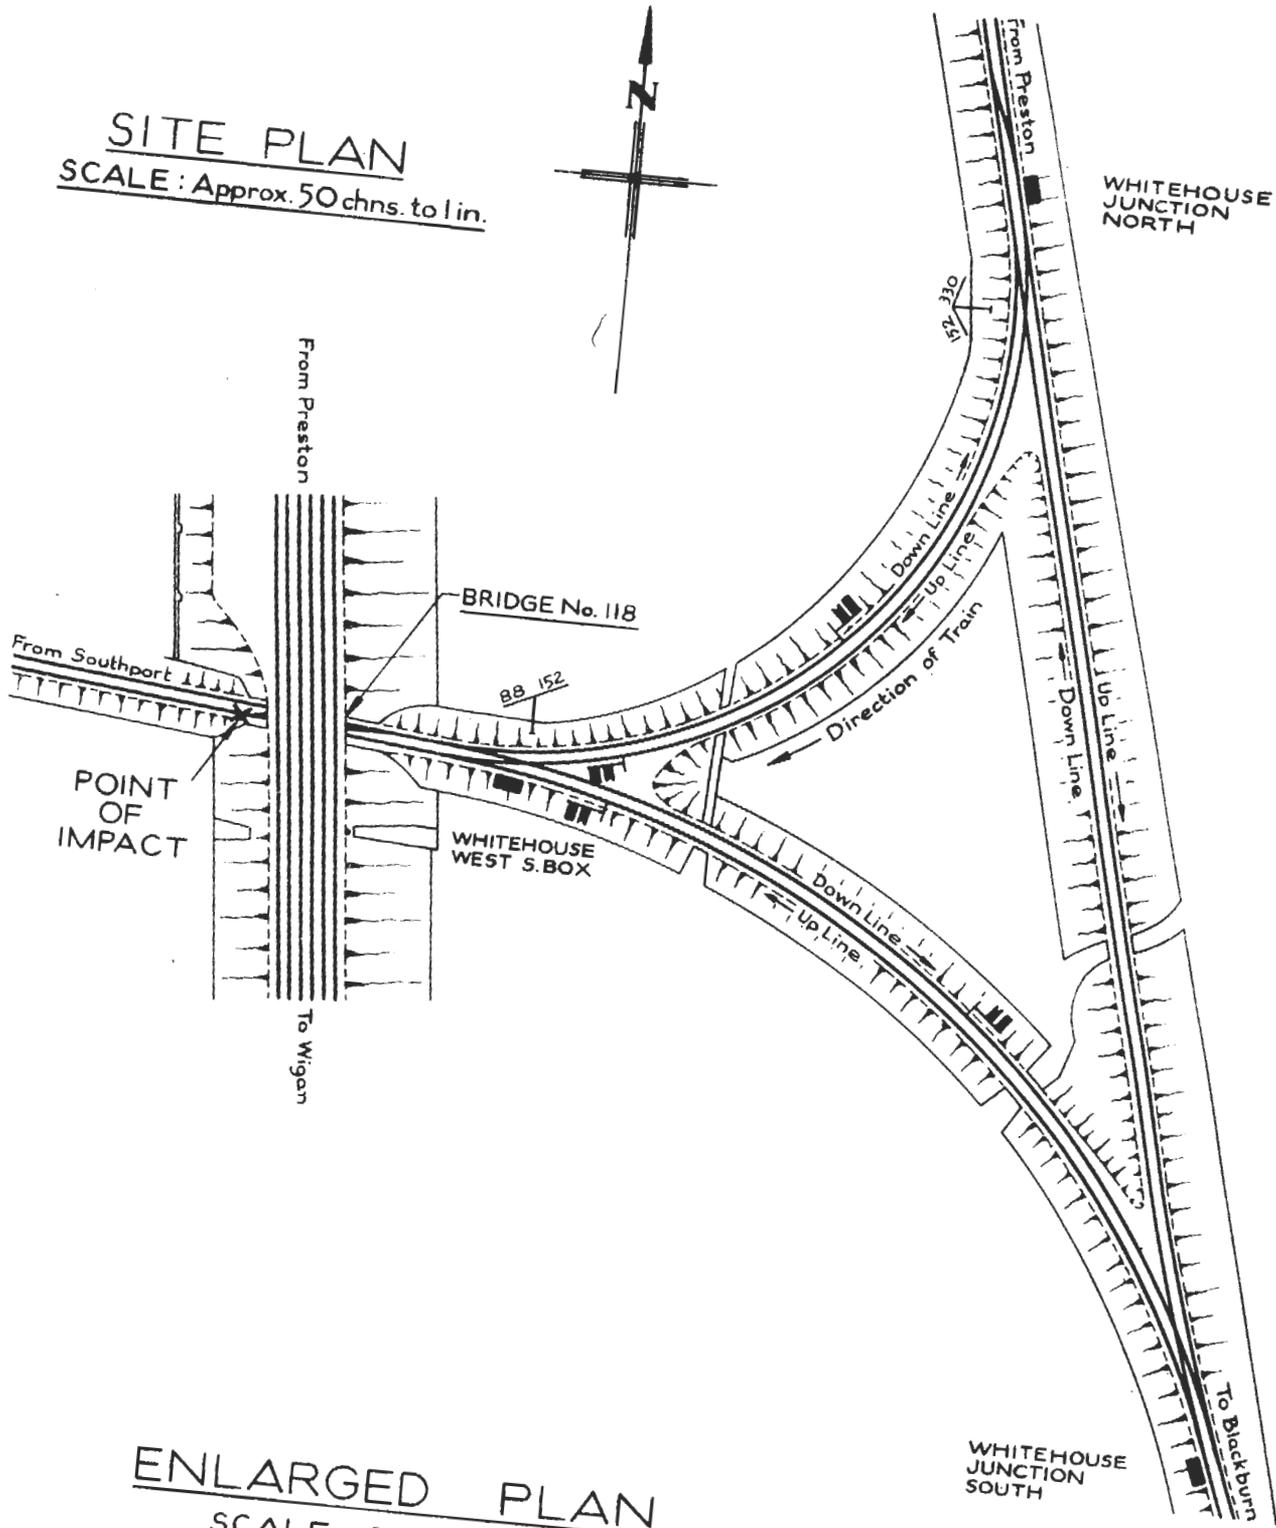
SITE PLAN
 SCALE: Approx. 50 chns. to 1 in.

1. The double line from Preston to Blackburn runs South through Whitehouse North and South Junctions as indicated on the diagram. The Southport route diverges to the right at the first-named junction and passes round a 12 chain curve to Whitehouse West Junction, where it is joined by a loop (known as the Fork line) from Whitehouse South, thus forming a triangle which is used for turning engines. The gradient from the North Junction falls at 1 in 152 to a point nearly opposite the West box, where it changes to 1 in 80 and then to level at the crossover trailing points. The formation at the West Junction is on a 20 feet embankment, and at the west end there is a 75 feet long overbridge carrying six railway tracks, including the main lines to the North via Preston. A 20 m.p.h. speed restriction is imposed through the Whitehouse North and West diverging junctions.

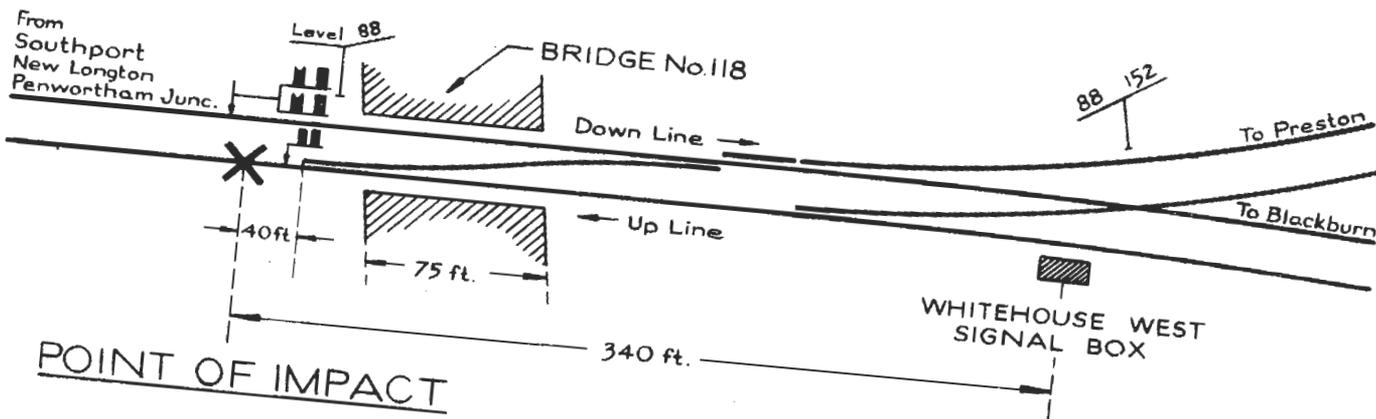
ENLARGED PLAN
 SCALE: 80 ft. to 1 in.

2. Whitehouse West signal box is conveniently located on the Up side overlooking the junction and the floor of the box is approximately 7 feet 6 inches above rail level. The trailing crossover, which is under the overbridge, can be clearly seen from the box, as can an engine waiting on the Up line at the Southport end, provided it does not pass the trailing points by more than an engine length. If it moves further towards Southport it is somewhat obscured by the overbridge, though it can be seen for a long distance by leaning out of the signal box window. All running signals are of the upper quadrant type, mechanically operated. The junction is protected in the normal way by Home signals, but Starters have only been provided on the two Down lines to Preston and Blackburn respectively. There is no Starting signal for the Up line to Southport nor are there any track circuits. A two-armed dwarf signal located in the six foot space at the west end of the overbridge controls shunting movements over the Up to Down crossover.
