APPENDIX No. 29.

LIVERPOOL, CROSBY, AND SOUTHPORT RAILWAY.

I HAVE the honour to report to you, for the information of the Lords of the Committee of Privy Council for Trade, the result of an inquiry which, in compliance with the instructions conveyed to me in your letter of the 26th ultimo, I made into the circumstances attending a singular accident which occurred upon the Liverpool, Crosby, and Southport Railway on the evening of the 11th ultimo.

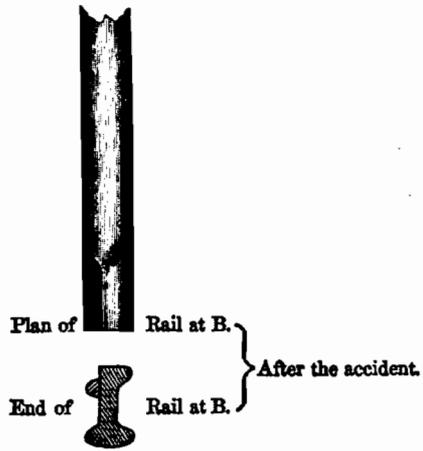
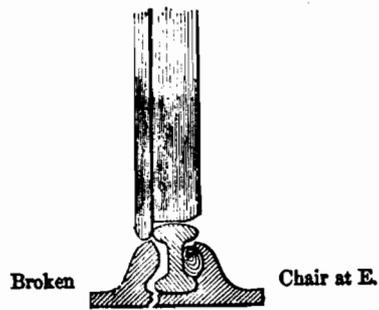
SKETCH No. 2.

On turning to the permanent way, several chairs were broken between A and B, three of the rails slightly bent, the fourth very much so, and in shape, as shown by sketch No. 1, leaving a break upon the inner surface of the next rail; upon this break the right leading wheel of the engine mounted, and ran off the rails suddenly; the right leading side of the engine had then mounted upon the bank, and its hinder end having been carried round upon the front end of the tender, was lodged cleared off the rails altogether, and the remainder of the tender was forced onwards by the carriages, for some distance beyond where the engine lay; everything showed that the right hind part and the right front of the tender had been in contact as described; under the foot-plate all was cleared away by the frame of the tender, and over it the hand railing, &c. had been taken off by the water tank, which was projected to the opposite side of the line, and the right side of the tender framing was broken downwards to the first axle, bearing on the same side.
