Ministry of Transport.

Railway Accidents.

On the Derailment of a Passenger Train,
which occurred on the 3rd November, 1924,
near Lytham, on the London, Midland and
Scottish Railway, as the result of the failure
of an engine tyre.

DERAILMENT AT LYTHAM (L.M. & S. RLY.)

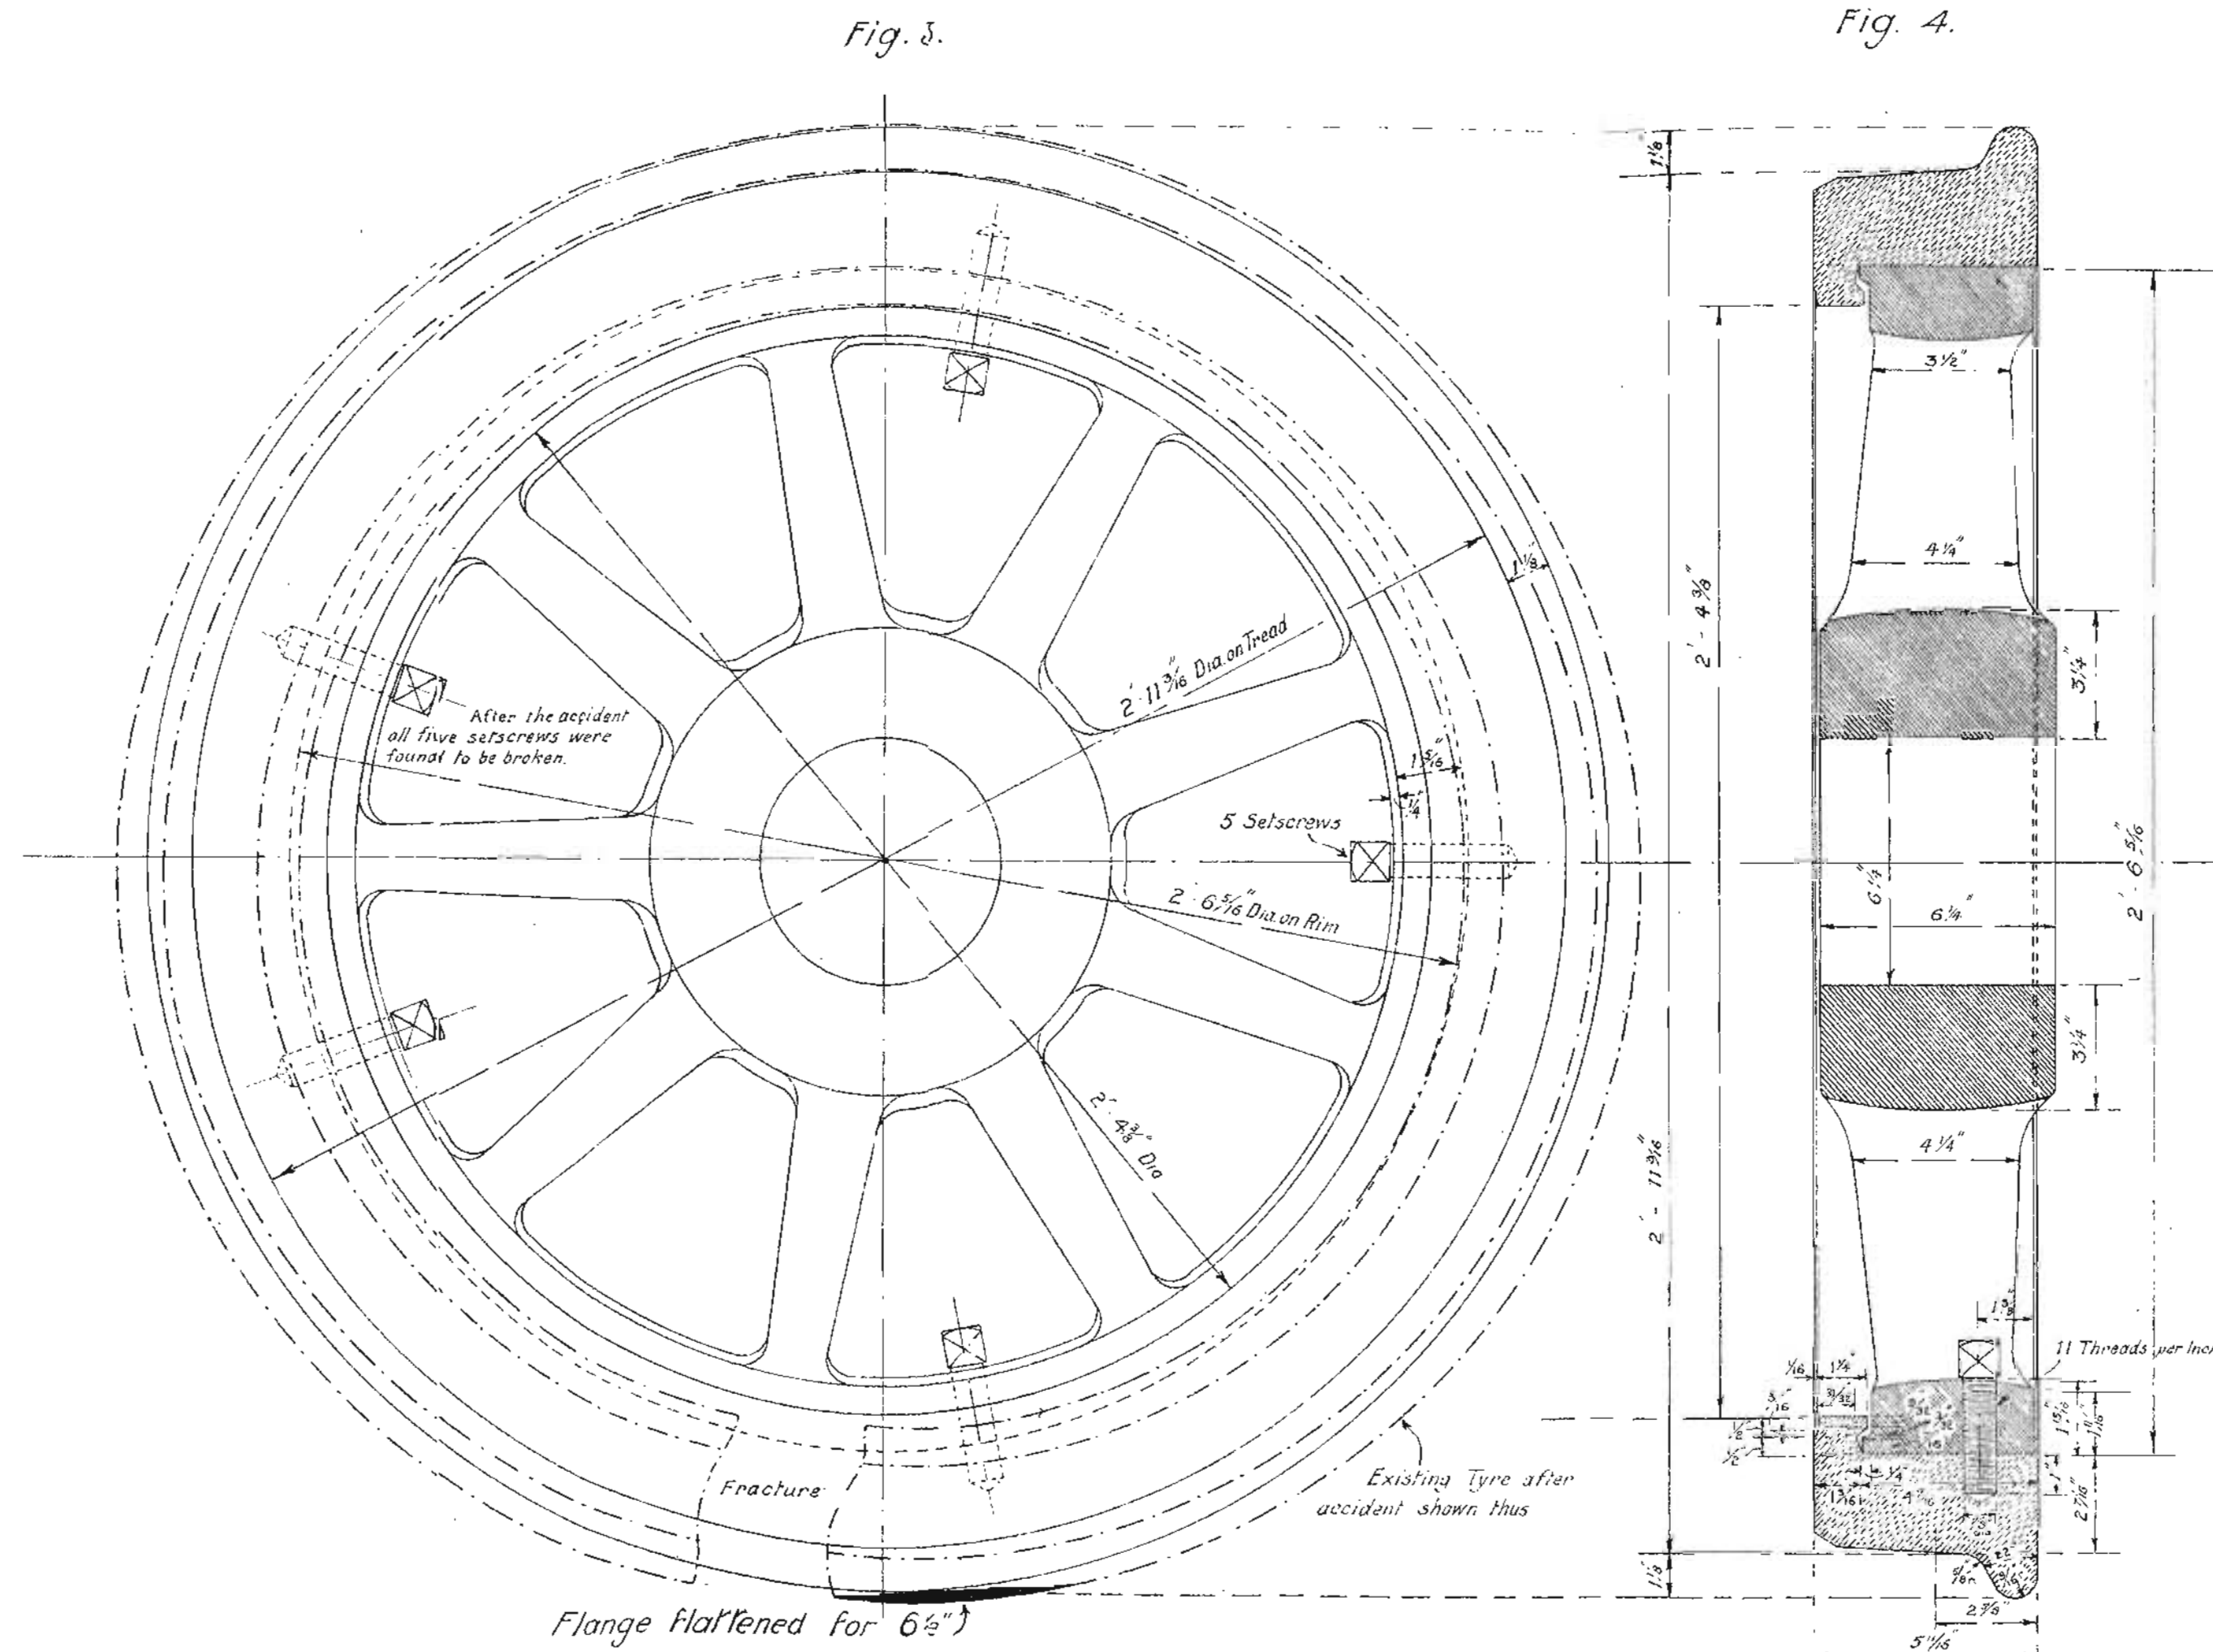
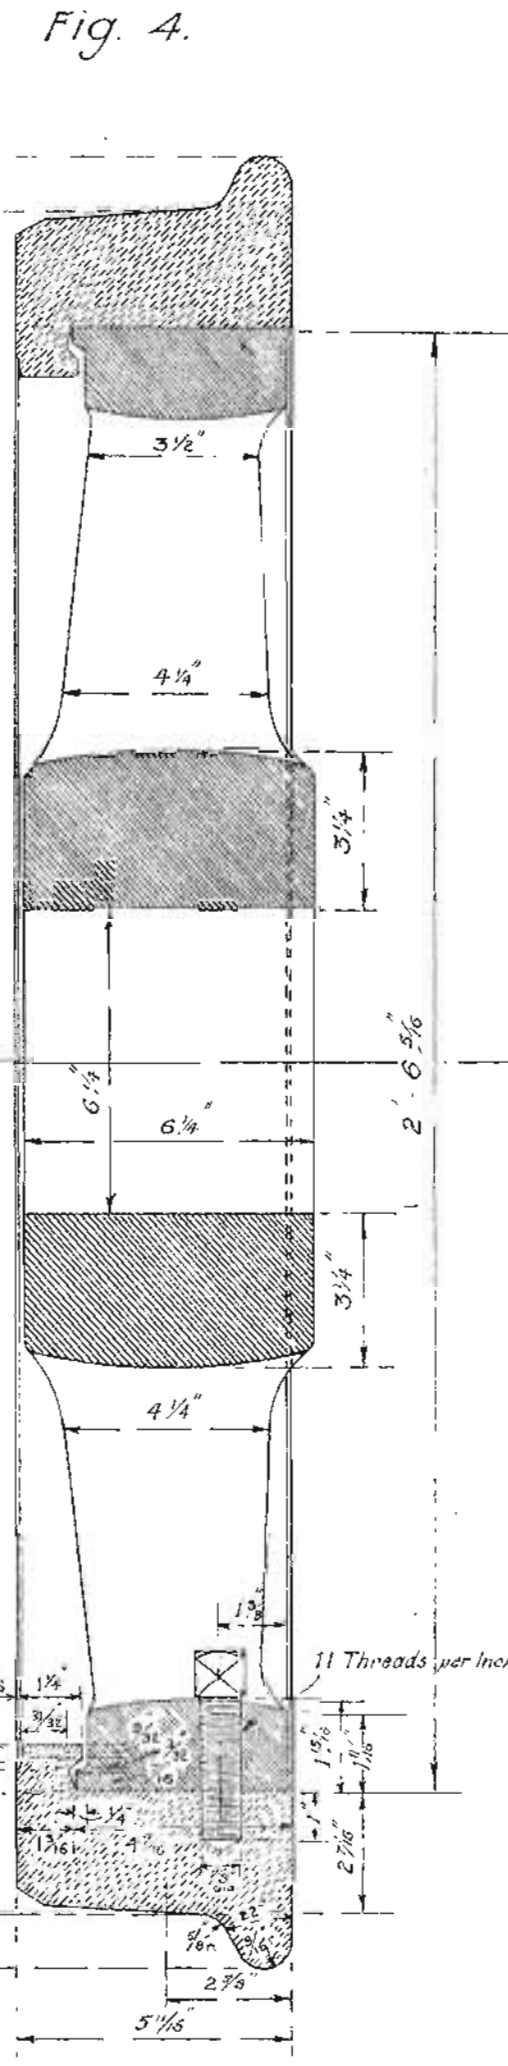
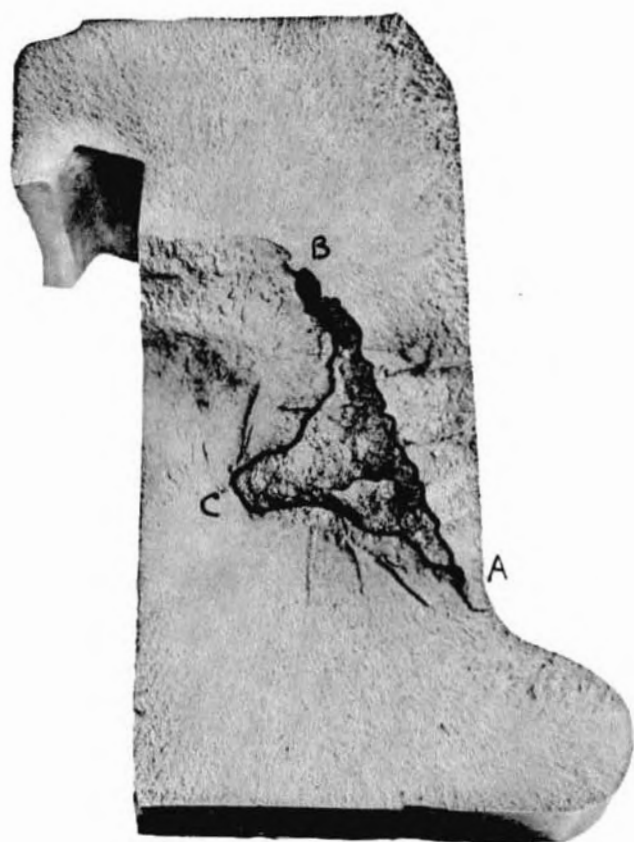
SKETCH OF BROKEN TYRE S628 3.20 W.

Fracture reveals presence of large defect (Plate III shews extent of defect as outlined in black).

Examination in the immediate region of the defect shews that there are many minute cavities and inclusions extending from the main cavity. From the arrangement of these it would appear that the walls of the cavity formerly larger in size were folded into the material during the manufacture of the tyre, without complete welding. The strength of the material in the region of the cavity has therefore been considerably reduced. No evidence has been found that the cavity at any point reached the outside of the tyre, so that its presence during manufacture would not be readily observed.

Chemical analysis and micro-structure do not reveal any causes which would account for the failure of the tyre. The fracture has occurred in the region of a defect due to a cavity in the original steel ingot, which occupies a considerable proportion of the cross section. The defect has probably been considerably reduced in size by rolling, but the folded surfaces still constitute lines of weakness. Defects of this character are usually situated in the centre of the ingot and are generally removed by cropping or by piercing of the tyre blank. The unusual position of the cavity has probably been responsible for the failure to detect it during manufacture.

The presence of a defect of this size is sufficient to account for the failure.
