**RAILWAY ACCIDENT AT HUDDERSFIELD**

A report on a collision that occurred  
on 6 November 1989

I report for the information of the Secretary of State for Transport, in accordance with the Direction dated 11 December 1989, the result of my Inquiry into the head-on collision between two passenger trains that occurred at 21.56 on Monday, 6 November 1989, at Huddersfield in the then Eastern Region of British Railways.

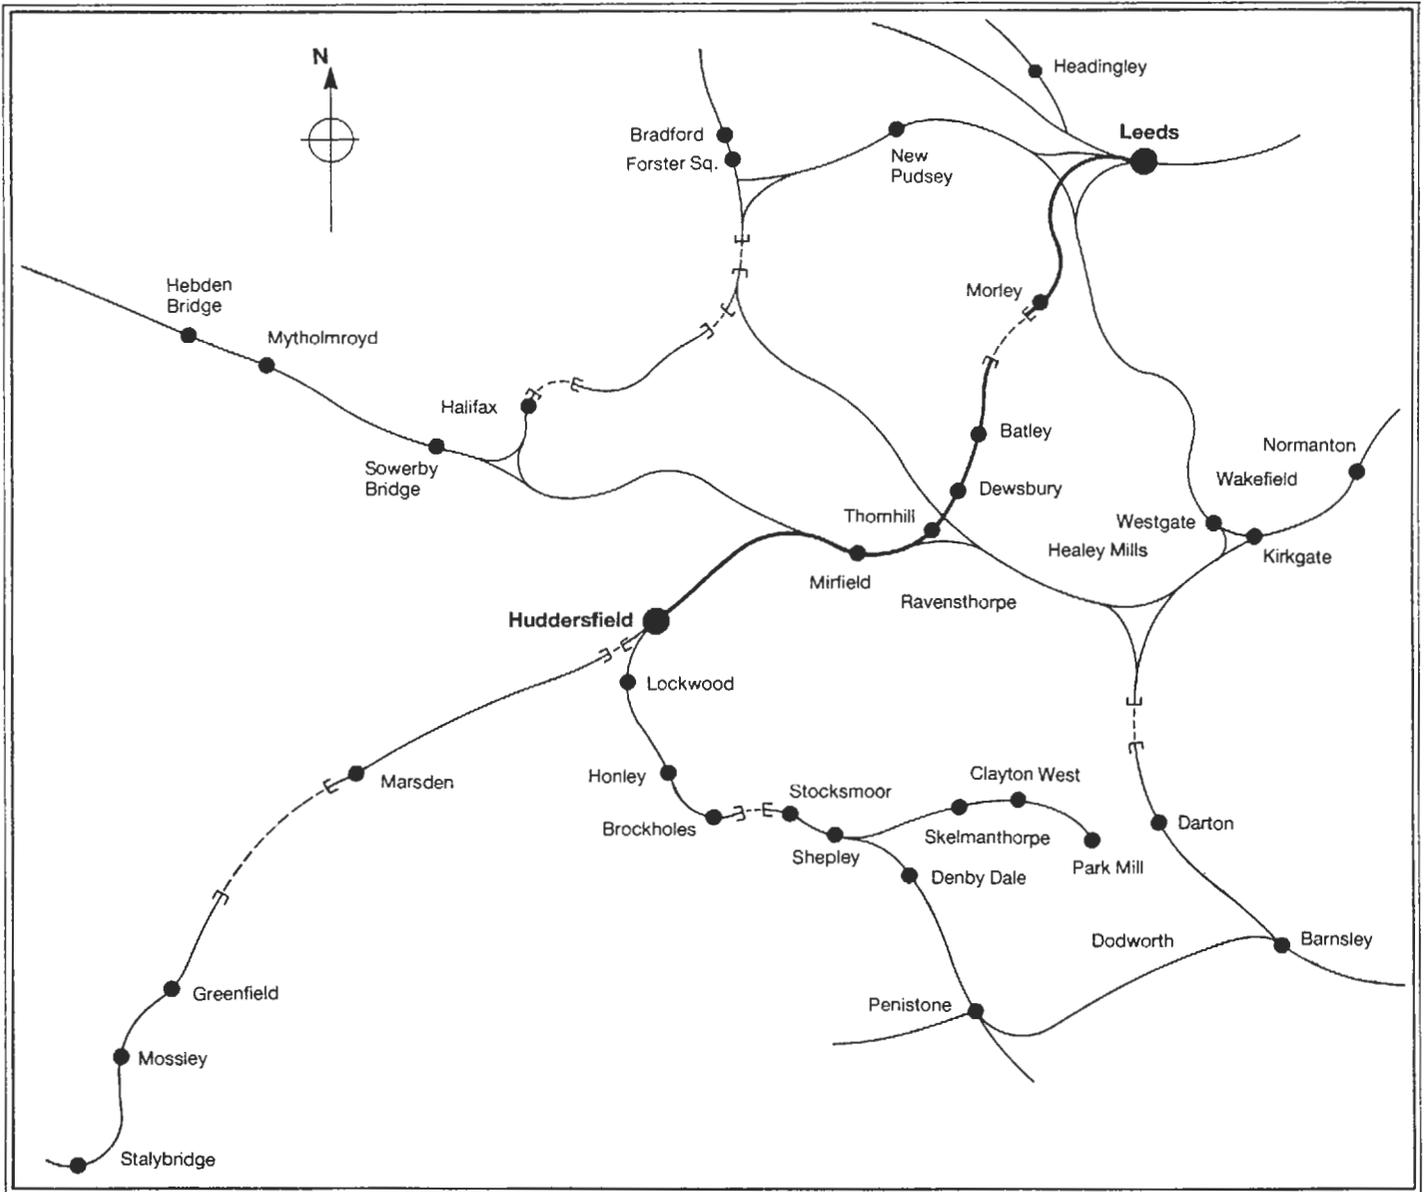
Figure 1 Location plan

2 The primary running lines at the east end of the station comprised an Up Main line (from Leeds direction) and a Down Main line (towards Leeds). The collision occurred at Signal HU77, when the Wakefield train had travelled some 314 metres. The location is depicted at Figure 1. Figure 2 shows the general layout.
