DEPARTMENT OF TRANSPORT

RAILWAY ACCIDENT

Report on the Derailment and Fire that occurred on 20th December 1984 at Summit Tunnel

IN THE
LONDON MIDLAND REGION
OF BRITISH RAILWAYS

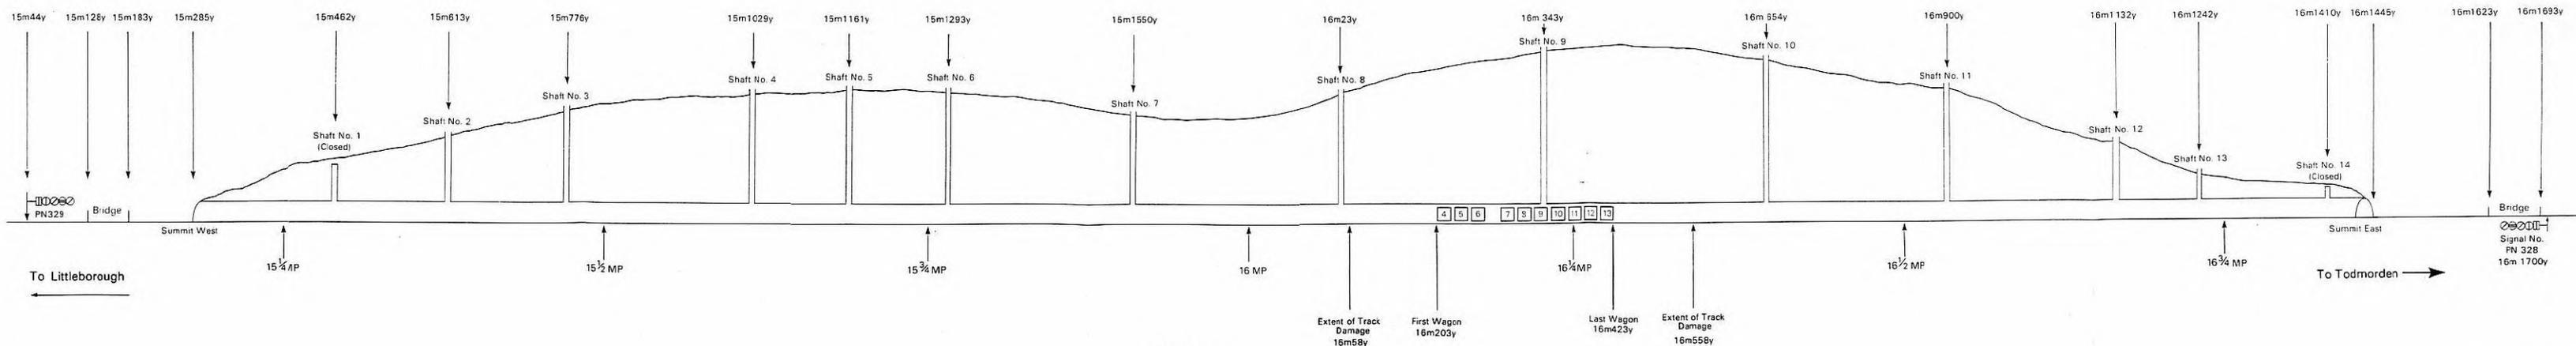
Fig. 1a
TUNNEL DIAGRAM
(Not to scale)

ELEVATION: WITH PROBABLE TEMPERATURE RANGES DURING HEIGHT OF FIRE

SPOT TEMPERATURES RELATE TO IDENTIFIABLE PHYSICAL DEGRADATION

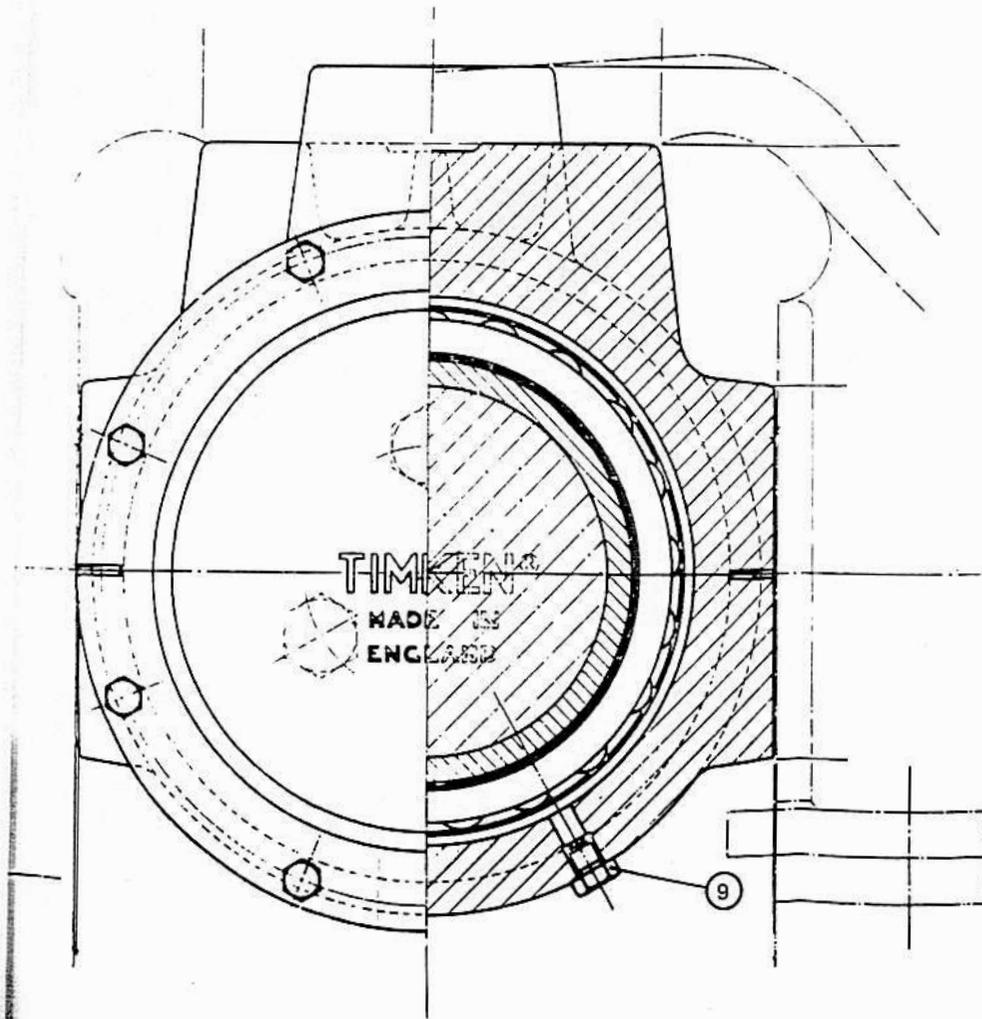
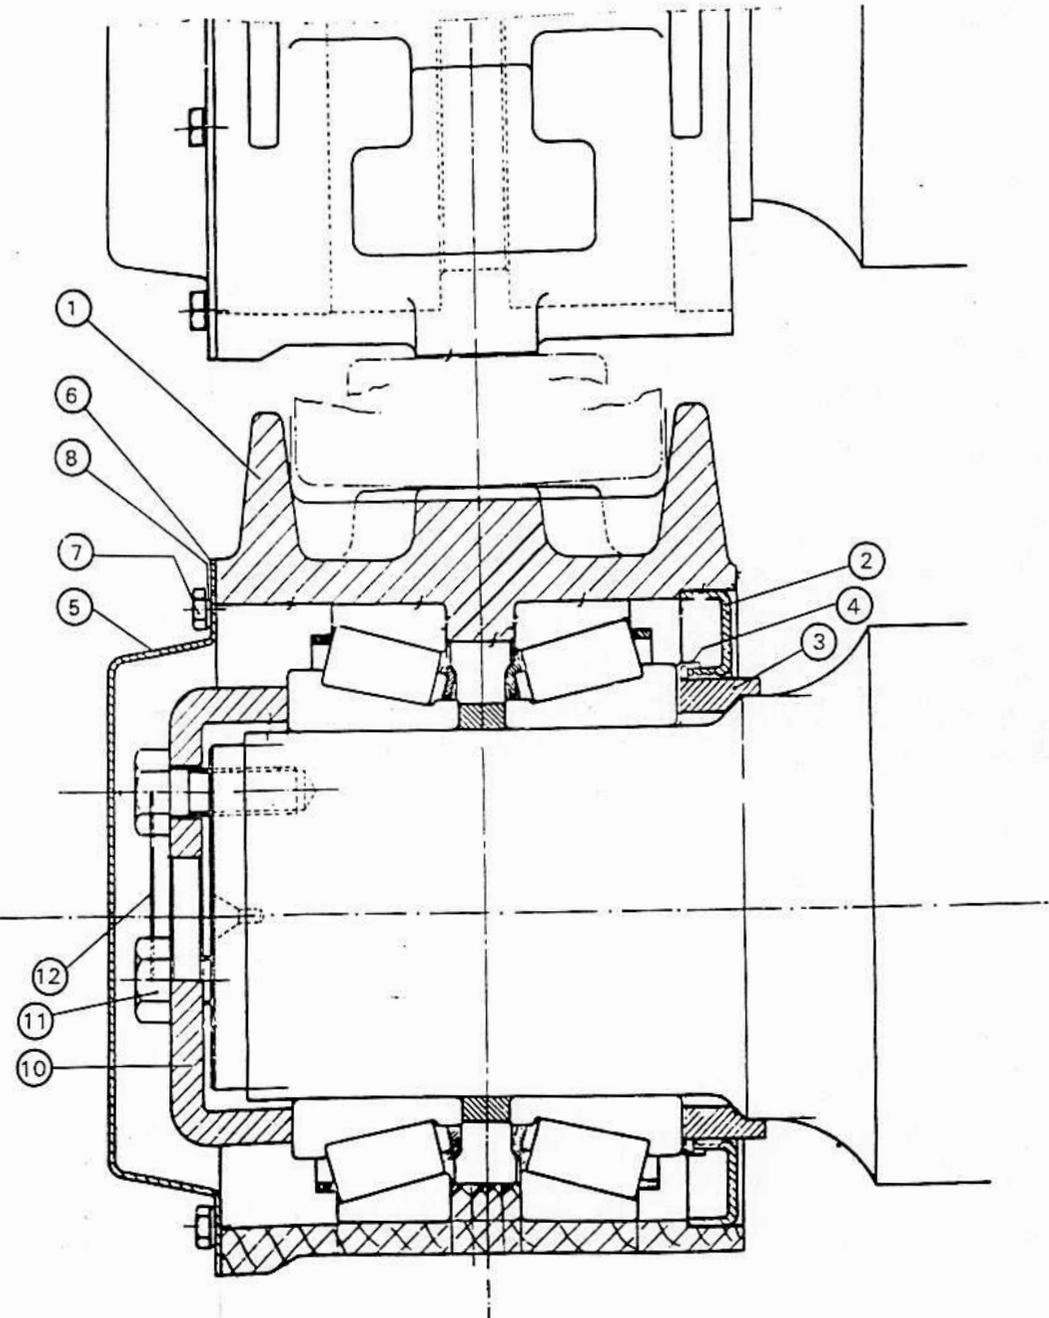
Fig. 3

Photograph 8 shows the axlebox with the broken journal inside and Photograph 9 the outer end of the bearing with the inspection plate removed to reveal the outboard bearing and locking cap. In both views displaced or misshapen rollers can be seen together with their damaged cages. A general arrangement drawing of the axlebox assembly mounted on the journal is at Fig 3 at the back of this report.
