# **RAILWAY ACCIDENT**

**Report on the Collision that  
occurred on 18th January 1986  
at Preston**

**IN THE  
LONDON MIDLAND REGION  
OF BRITISH RAILWAYS**

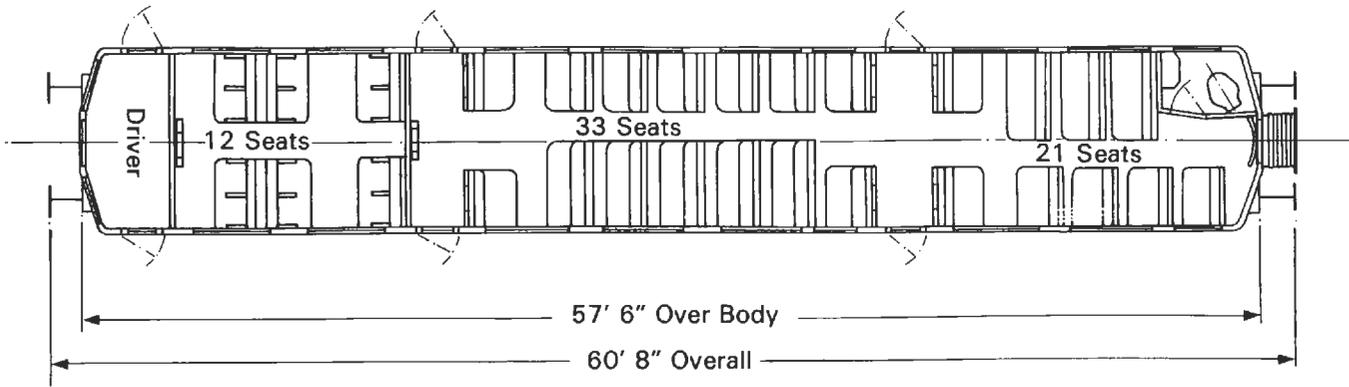
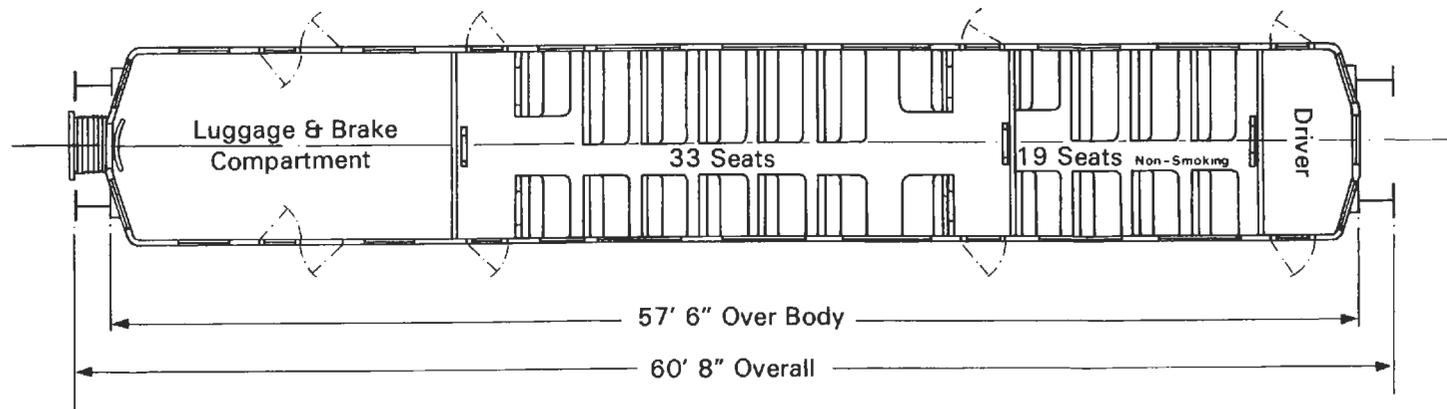
Diagram 3 : Layout of the Diesel Multiple Unit

Leading Car 53482

Trailing Car 53433

26. He said that the front cab and passenger compartment of the DMU were completely destroyed and the leading (No 1) bogie had been forced back to a position under the No 2 engine. He examined the brake blocks, which were in good condition, and the wheels of the DMU and found no overheating or other signs of prolonged or heavy braking. From this he concluded that if the brakes of the DMU had been applied it would only have been for a short distance before the collision. His attention was drawn to the fact that the pistons on the three brake cylinders, which were intact, were in the released position. One of the exhausters had been destroyed but the other three appeared to be in working order and the driving belts were intact and in line.
